Profile/Photo Observation Report

Date:	03/28/2018	Weather:		Coding:	PACP 6.0
Pipe Length (ft):	103.6	Owner:	NA	Pre Clean:	Not Known
P.O.#:		Surveyor:	Selasie Honu	PSR:	P-804-073-032
Customer:		Clean Date:	01/01/1900	Shape:	C

Street:	HIGH ST	Flow Control:	Not Controlled
City:	Hobart, IN	Year Renewed:	
Location:	Other	Tape/Media #:	
Purpose:	Not Known	Dia/Height:	10"
Use:	Sanitary	Material:	VCP
Drain Area:	NA	Lining:	
Category:	NA		
Comment:

Location Details:		Direction of Survey:	Upstream
US MH:	M-803-032	DS MH:	M-804-073
		Total Length Surveyed (ft):	94.4

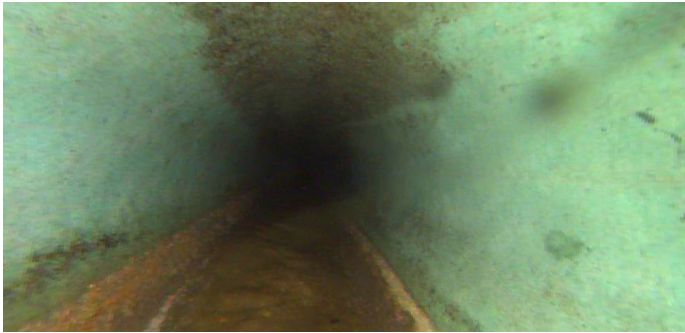
Code:	MWL
Description:	Water Level

Distance (ft):	.0
Structural Grade:	0
O&M Grade:	0
Clock Start/From:	
Clock To:	
1st Value:	
2nd Value:	
Value Percent:	5.000
Continuous Index:	
Within 8" of Joint:	NO
Remarks:

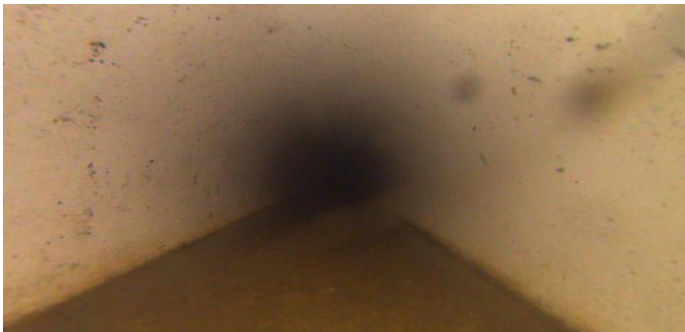
Code:	MWL
Description:	Water Level

Distance (ft):	47.8
Structural Grade:	0
O&M Grade:	0
Clock Start/From:	
Clock To:	
1st Value:	
2nd Value:	
Value Percent:	20.000
Continuous Index:	
Within 8" of Joint:	NO
Remarks:

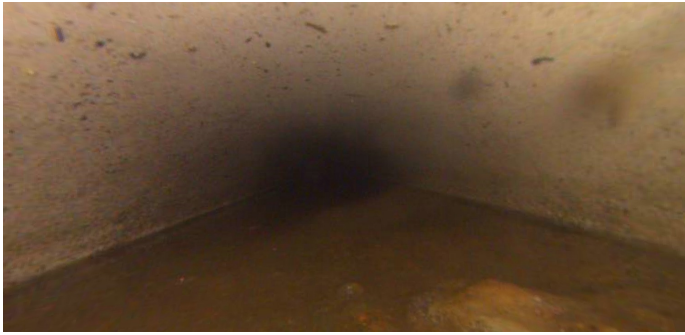
Code: **MWL**
Description: **Water Level**

Distance (ft): **65.7**
Structural Grade: **0**
O&M Grade: **0**
Clock Start/From:
Clock To:
1st Value:
2nd Value:
Value Percent: **40.000**
Continuous Index:
Within 8" of Joint: **NO**
Remarks:

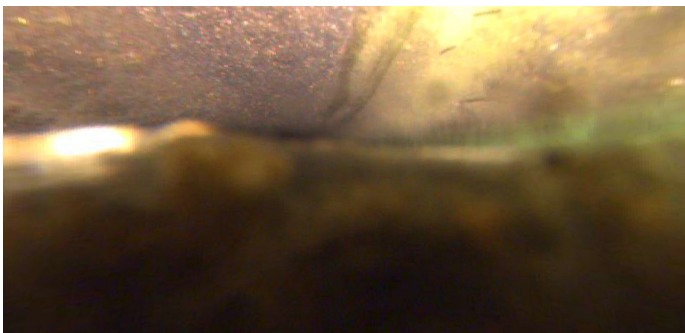
Code: **MWLS**
Description: **Water Level Sag**

Distance (ft): **90.4**
Structural Grade: **2**
O&M Grade: **3**
Clock Start/From:
Clock To:
1st Value:
2nd Value:
Value Percent: **10.000**
Continuous Index:
Within 8" of Joint: **NO**
Remarks:
