Profile/Photo Observation Report

Street:	HIGH ST	Flow Control:	Not Controlled
City:	Hobart, IN	Year Renewed:	
Location:	Other	Tape/Media #:	
Purpose:	Not Known	Dia/Height:	10"
Use:	Sanitary	Material:	VCP
Drain Area:	NA	Lining:	
Category:	NA		
Comment:

Location Details:		Direction of Survey:	Upstream
US MH:	M-803-032	DS MH:	M-804-073
		Total Length Surveyed (ft):	94.4

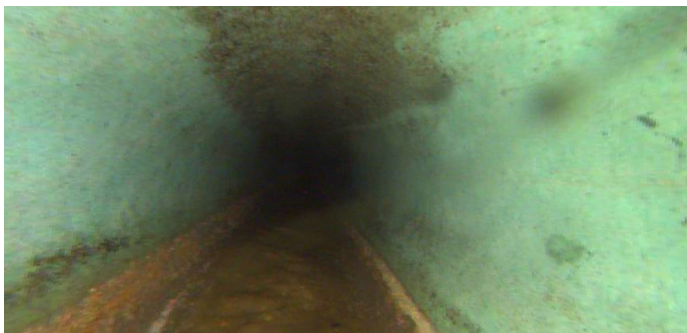
Code: **AMH**
 Description: **Manhole**
 Distance (ft): **.0**
 Structural Grade: **0**
 O&M Grade: **0**
 Clock Start/From:
 Clock To:
 1st Value:
 2nd Value:
 Value Percent:
 Continuous Index:
 Within 8" of Joint: **NO**
 Remarks: **M-804-073**

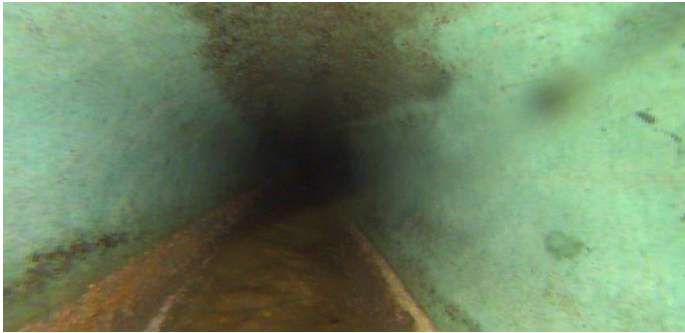
Code:	MWL
Description:	Water Level

Distance (ft):	.0
Structural Grade:	0
O&M Grade:	0
Clock Start/From:	
Clock To:	
1st Value:	
2nd Value:	
Value Percent:	5.000
Continuous Index:	
Within 8" of Joint:	NO
Remarks:

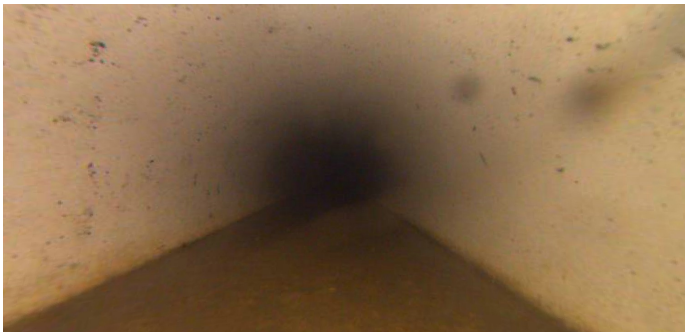
Code:	MWL
Description:	Water Level

Distance (ft):	47.8
Structural Grade:	0
O&M Grade:	0
Clock Start/From:	
Clock To:	
1st Value:	
2nd Value:	
Value Percent:	20.000
Continuous Index:	
Within 8" of Joint:	NO
Remarks:

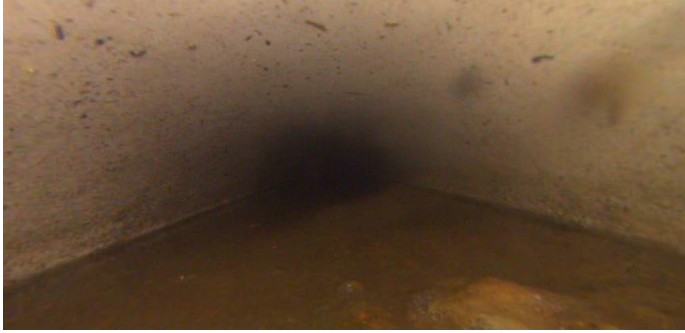
Code: **MWL**
Description: **Water Level**

Distance (ft): **65.7**
Structural Grade: **0**
O&M Grade: **0**
Clock Start/From:
Clock To:
1st Value:
2nd Value:
Value Percent: **40.000**
Continuous Index:
Within 8" of Joint: **NO**
Remarks:

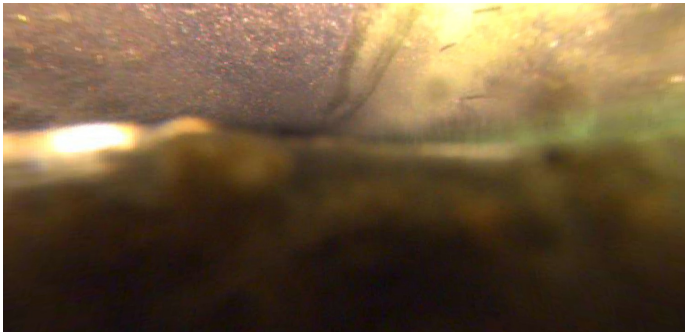
Code: **MWLS**
Description: **Water Level Sag**

Distance (ft): **90.4**
Structural Grade: **2**
O&M Grade: **3**
Clock Start/From:
Clock To:
1st Value:
2nd Value:
Value Percent: **10.000**
Continuous Index:
Within 8" of Joint: **NO**
Remarks:
