Profile/Photo Observation Report

Street:	ALLEY BETWEEN N INDIANA ST & N	Flow Control:	Not Controlled
City:	Hobart, IN	Year Renewed:	
Location:	Other	Tape/Media #:	
Purpose:	Not Known	Dia/Height:	10"
Use:	Sanitary	Material:	VCP
Drain Area:	NA	Lining:	
Category:	NA		
Comment:

Location Details:		Direction of Survey:	Upstream
US MH:	M-803-033	DS MH:	M-803-032
		Total Length Surveyed (ft):	7.1

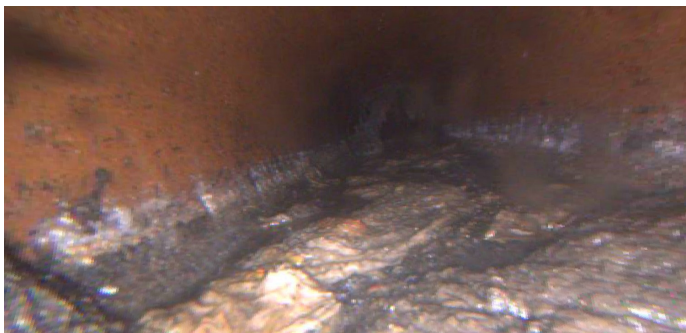
Code: **AMH**
Description: **Manhole**

Distance (ft): **.0**
Structural Grade: **0**
O&M Grade: **0**
Clock Start/From:
Clock To:
1st Value:
2nd Value:
Value Percent:
Continuous Index:
Within 8" of Joint: **NO**
Remarks: **M-803-032**

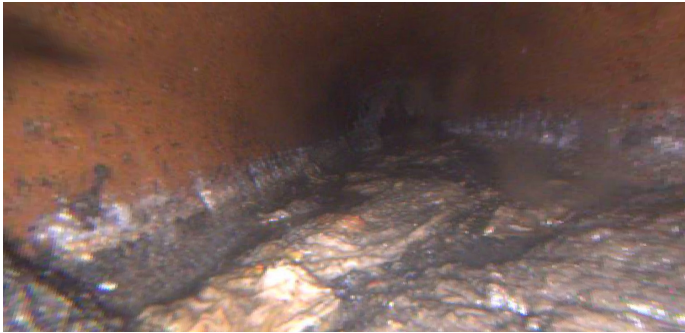
Code:	MWL
Description:	Water Level

Distance (ft):	.0
Structural Grade:	0
O&M Grade:	0
Clock Start/From:	
Clock To:	
1st Value:	
2nd Value:	
Value Percent:	5.000
Continuous Index:	
Within 8" of Joint:	NO
Remarks:

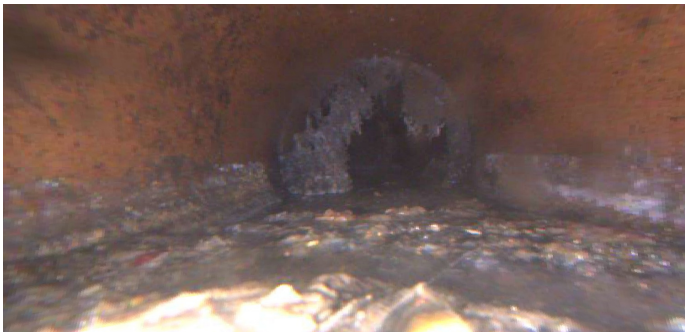
Code:	RMJ
Description:	Roots Medium Joint

Distance (ft):	2.8
Structural Grade:	0
O&M Grade:	3
Clock Start/From:	7
Clock To:	5
1st Value:	
2nd Value:	
Value Percent:	40.000
Continuous Index:	
Within 8" of Joint:	YES
Remarks:

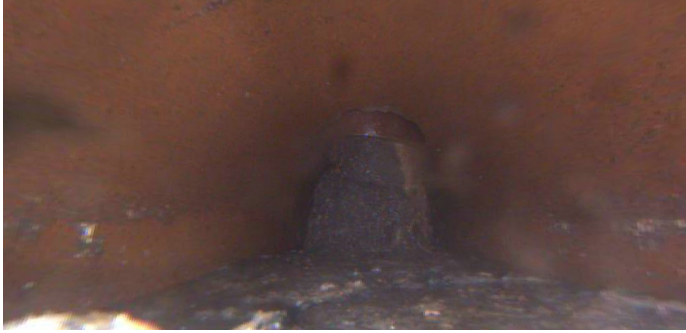
Code: **RBL**
Description: **Roots Ball Lateral**

Distance (ft): **4.8**
Structural Grade: **0**
O&M Grade: **4**
Clock Start/From: **12**
Clock To: **12**
1st Value:
2nd Value:
Value Percent: **60.000**
Continuous Index:
Within 8" of Joint: **NO**
Remarks:

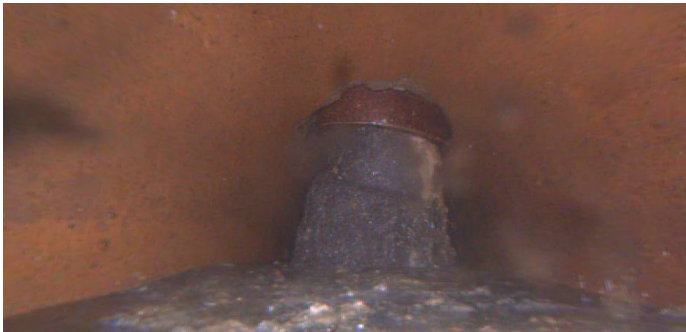
Code: **TBI**
Description: **Tap Break-in Intruding**

Distance (ft): **5.2**
Structural Grade: **0**
O&M Grade: **2**
Clock Start/From: **12**
Clock To:
1st Value: **4.000**
2nd Value: **1.000**
Value Percent:
Continuous Index:
Within 8" of Joint: **NO**
Remarks:

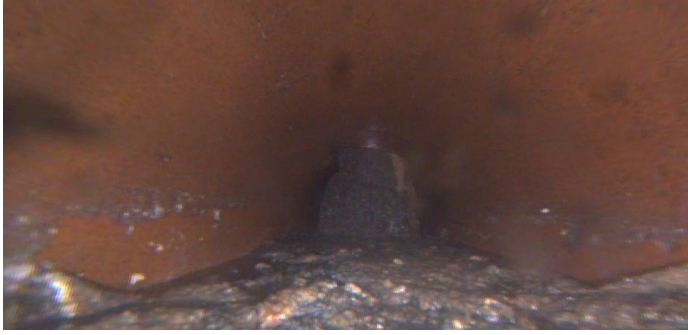
Code:	MSA
Description:	Abandoned Survey
Distance (ft):	7.1
Structural Grade:	0
O&M Grade:	0
Clock Start/From:	
Clock To:	
1st Value:	
2nd Value:	
Value Percent:	
Continuous Index:	
Within 8" of Joint:	NO
Remarks:	camera stopped
