Profile/Photo Observation Report

Date:	03/28/2018	Weather:		Coding:	PACP 6.0
Pipe Length (ft):	301.5	Owner:	NA	Pre Clean:	Not Known
P.O.#:		Surveyor:	Selasie Honu	PSR:	P-803-032-033
Customer:		Clean Date:	01/01/1900	Shape:	C

Street:	N INDIANA ST	Flow Control:	Not Controlled
City:	Hobart, IN	Year Renewed:	
Location:	Other	Tape/Media #:	
Purpose:	Not Known	Dia/Height:	10"
Use:	Sanitary	Material:	VCP
Drain Area:	NA	Lining:	
Category:	NA		
Comment:

Location Details:		Direction of Survey:	Upstream
US MH:	M-803-033	DS MH:	M-803-032
		Total Length Surveyed (ft):	7.1

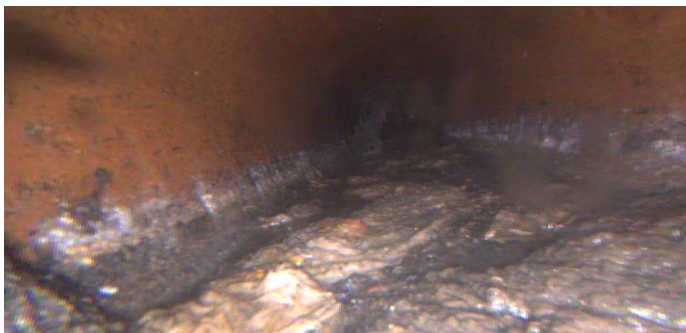
Code: **AMH**
Description: **Manhole**

Distance (ft): **.0**
Structural Grade: **0**
O&M Grade: **0**
Clock Start/From:
Clock To:
1st Value:
2nd Value:
Value Percent:
Continuous Index:
Within 8" of Joint: **NO**
Remarks: **M-803-032**

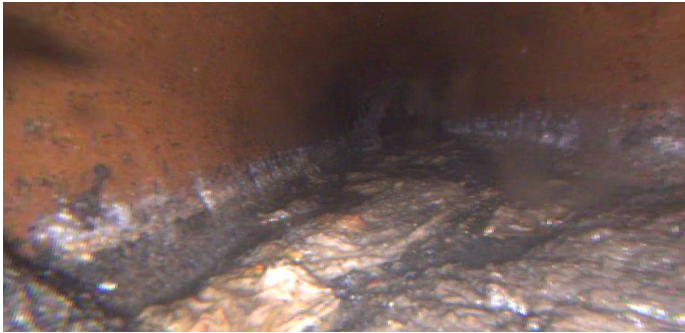
Code:	MWL
Description:	Water Level

Distance (ft):	.0
Structural Grade:	0
O&M Grade:	0
Clock Start/From:	
Clock To:	
1st Value:	
2nd Value:	
Value Percent:	5.000
Continuous Index:	
Within 8" of Joint:	NO
Remarks:

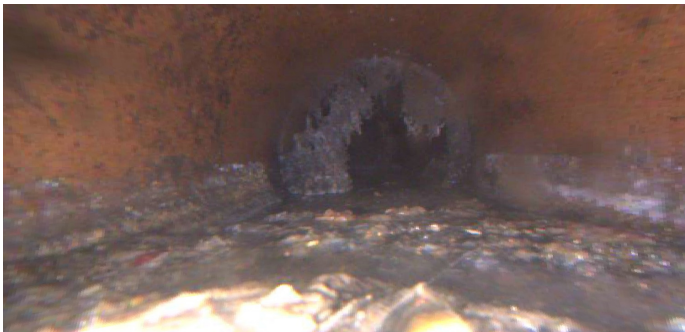
Code:	RMJ
Description:	Roots Medium Joint

Distance (ft):	2.8
Structural Grade:	0
O&M Grade:	3
Clock Start/From:	7
Clock To:	5
1st Value:	
2nd Value:	
Value Percent:	40.000
Continuous Index:	
Within 8" of Joint:	YES
Remarks:

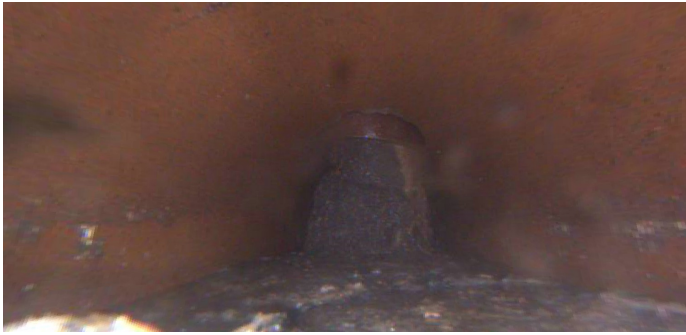
Code: **RBL**
Description: **Roots Ball Lateral**

Distance (ft): **4.8**
Structural Grade: **0**
O&M Grade: **4**
Clock Start/From: **12**
Clock To: **12**
1st Value:
2nd Value:
Value Percent: **60.000**
Continuous Index:
Within 8" of Joint: **NO**
Remarks:

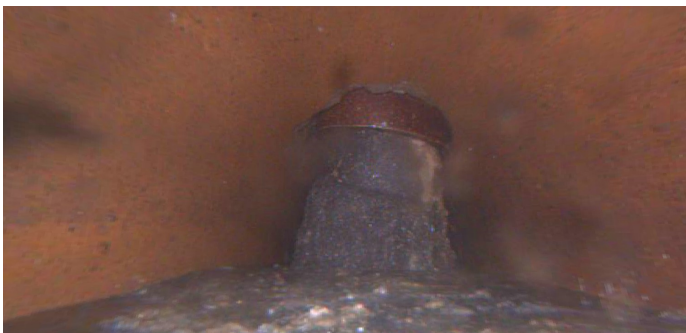
Code: **TBI**
Description: **Tap Break-in Intruding**

Distance (ft): **5.2**
Structural Grade: **0**
O&M Grade: **2**
Clock Start/From: **12**
Clock To:
1st Value: **4.000**
2nd Value: **1.000**
Value Percent:
Continuous Index:
Within 8" of Joint: **NO**
Remarks:

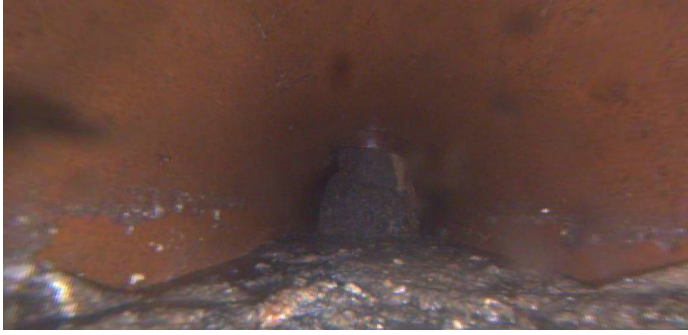
Code:	MSA
Description:	Abandoned Survey
Distance (ft):	7.1
Structural Grade:	0
O&M Grade:	0
Clock Start/From:	
Clock To:	
1st Value:	
2nd Value:	
Value Percent:	
Continuous Index:	
Within 8" of Joint:	NO
Remarks:	camera stopped
