## Profile/Photo Observation Report

Street:	<b>ALLEY BETWEEN N INDIANA ST &amp; N</b>	Flow Control:	<b>Not Controlled</b>
City:	<b>Hobart, IN</b>	Year Renewed:	
Location:	<b>Light Highway</b>	Tape/Media #:	
Purpose:	<b>Routine Assessment</b>	Dia/Height:	<b>12"</b>
Use:	<b>Sanitary</b>	Material:	<b>VCP</b>
Drain Area:	<b>NA</b>	Lining:	
Category:	<b>NA</b>		
Comment:

Location Details:		Direction of Survey:	<b>Upstream</b>
US MH:	<b>M-803-033</b>	DS MH:	<b>M-803-032</b>
		Total Length Surveyed (ft):	<b>5.2</b>

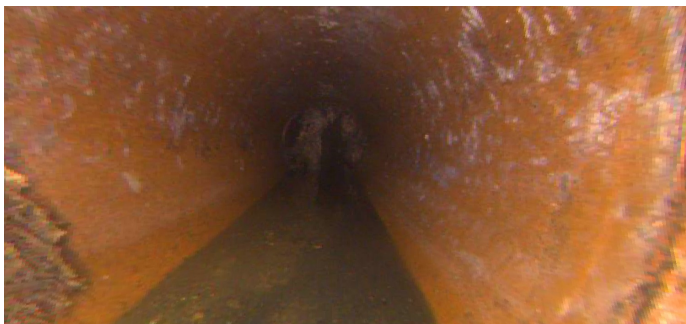
Code: **AMH**  
Description: **Manhole**

Distance (ft): **.0**  
Structural Grade: **0**  
O&M Grade: **0**  
Clock Start/From:  
Clock To:  
1st Value:  
2nd Value:  
Value Percent:  
Continuous Index:  
Within 8" of Joint: **NO**  
Remarks: **M-803-032**

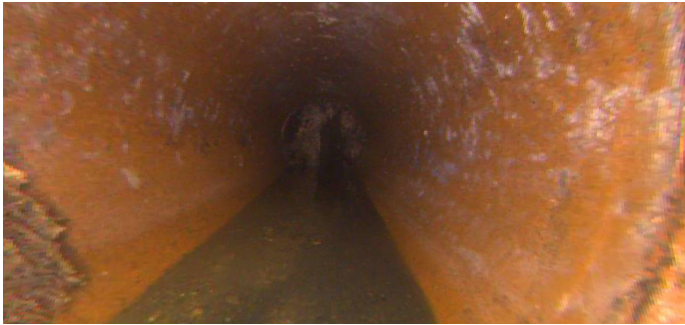
Code:	<b>MWL</b>
Description:	<b>Water Level</b>

Distance (ft):	<b>.0</b>
Structural Grade:	<b>0</b>
O&M Grade:	<b>0</b>
Clock Start/From:	
Clock To:	
1st Value:	
2nd Value:	
Value Percent:	<b>5.000</b>
Continuous Index:	
Within 8" of Joint:	<b>NO</b>
Remarks:

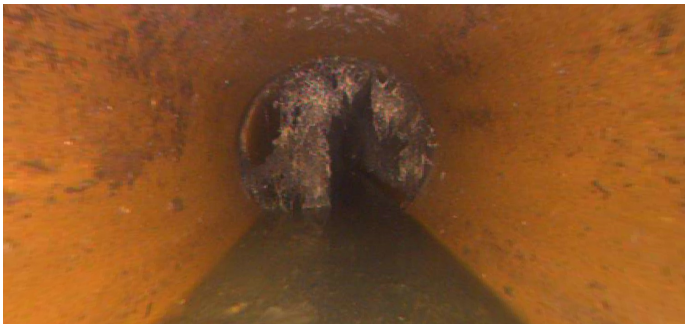
Code:	<b>RMJ</b>
Description:	<b>Roots Medium Joint</b>

Distance (ft):	<b>2.6</b>
Structural Grade:	<b>0</b>
O&M Grade:	<b>3</b>
Clock Start/From:	<b>6</b>
Clock To:	<b>4</b>
1st Value:	
2nd Value:	
Value Percent:	<b>20.000</b>
Continuous Index:	
Within 8" of Joint:	<b>YES</b>
Remarks:

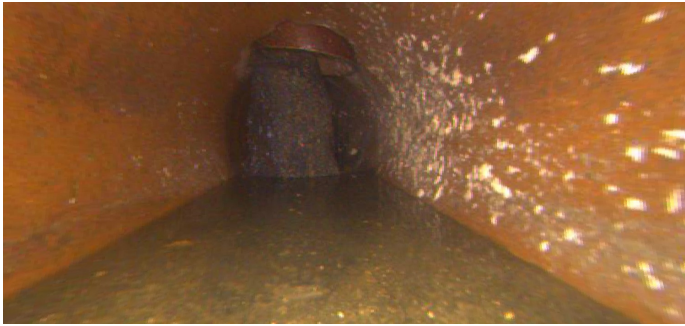
Code: **TFD**  
Description: **Tap Factory Defective**

Distance (ft): **4.2**  
Structural Grade: **0**  
O&M Grade: **2**  
Clock Start/From: **6**  
Clock To:  
1st Value: **4.000**  
2nd Value:  
Value Percent:  
Continuous Index:  
Within 8" of Joint:  
Remarks: **root infiltration**

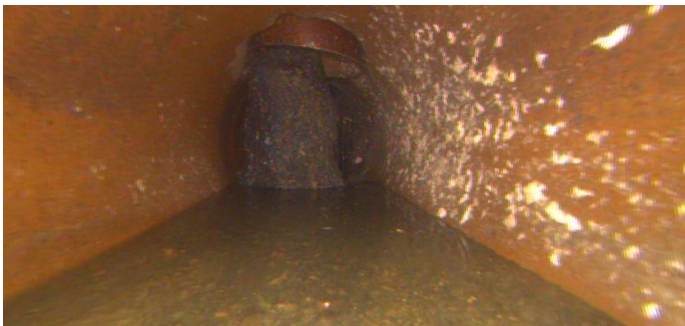
Code: **RMB**  
Description: **Roots Medium Barrel**

Distance (ft): **4.4**  
Structural Grade: **0**  
O&M Grade: **4**  
Clock Start/From: **6**  
Clock To: **12**  
1st Value:  
2nd Value:  
Value Percent: **50.000**  
Continuous Index:  
Within 8" of Joint: **NO**  
Remarks:
