## Profile/Photo Observation Report

Street:	<b>Kelly St.</b>	Flow Control:	<b>Not Controlled</b>
City:	<b>Hobart, IN</b>	Year Renewed:	
Location:	<b>Light Highway</b>	Tape/Media #:	
Purpose:	<b>Routine Assessment</b>	Dia/Height:	<b>12"</b>
Use:	<b>Sanitary</b>	Material:	<b>VCP</b>
Drain Area:	<b>NA</b>	Lining:	
Category:	<b>NA</b>		
Comment:

Location Details:		Direction of Survey:	<b>Upstream</b>
US MH:	<b>M-803-033</b>	DS MH:	<b>M-803-032</b>
		Total Length Surveyed (ft):	<b>5.2</b>

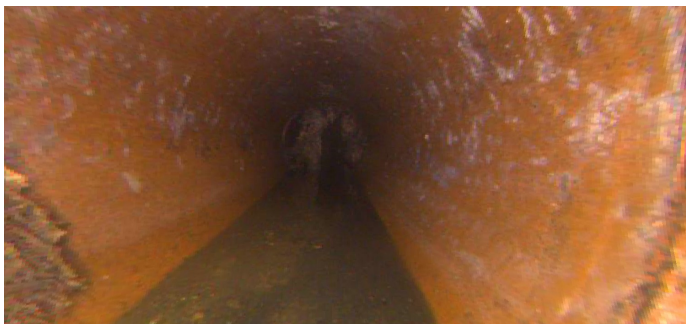
Code: **AMH**  
Description: **Manhole**

Distance (ft): **.0**  
Structural Grade: **0**  
O&M Grade: **0**  
Clock Start/From:  
Clock To:  
1st Value:  
2nd Value:  
Value Percent:  
Continuous Index:  
Within 8" of Joint: **NO**  
Remarks: **M-803-032**

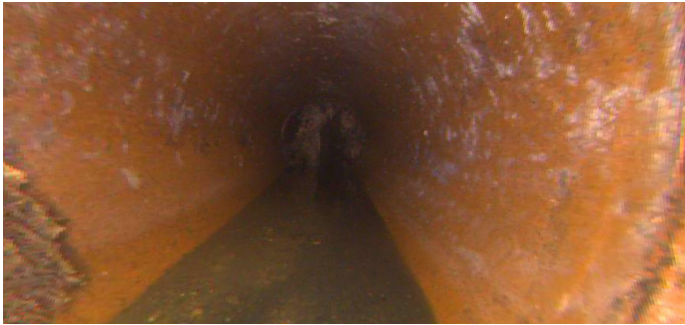
Code:	<b>MWL</b>
Description:	<b>Water Level</b>

Distance (ft):	<b>.0</b>
Structural Grade:	<b>0</b>
O&M Grade:	<b>0</b>
Clock Start/From:	
Clock To:	
1st Value:	
2nd Value:	
Value Percent:	<b>5.000</b>
Continuous Index:	
Within 8" of Joint:	<b>NO</b>
Remarks:

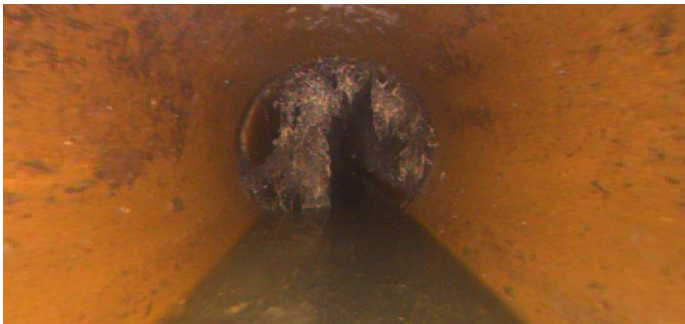
Code:	<b>RMJ</b>
Description:	<b>Roots Medium Joint</b>

Distance (ft):	<b>2.6</b>
Structural Grade:	<b>0</b>
O&M Grade:	<b>3</b>
Clock Start/From:	<b>6</b>
Clock To:	<b>4</b>
1st Value:	
2nd Value:	
Value Percent:	<b>20.000</b>
Continuous Index:	
Within 8" of Joint:	<b>YES</b>
Remarks:

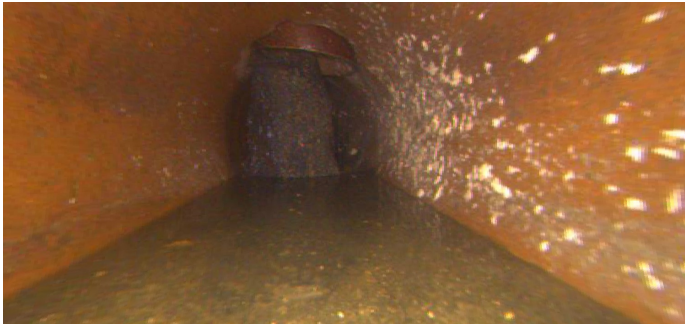
Code: **TFD**  
Description: **Tap Factory Defective**

Distance (ft): **4.2**  
Structural Grade: **0**  
O&M Grade: **2**  
Clock Start/From: **6**  
Clock To:  
1st Value: **4.000**  
2nd Value:  
Value Percent:  
Continuous Index:  
Within 8" of Joint:  
Remarks: **root infiltration**

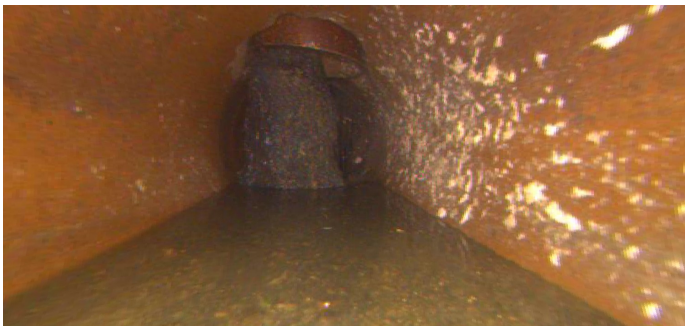
Code: **RMB**  
Description: **Roots Medium Barrel**

Distance (ft): **4.4**  
Structural Grade: **0**  
O&M Grade: **4**  
Clock Start/From: **6**  
Clock To: **12**  
1st Value:  
2nd Value:  
Value Percent: **50.000**  
Continuous Index:  
Within 8" of Joint: **NO**  
Remarks:
