Profile/Ph	oto Observatior	n Report				RedZo
Date:	03/28/2018	Weather:			Coding:	PACP 6.0
Pipe Length (ft)): 167.2	Owner:	NA		Pre Clean:	Not Known
P.O.#:		Surveyor:	Selasie Honu		PSR:	P-803-026-034
Customer:		Clean Date:	01/01/1900		Shape:	С
Street:	N INDIANA ST		Flow Control:		Not Controlled	
City:	Hobart, IN		Year Renewed	:		
Location:	Other		Tape/Media #:			
Purpose:	Not Known		Dia/Height:		10"	
Use:	Sanitary		Material:		VCP	
Drain Area:	NA		Lining:			
Category:	NA					
Comment:						
Location Detail	s:		Direction of Su	rvey:	Downstream	
US MH:	M-803-034	DS MH:	M-803-026	Total Le	ngth Surveyed (ft):	26.2
D&M Index:	3.00	O&M Quick:	35	500	O&M Rating:	15.00
Structural Index:	0.00	Structural Qu	iick: 00	000	Structural Rating:	0.00
Overall Index:	3.00	Overall Quick			Overall Rating:	15.00

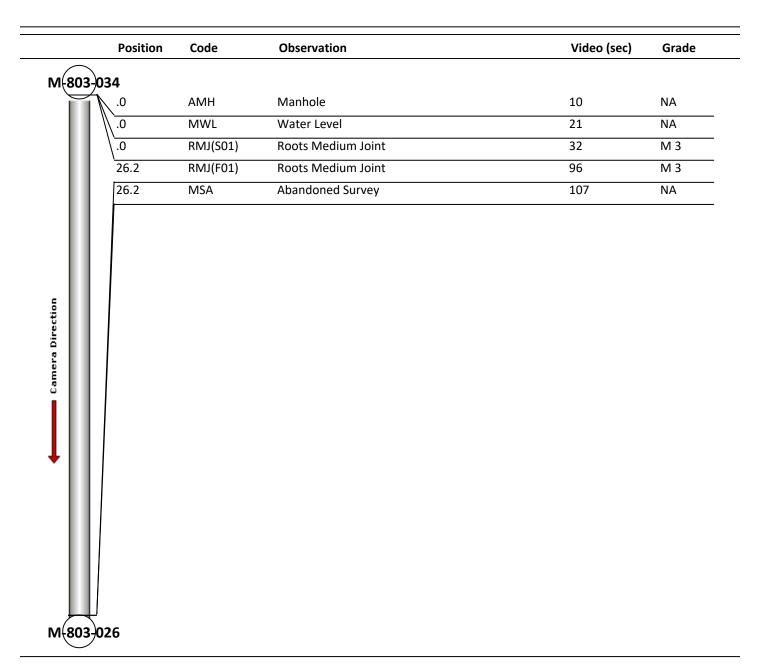
Code: Description:	AMH Manhole
Distance (ft):	.0
Structural Grade:	0
O&M Grade:	0
Clock Start/From:	
Clock To:	
1st Value:	
2nd Value:	
Value Percent:	
Continuous Index:	
Within 8" of Joint:	NO
Remarks:	M-803-034
