Profile/Photo Observation Report

Date:	03/28/2018	Weather:		Coding:	PACP 6.0
Pipe Length (ft):	272.0	Owner:	NA	Pre Clean:	Not Known
P.O.#:		Surveyor:	Selasie Honu	PSR:	P-803-033-034
Customer:		Clean Date:	01/01/1900	Shape:	C

Street:	N INDIANA ST	Flow Control:	Not Controlled
City:	Hobart, IN	Year Renewed:	
Location:	Other	Tape/Media #:	
Purpose:	Not Known	Dia/Height:	10"
Use:	Sanitary	Material:	VCP
Drain Area:	NA	Lining:	
Category:	NA		
Comment:

Location Details:		Direction of Survey:	Upstream
US MH:	M-803-034	DS MH:	M-803-033
		Total Length Surveyed (ft):	132.1

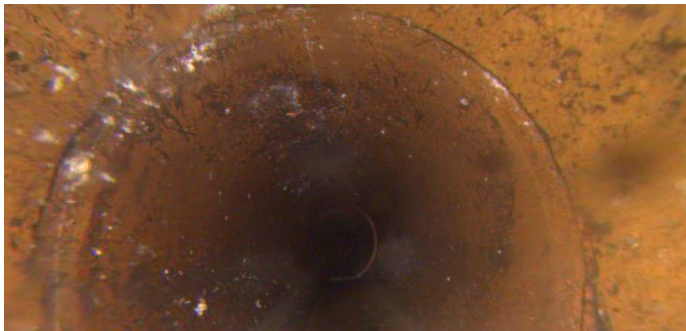
Code: RFJ
Description: Roots Fine Joint

Distance (ft): .0
Structural Grade: 0
O&M Grade: 1
Clock Start/From: 10
Clock To: 12
1st Value:
2nd Value:
Value Percent:
Continuous Index:
Within 8" of Joint: YES
Remarks:

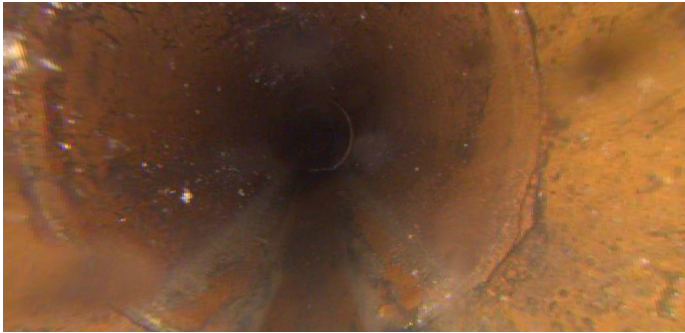
Code:	AMH
Description:	Manhole

Distance (ft):	.0
Structural Grade:	0
O&M Grade:	0
Clock Start/From:	
Clock To:	
1st Value:	
2nd Value:	
Value Percent:	
Continuous Index:	
Within 8" of Joint:	NO
Remarks:	M-803-033

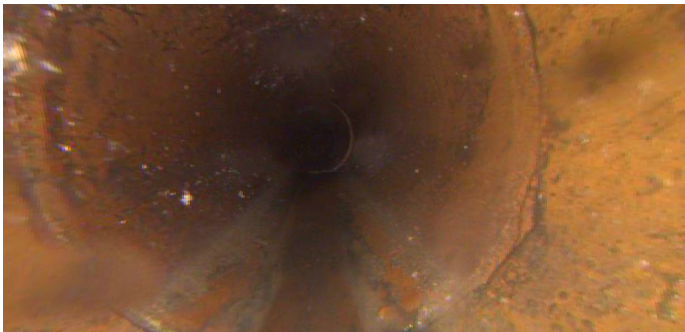
Code:	MWL
Description:	Water Level

Distance (ft):	.0
Structural Grade:	0
O&M Grade:	0
Clock Start/From:	
Clock To:	
1st Value:	
2nd Value:	
Value Percent:	5.000
Continuous Index:	
Within 8" of Joint:	NO
Remarks:

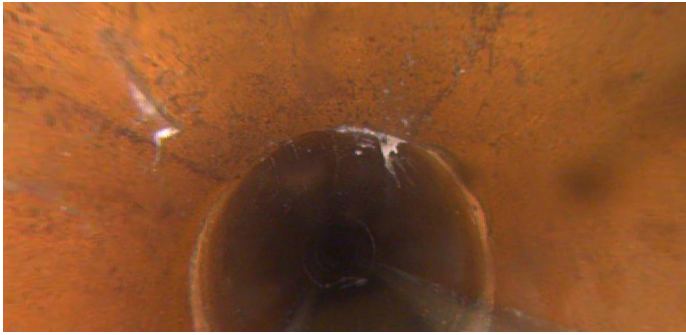
Code: **RFJ**
Description: **Roots Fine Joint**

Distance (ft): **15.2**
Structural Grade: **0**
O&M Grade: **1**
Clock Start/From: **11**
Clock To: **1**
1st Value:
2nd Value:
Value Percent:
Continuous Index:
Within 8" of Joint: **YES**
Remarks:

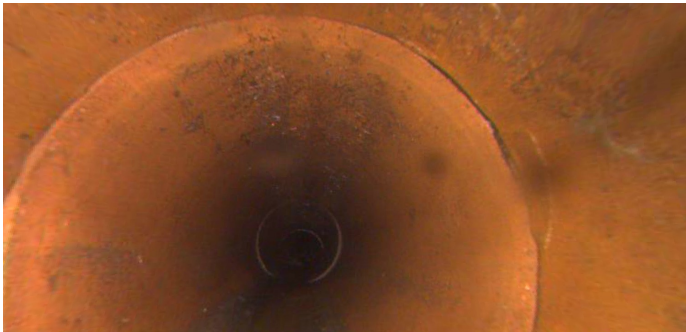
Code: **FC**
Description: **Fracture Circumferential**

Distance (ft): **27.6**
Structural Grade: **2**
O&M Grade: **0**
Clock Start/From: **2**
Clock To: **3**
1st Value:
2nd Value:
Value Percent:
Continuous Index:
Within 8" of Joint: **YES**
Remarks:

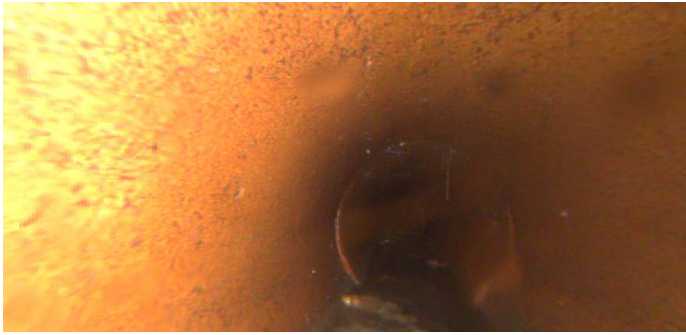
Code: **RFJ**
Description: **Roots Fine Joint**

Distance (ft): **35.5**
Structural Grade: **0**
O&M Grade: **1**
Clock Start/From: **1**
Clock To:
1st Value:
2nd Value:
Value Percent:
Continuous Index:
Within 8" of Joint: **YES**
Remarks:

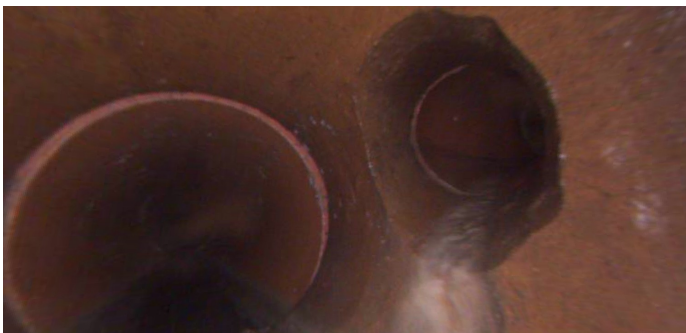
Code: **TFA**
Description: **Tap Factory Active**

Distance (ft): **66.8**
Structural Grade: **0**
O&M Grade: **0**
Clock Start/From: **9**
Clock To:
1st Value: **4.000**
2nd Value:
Value Percent:
Continuous Index:
Within 8" of Joint:
Remarks:

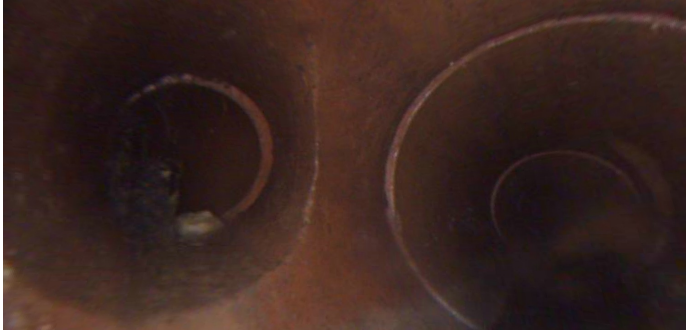
Code: **TF**
Description: **Tap Factory**

Distance (ft): **68.6**
Structural Grade: **0**
O&M Grade: **0**
Clock Start/From: **3**
Clock To:
1st Value: **4.000**
2nd Value:
Value Percent:
Continuous Index:
Within 8" of Joint:
Remarks:

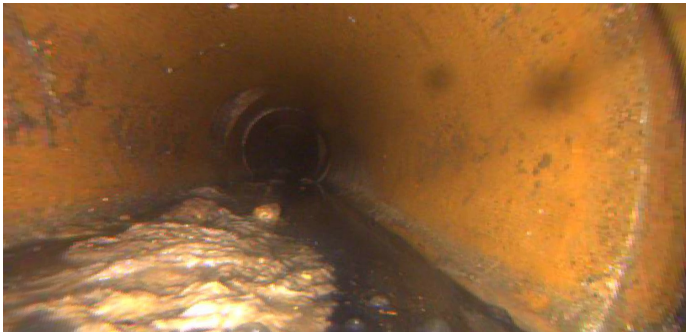
Code: **MSA**
Description: **Abandoned Survey**

Distance (ft): **132.1**
Structural Grade: **0**
O&M Grade: **0**
Clock Start/From:
Clock To:
1st Value:
2nd Value:
Value Percent:
Continuous Index:
Within 8" of Joint: **NO**
Remarks: **camera stopped**
