## Profile/Photo Observation Report

Date:	<b>03/28/2018</b>	Weather:		Coding:	<b>PACP 6.0</b>
Pipe Length (ft):	<b>207.8</b>	Owner:	<b>NA</b>	Pre Clean:	<b>Not Known</b>
P.O.#:		Surveyor:	<b>Selasie Honu</b>	PSR:	<b>P-803-034-035</b>
Customer:		Clean Date:	<b>01/01/1900</b>	Shape:	<b>C</b>

Street:	<b>E 40TH AVE</b>	Flow Control:	<b>Not Controlled</b>
City:	<b>Hobart, IN</b>	Year Renewed:	
Location:	<b>Other</b>	Tape/Media #:	
Purpose:	<b>Not Known</b>	Dia/Height:	<b>10"</b>
Use:	<b>Sanitary</b>	Material:	<b>VCP</b>
Drain Area:	<b>NA</b>	Lining:	
Category:	<b>NA</b>		
Comment:

Location Details:		Direction of Survey:	<b>Downstream</b>
US MH:	<b>M-803-035</b>	DS MH:	<b>M-803-034</b>
		Total Length Surveyed (ft):	<b>53.1</b>

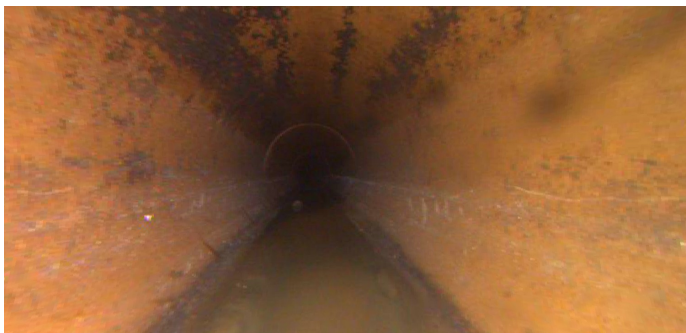
Code: **AMH**  
Description: **Manhole**

Distance (ft): **.0**  
Structural Grade: **0**  
O&M Grade: **0**  
Clock Start/From:  
Clock To:  
1st Value:  
2nd Value:  
Value Percent:  
Continuous Index:  
Within 8" of Joint: **NO**  
Remarks: **M-803-035**

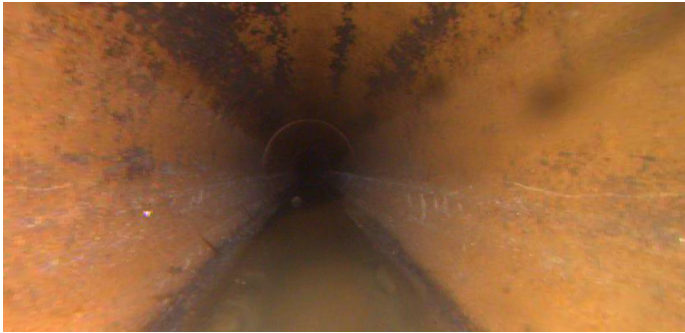
Code:	<b>MWL</b>
Description:	<b>Water Level</b>

Distance (ft):	<b>.0</b>
Structural Grade:	<b>0</b>
O&M Grade:	<b>0</b>
Clock Start/From:	
Clock To:	
1st Value:	
2nd Value:	
Value Percent:	<b>5.000</b>
Continuous Index:	
Within 8" of Joint:	<b>NO</b>
Remarks:

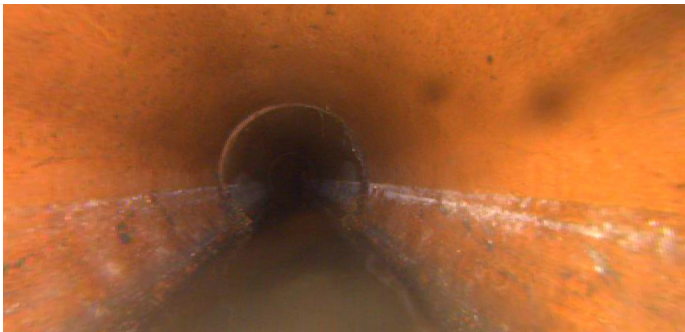
Code:	<b>RFJ</b>
Description:	<b>Roots Fine Joint</b>

Distance (ft):	<b>6.4</b>
Structural Grade:	<b>0</b>
O&M Grade:	<b>1</b>
Clock Start/From:	<b>7</b>
Clock To:	<b>5</b>
1st Value:	
2nd Value:	
Value Percent:	
Continuous Index:	
Within 8" of Joint:	<b>YES</b>
Remarks:

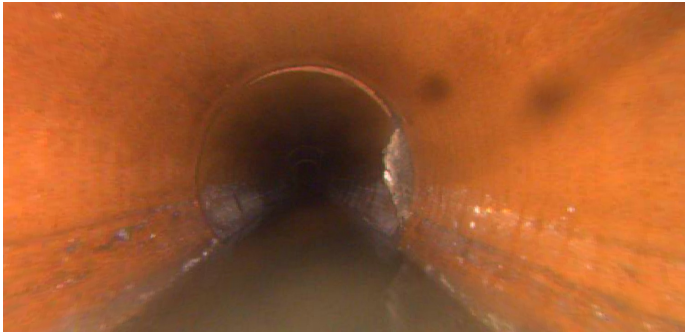
Code: **RFJ**  
Description: **Roots Fine Joint**

Distance (ft): **14.9**  
Structural Grade: **0**  
O&M Grade: **1**  
Clock Start/From: **3**  
Clock To: **4**  
1st Value:  
2nd Value:  
Value Percent:  
Continuous Index:  
Within 8" of Joint: **YES**  
Remarks:

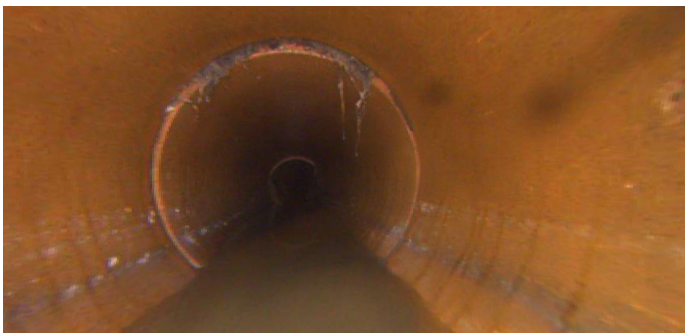
Code: **RFJ**  
Description: **Roots Fine Joint**

Distance (ft): **19.2**  
Structural Grade: **0**  
O&M Grade: **1**  
Clock Start/From: **11**  
Clock To: **2**  
1st Value:  
2nd Value:  
Value Percent:  
Continuous Index:  
Within 8" of Joint: **YES**  
Remarks:

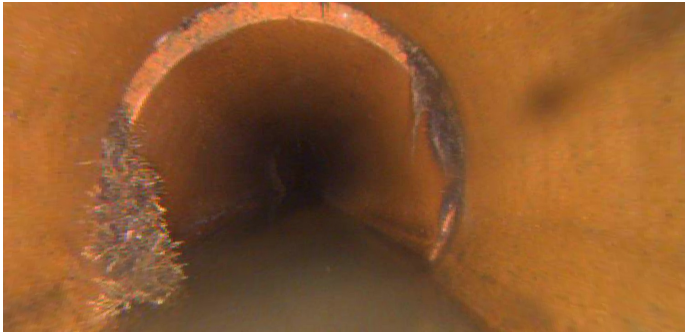
Code: **RFJ**  
Description: **Roots Fine Joint**

Distance (ft): **23.5**  
Structural Grade: **0**  
O&M Grade: **1**  
Clock Start/From: **7**  
Clock To: **5**  
1st Value:  
2nd Value:  
Value Percent:  
Continuous Index:  
Within 8" of Joint: **YES**  
Remarks:

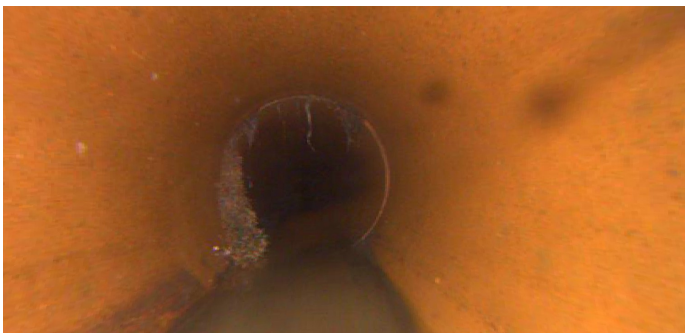
Code: **RFJ**  
Description: **Roots Fine Joint**

Distance (ft): **26.7**  
Structural Grade: **0**  
O&M Grade: **1**  
Clock Start/From: **7**  
Clock To: **5**  
1st Value:  
2nd Value:  
Value Percent:  
Continuous Index:  
Within 8" of Joint: **YES**  
Remarks:

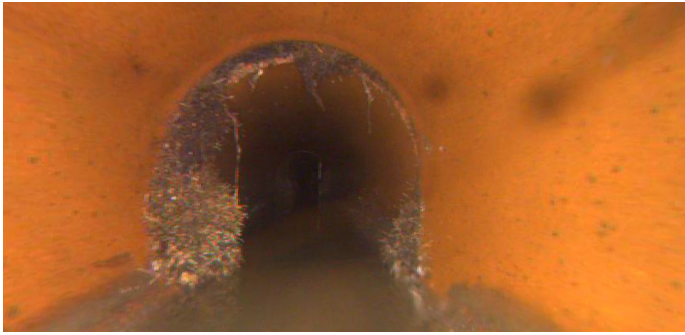
Code: **RMJ**  
Description: **Roots Medium Joint**

Distance (ft): **35.3**  
Structural Grade: **0**  
O&M Grade: **3**  
Clock Start/From: **7**  
Clock To: **5**  
1st Value:  
2nd Value:  
Value Percent: **30.000**  
Continuous Index: **S01**  
Within 8" of Joint: **YES**  
Remarks:

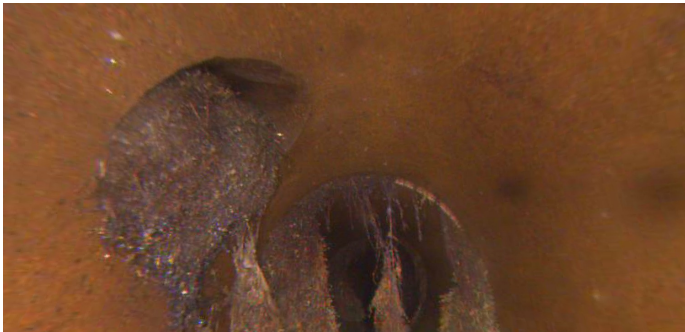
Code: **TFD**  
Description: **Tap Factory Defective**

Distance (ft): **49.3**  
Structural Grade: **0**  
O&M Grade: **2**  
Clock Start/From: **10**  
Clock To:  
1st Value: **4.000**  
2nd Value:  
Value Percent:  
Continuous Index:  
Within 8" of Joint:  
Remarks: **RML**

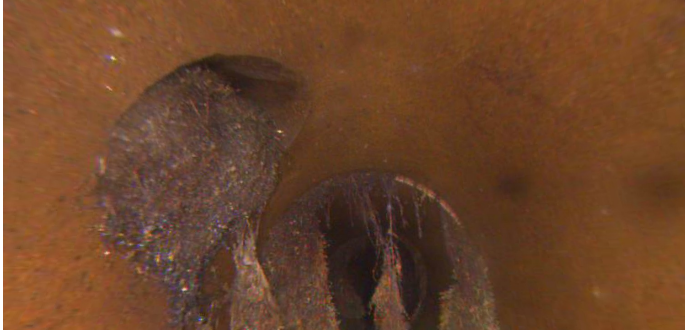
Code: **RML**  
Description: **Roots Medium Lateral**

Distance (ft): **49.3**  
Structural Grade: **0**  
O&M Grade: **3**  
Clock Start/From: **9**  
Clock To: **10**  
1st Value:  
2nd Value:  
Value Percent: **5.000**  
Continuous Index:  
Within 8" of Joint: **NO**  
Remarks:

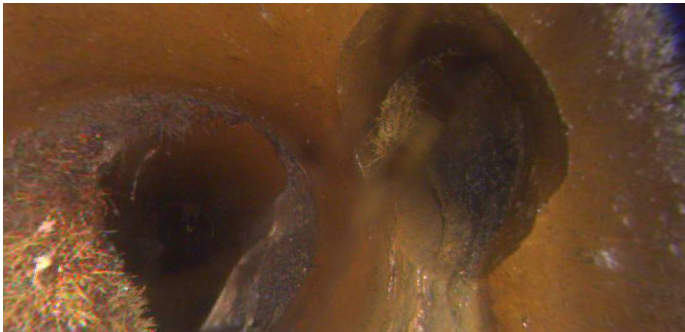
Code: **TFD**  
Description: **Tap Factory Defective**

Distance (ft): **51.6**  
Structural Grade: **0**  
O&M Grade: **2**  
Clock Start/From: **2**  
Clock To:  
1st Value: **4.000**  
2nd Value:  
Value Percent:  
Continuous Index:  
Within 8" of Joint:  
Remarks: **ROOTS**

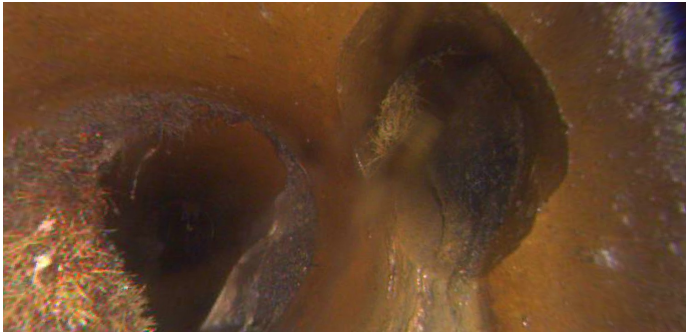
Code: **RFL**  
Description: **Roots Fine Lateral**

Distance (ft): **51.6**  
Structural Grade: **0**  
O&M Grade: **1**  
Clock Start/From: **2**  
Clock To:  
1st Value:  
2nd Value:  
Value Percent:  
Continuous Index:  
Within 8" of Joint: **NO**  
Remarks:

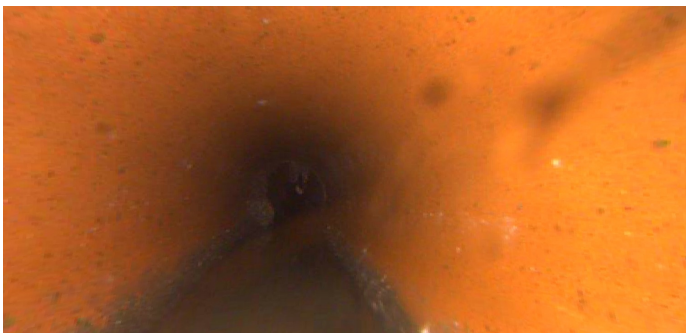
Code: **RMJ**  
Description: **Roots Medium Joint**

Distance (ft): **53.1**  
Structural Grade: **0**  
O&M Grade: **3**  
Clock Start/From: **7**  
Clock To: **5**  
1st Value:  
2nd Value:  
Value Percent: **30.000**  
Continuous Index: **F01**  
Within 8" of Joint: **YES**  
Remarks:

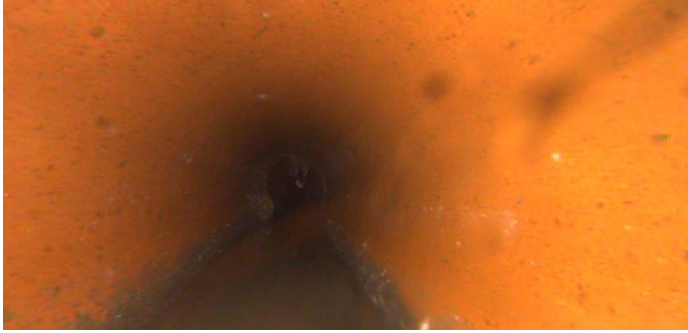
Code:	<b>MSA</b>
Description:	<b>Abandoned Survey</b>
Distance (ft):	<b>53.1</b>
Structural Grade:	<b>0</b>
O&M Grade:	<b>0</b>
Clock Start/From:	
Clock To:	
1st Value:	
2nd Value:	
Value Percent:	
Continuous Index:	
Within 8" of Joint:	<b>NO</b>
Remarks:	<b>camera stopped</b>
