Profile/Photo Observation Report

Date:	03/28/2018	Weather:		Coding:	PACP 6.0
Pipe Length (ft):	207.8	Owner:	NA	Pre Clean:	Not Known
P.O.#:		Surveyor:	Selasie Honu	PSR:	P-803-034-035
Customer:		Clean Date:	01/01/1900	Shape:	C

Street:	E 40TH AVE	Flow Control:	Not Controlled
City:	Hobart, IN	Year Renewed:	
Location:	Other	Tape/Media #:	
Purpose:	Not Known	Dia/Height:	10"
Use:	Sanitary	Material:	VCP
Drain Area:	NA	Lining:	
Category:	NA		
Comment:

Location Details:		Direction of Survey:	Upstream
US MH:	M-803-035	DS MH:	M-803-034
		Total Length Surveyed (ft):	8.0

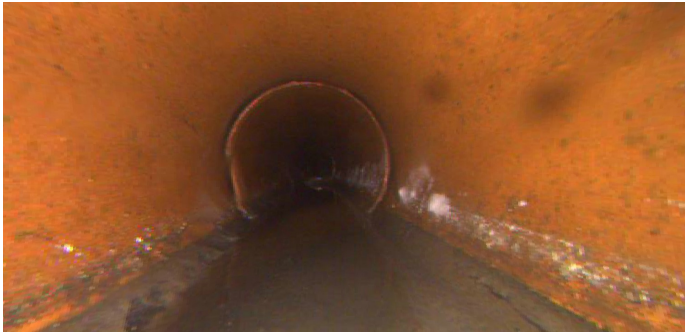
Code:	MWL
Description:	Water Level

Distance (ft):	.0
Structural Grade:	0
O&M Grade:	0
Clock Start/From:	
Clock To:	
1st Value:	
2nd Value:	
Value Percent:	5.000
Continuous Index:	
Within 8" of Joint:	NO
Remarks:

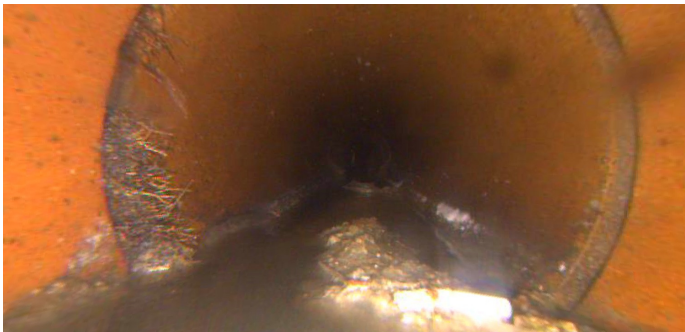
Code:	RMJ
Description:	Roots Medium Joint

Distance (ft):	6.3
Structural Grade:	0
O&M Grade:	3
Clock Start/From:	8
Clock To:	9
1st Value:	
2nd Value:	
Value Percent:	5.000
Continuous Index:	
Within 8" of Joint:	YES
Remarks:

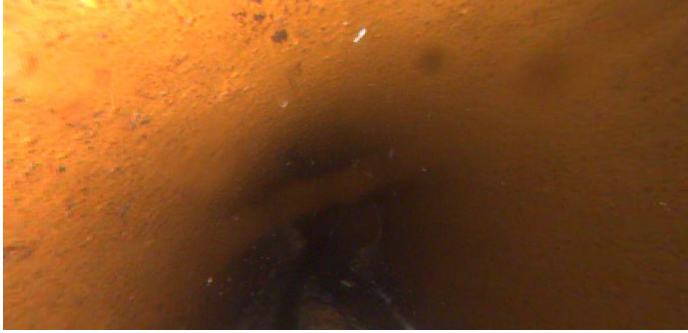
Code:	MSA
Description:	Abandoned Survey
Distance (ft):	8.0
Structural Grade:	0
O&M Grade:	0
Clock Start/From:	
Clock To:	
1st Value:	
2nd Value:	
Value Percent:	
Continuous Index:	
Within 8" of Joint:	NO
Remarks:	camera stopped
