Profile/Photo Observation Report

Date:	09/30/2018	Weather:		Coding:	PACP 6.0
Pipe Length (ft):	207.8	Owner:	NA	Pre Clean:	Not Known
P.O.#:		Surveyor:	Justin Gonzales	PSR:	P-803-034-035
Customer:		Clean Date:	01/01/1900	Shape:	C

Street:	E 40TH AVE	Flow Control:	Not Controlled
City:	Hobart, IN	Year Renewed:	
Location:	Light Highway	Tape/Media #:	
Purpose:	Routine Assessment	Dia/Height:	12"
Use:	Sanitary	Material:	VCP
Drain Area:	NA	Lining:	
Category:	NA		
Comment:

Location Details:		Direction of Survey:	Upstream
US MH:	M-803-035	DS MH:	M-803-034
		Total Length Surveyed (ft):	202.5

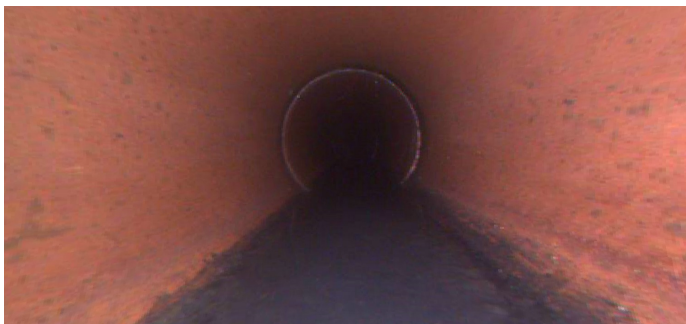
Code: **AMH**
Description: **Manhole**

Distance (ft): **.0**
Structural Grade: **0**
O&M Grade: **0**
Clock Start/From:
Clock To:
1st Value:
2nd Value:
Value Percent:
Continuous Index:
Within 8" of Joint: **NO**
Remarks: **M-803-034**

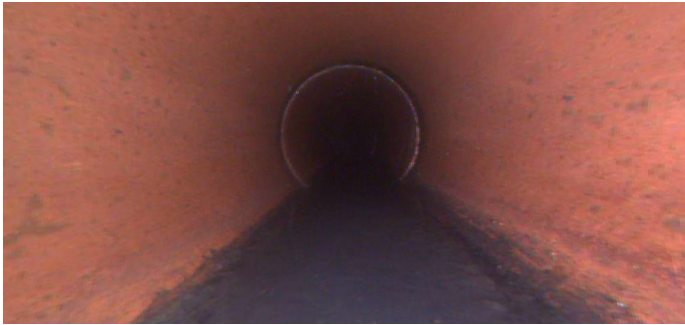
Code:	MWL
Description:	Water Level

Distance (ft):	.0
Structural Grade:	0
O&M Grade:	0
Clock Start/From:	
Clock To:	
1st Value:	
2nd Value:	
Value Percent:	10.000
Continuous Index:	
Within 8" of Joint:	NO
Remarks:

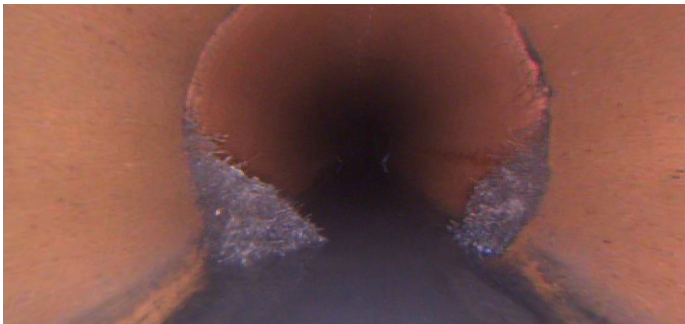
Code:	RFJ
Description:	Roots Fine Joint

Distance (ft):	10.5
Structural Grade:	0
O&M Grade:	1
Clock Start/From:	7
Clock To:	5
1st Value:	
2nd Value:	
Value Percent:	
Continuous Index:	
Within 8" of Joint:	YES
Remarks:

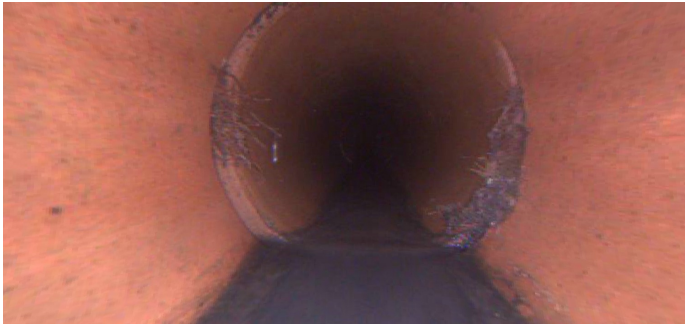
Code: **RFJ**
Description: **Roots Fine Joint**

Distance (ft): **18.6**
Structural Grade: **0**
O&M Grade: **1**
Clock Start/From: **9**
Clock To: **5**
1st Value:
2nd Value:
Value Percent:
Continuous Index:
Within 8" of Joint: **YES**
Remarks:

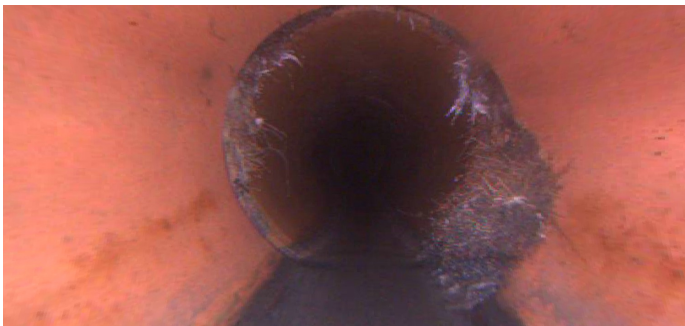
Code: **RFJ**
Description: **Roots Fine Joint**

Distance (ft): **26.7**
Structural Grade: **0**
O&M Grade: **1**
Clock Start/From: **9**
Clock To: **5**
1st Value:
2nd Value:
Value Percent:
Continuous Index:
Within 8" of Joint: **YES**
Remarks:

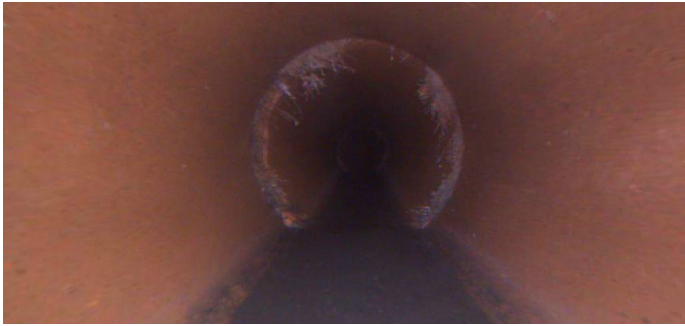
Code: **RFJ**
Description: **Roots Fine Joint**

Distance (ft): **38.7**
Structural Grade: **0**
O&M Grade: **1**
Clock Start/From: **7**
Clock To: **5**
1st Value:
2nd Value:
Value Percent:
Continuous Index:
Within 8" of Joint: **YES**
Remarks:

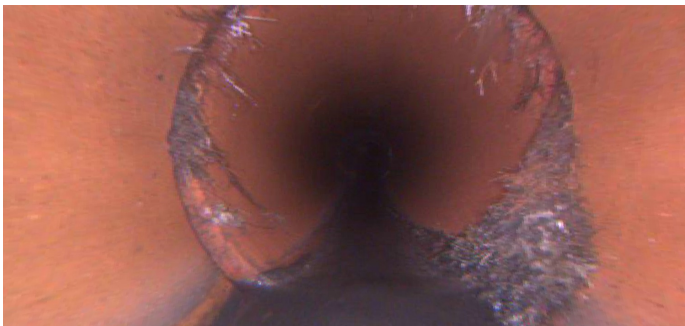
Code: **RFJ**
Description: **Roots Fine Joint**

Distance (ft): **43.3**
Structural Grade: **0**
O&M Grade: **1**
Clock Start/From: **8**
Clock To: **5**
1st Value:
2nd Value:
Value Percent:
Continuous Index:
Within 8" of Joint: **YES**
Remarks:

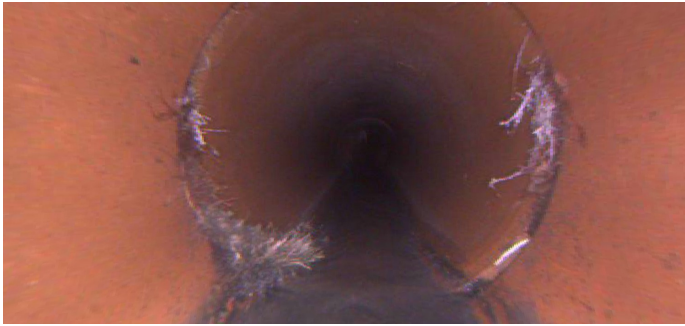
Code: **RFJ**
Description: **Roots Fine Joint**

Distance (ft): **47.4**
Structural Grade: **0**
O&M Grade: **1**
Clock Start/From: **7**
Clock To: **5**
1st Value:
2nd Value:
Value Percent:
Continuous Index: **S01**
Within 8" of Joint: **YES**
Remarks: **WANDER**

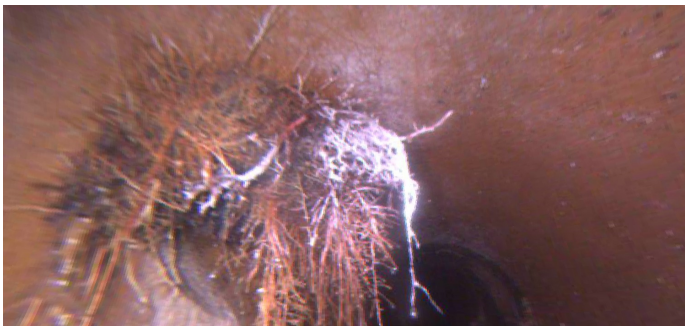
Code: **TFD**
Description: **Tap Factory Defective**

Distance (ft): **52.3**
Structural Grade: **0**
O&M Grade: **2**
Clock Start/From: **10**
Clock To:
1st Value: **4.000**
2nd Value:
Value Percent:
Continuous Index:
Within 8" of Joint:
Remarks: **RF COMING FROM TAP**

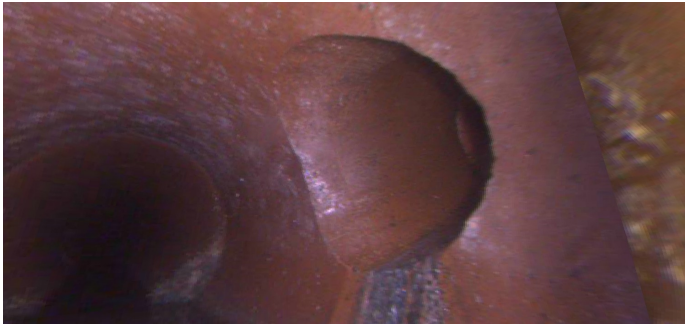
Code: **TF**
Description: **Tap Factory**

Distance (ft): **54.5**
Structural Grade: **0**
O&M Grade: **0**
Clock Start/From: **2**
Clock To:
1st Value: **4.000**
2nd Value:
Value Percent:
Continuous Index:
Within 8" of Joint:
Remarks:

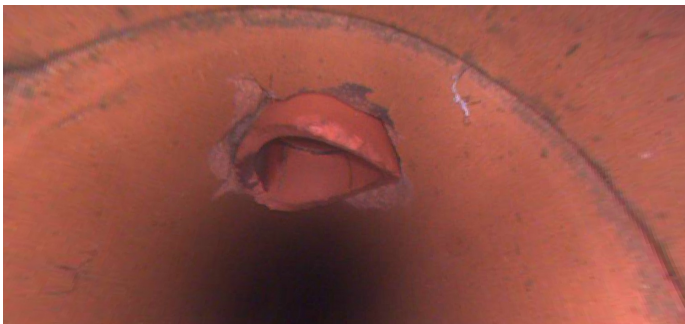
Code: **TBI**
Description: **Tap Break-in Intruding**

Distance (ft): **72.3**
Structural Grade: **0**
O&M Grade: **2**
Clock Start/From: **12**
Clock To:
1st Value: **4.000**
2nd Value: **0.500**
Value Percent:
Continuous Index:
Within 8" of Joint:
Remarks:

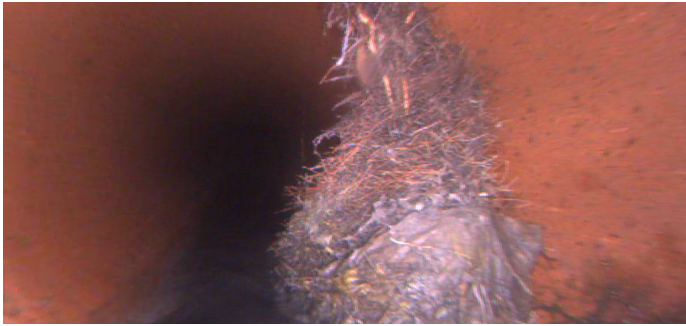
Code: **RMJ**
Description: **Roots Medium Joint**

Distance (ft): **125.4**
Structural Grade: **0**
O&M Grade: **3**
Clock Start/From: **1**
Clock To: **5**
1st Value:
2nd Value:
Value Percent: **10.000**
Continuous Index:
Within 8" of Joint: **YES**
Remarks:

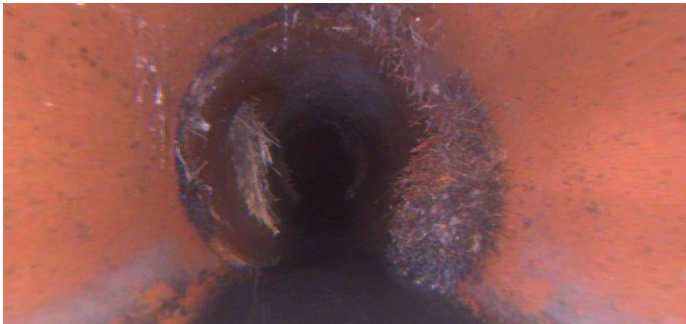
Code: **RMJ**
Description: **Roots Medium Joint**

Distance (ft): **145.7**
Structural Grade: **0**
O&M Grade: **3**
Clock Start/From: **7**
Clock To: **5**
1st Value:
2nd Value:
Value Percent: **10.000**
Continuous Index:
Within 8" of Joint: **YES**
Remarks:

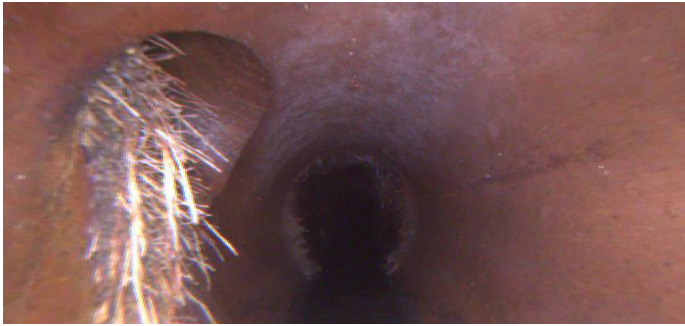
Code: **TFD**
Description: **Tap Factory Defective**

Distance (ft): **146.6**
Structural Grade: **0**
O&M Grade: **2**
Clock Start/From: **10**
Clock To:
1st Value: **4.000**
2nd Value:
Value Percent:
Continuous Index:
Within 8" of Joint:
Remarks: **RF COMING FROM TAP**

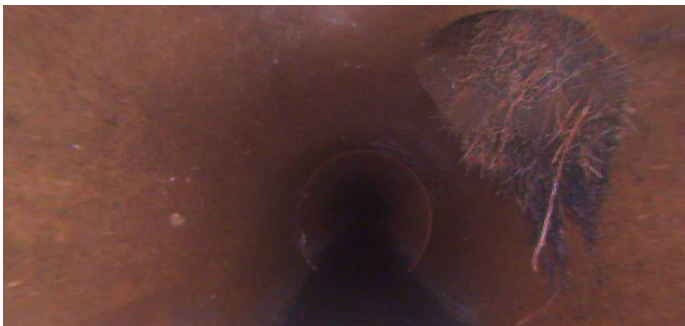
Code: **TFD**
Description: **Tap Factory Defective**

Distance (ft): **148.6**
Structural Grade: **0**
O&M Grade: **2**
Clock Start/From: **2**
Clock To:
1st Value: **4.000**
2nd Value:
Value Percent:
Continuous Index:
Within 8" of Joint: **NO**
Remarks: **RF COMING FROM TAP**

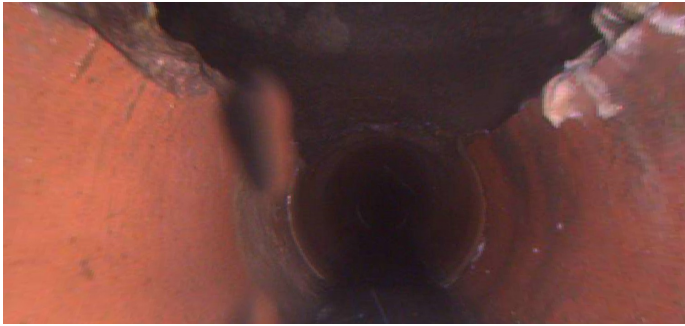
Code: **AMH**
Description: **Manhole**

Distance (ft): **202.5**
Structural Grade: **0**
O&M Grade: **0**
Clock Start/From:
Clock To:
1st Value:
2nd Value:
Value Percent:
Continuous Index:
Within 8" of Joint: **NO**
Remarks: **M-803-035**

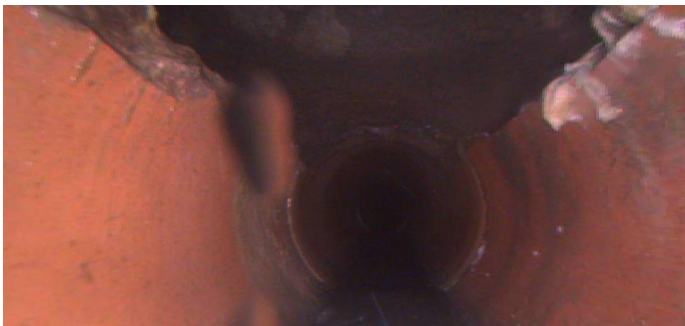
Code: **RFJ**
Description: **Roots Fine Joint**

Distance (ft): **202.5**
Structural Grade: **0**
O&M Grade: **1**
Clock Start/From: **7**
Clock To: **5**
1st Value:
2nd Value:
Value Percent:
Continuous Index: **F01**
Within 8" of Joint: **YES**
Remarks: **WANDER**
