Profile/Photo Observation Report

Date:	03/28/2018	Weather:		Coding:	PACP 6.0
Pipe Length (ft):	163.8	Owner:	NA	Pre Clean:	Not Known
P.O.#:		Surveyor:	Selasie Honu	PSR:	P-803-037-038
Customer:		Clean Date:	01/01/1900	Shape:	C

Street:	E RAND ST	Flow Control:	Not Controlled
City:	Hobart, IN	Year Renewed:	
Location:	Other	Tape/Media #:	
Purpose:	Not Known	Dia/Height:	10"
Use:	Sanitary	Material:	VCP
Drain Area:	NA	Lining:	
Category:	NA		
Comment:

Location Details:		Direction of Survey:	Downstream
US MH:	M-803-037	DS MH:	M-803-038
		Total Length Surveyed (ft):	158.7

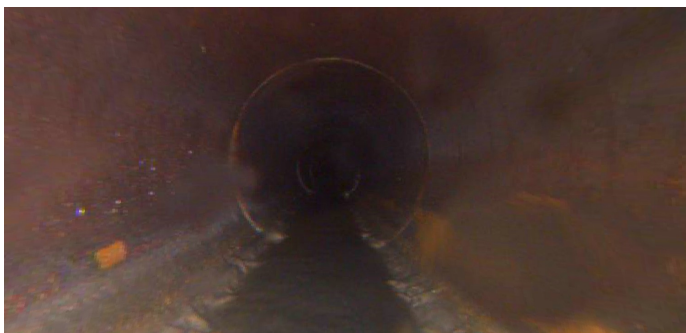
Code: **AMH**
Description: **Manhole**

Distance (ft): **.0**
Structural Grade: **0**
O&M Grade: **0**
Clock Start/From:
Clock To:
1st Value:
2nd Value:
Value Percent:
Continuous Index:
Within 8" of Joint: **NO**
Remarks: **M-803-037**

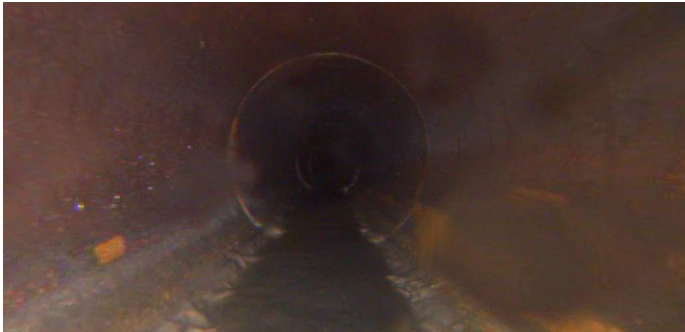
Code:	MWL
Description:	Water Level

Distance (ft):	.0
Structural Grade:	0
O&M Grade:	0
Clock Start/From:	
Clock To:	
1st Value:	
2nd Value:	
Value Percent:	5.000
Continuous Index:	
Within 8" of Joint:	NO
Remarks:

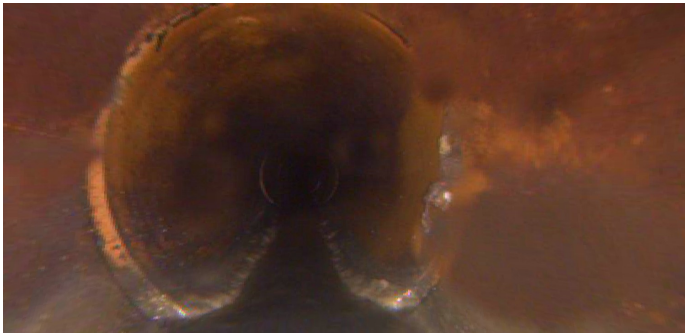
Code:	RFJ
Description:	Roots Fine Joint

Distance (ft):	4.6
Structural Grade:	0
O&M Grade:	1
Clock Start/From:	3
Clock To:	4
1st Value:	
2nd Value:	
Value Percent:	
Continuous Index:	
Within 8" of Joint:	YES
Remarks:

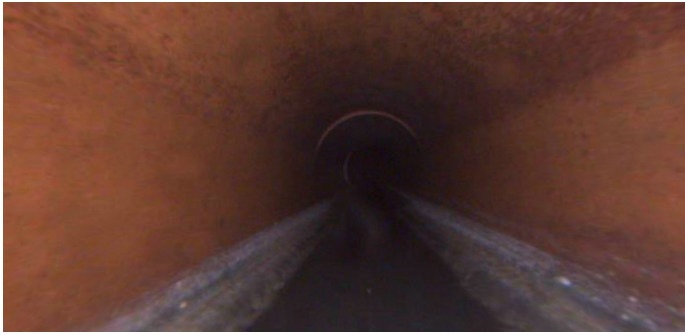
Code: **DAGS**
Description: **Deposits Attached Grease**

Distance (ft): **67.4**
Structural Grade: **0**
O&M Grade: **2**
Clock Start/From: **7**
Clock To: **5**
1st Value:
2nd Value:
Value Percent: **5.000**
Continuous Index: **S01**
Within 8" of Joint: **NO**
Remarks:

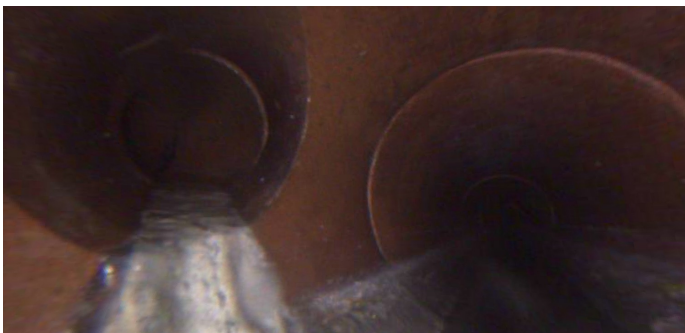
Code: **TFA**
Description: **Tap Factory Active**

Distance (ft): **101.5**
Structural Grade: **0**
O&M Grade: **0**
Clock Start/From: **3**
Clock To:
1st Value: **4.000**
2nd Value:
Value Percent:
Continuous Index:
Within 8" of Joint:
Remarks:

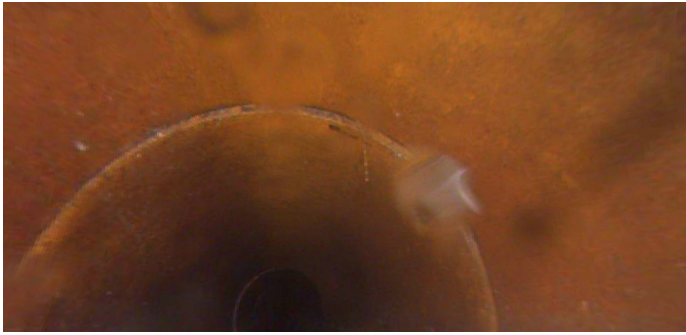
Code: **RFJ**
Description: **Roots Fine Joint**

Distance (ft): **119.4**
Structural Grade: **0**
O&M Grade: **1**
Clock Start/From: **1**
Clock To:
1st Value:
2nd Value:
Value Percent:
Continuous Index:
Within 8" of Joint: **YES**
Remarks:

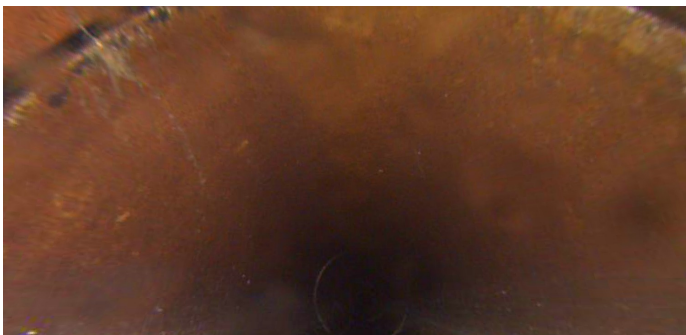
Code: **CL**
Description: **Crack Longitudinal**

Distance (ft): **122.8**
Structural Grade: **2**
O&M Grade: **0**
Clock Start/From: **10**
Clock To:
1st Value:
2nd Value:
Value Percent:
Continuous Index:
Within 8" of Joint: **YES**
Remarks:

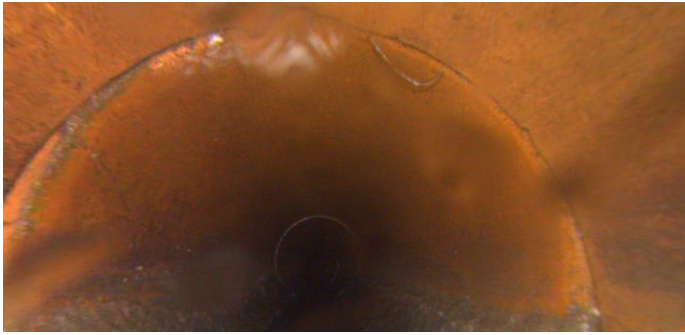
Code: **RFJ**
Description: **Roots Fine Joint**

Distance (ft): **137.4**
Structural Grade: **0**
O&M Grade: **1**
Clock Start/From: **12**
Clock To:
1st Value:
2nd Value:
Value Percent:
Continuous Index:
Within 8" of Joint: **YES**
Remarks:

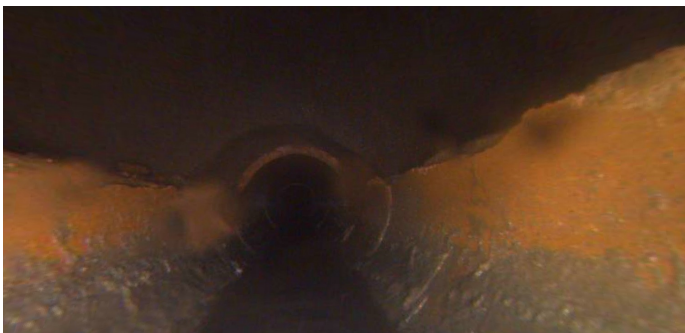
Code: **DAGS**
Description: **Deposits Attached Grease**

Distance (ft): **157.0**
Structural Grade: **0**
O&M Grade: **2**
Clock Start/From: **7**
Clock To: **5**
1st Value:
2nd Value:
Value Percent: **5.000**
Continuous Index: **F01**
Within 8" of Joint: **NO**
Remarks:

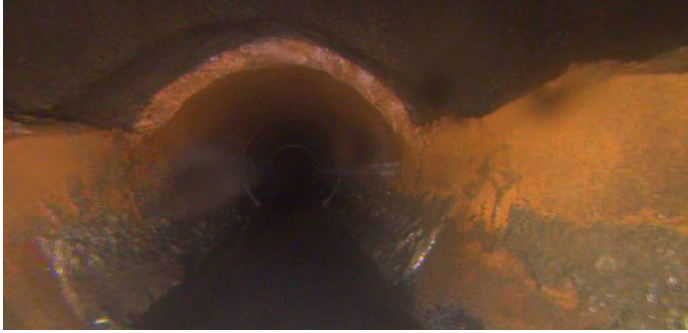
Code:	AMH
Description:	Manhole
Distance (ft):	158.7
Structural Grade:	0
O&M Grade:	0
Clock Start/From:	
Clock To:	
1st Value:	
2nd Value:	
Value Percent:	
Continuous Index:	
Within 8" of Joint:	NO
Remarks:	M-803-038
