Profile/Photo Observation Report

Street:	E RAND ST	Flow Control:	Not Controlled
City:	Hobart, IN	Year Renewed:	
Location:	Other	Tape/Media #:	
Purpose:	Not Known	Dia/Height:	10"
Use:	Sanitary	Material:	VCP
Drain Area:	NA	Lining:	
Category:	NA		
Comment:

Location Details:		Direction of Survey:	Downstream
US MH:	M-803-037	DS MH:	M-803-038
		Total Length Surveyed (ft):	158.7

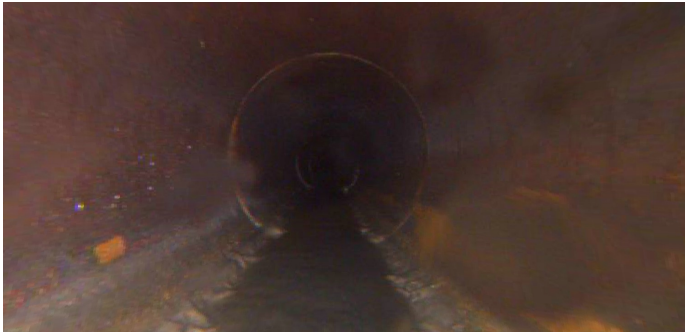
Code:	MWL
Description:	Water Level

Distance (ft):	.0
Structural Grade:	0
O&M Grade:	0
Clock Start/From:	
Clock To:	
1st Value:	
2nd Value:	
Value Percent:	5.000
Continuous Index:	
Within 8" of Joint:	NO
Remarks:

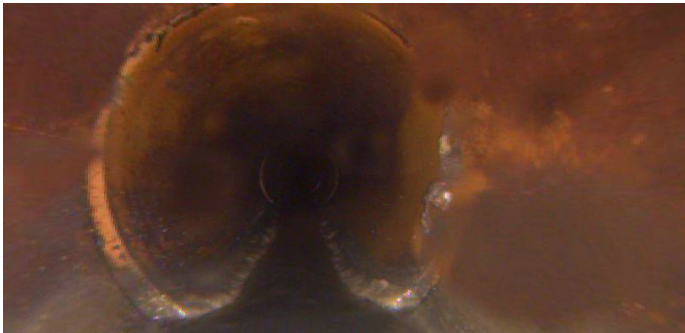
Code:	RFJ
Description:	Roots Fine Joint

Distance (ft):	4.6
Structural Grade:	0
O&M Grade:	1
Clock Start/From:	3
Clock To:	4
1st Value:	
2nd Value:	
Value Percent:	
Continuous Index:	
Within 8" of Joint:	YES
Remarks:

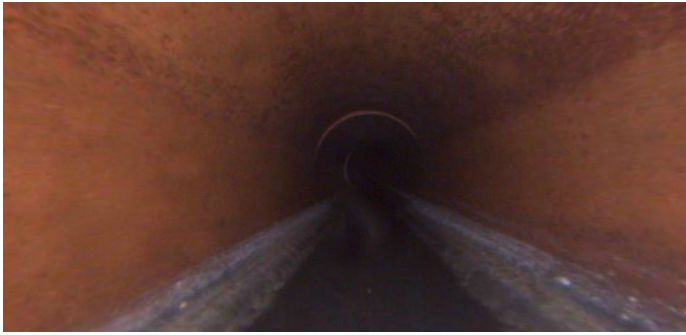
Code: **DAGS**
Description: **Deposits Attached Grease**

Distance (ft): **67.4**
Structural Grade: **0**
O&M Grade: **2**
Clock Start/From: **7**
Clock To: **5**
1st Value:
2nd Value:
Value Percent: **5.000**
Continuous Index: **S01**
Within 8" of Joint: **NO**
Remarks:

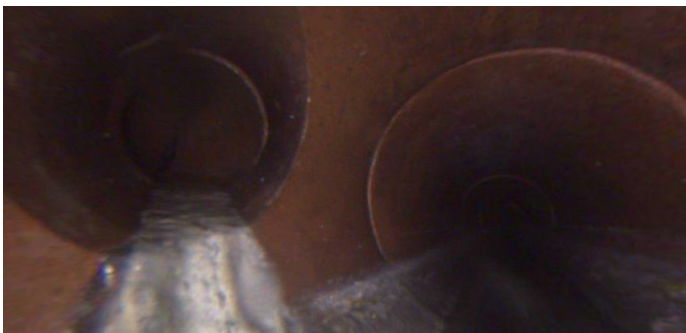
Code: **TFA**
Description: **Tap Factory Active**

Distance (ft): **101.5**
Structural Grade: **0**
O&M Grade: **0**
Clock Start/From: **3**
Clock To:
1st Value: **4.000**
2nd Value:
Value Percent:
Continuous Index:
Within 8" of Joint:
Remarks:

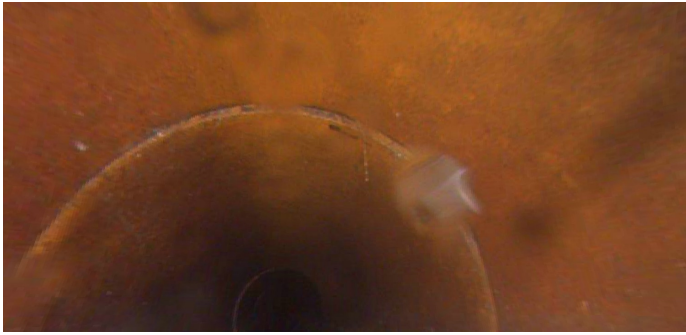
Code: **RFJ**
Description: **Roots Fine Joint**

Distance (ft): **119.4**
Structural Grade: **0**
O&M Grade: **1**
Clock Start/From: **1**
Clock To:
1st Value:
2nd Value:
Value Percent:
Continuous Index:
Within 8" of Joint: **YES**
Remarks:

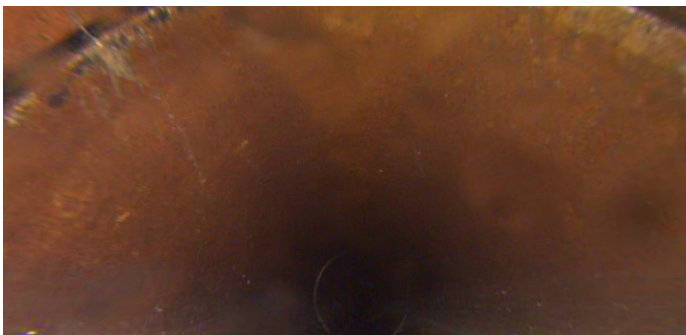
Code: **CL**
Description: **Crack Longitudinal**

Distance (ft): **122.8**
Structural Grade: **2**
O&M Grade: **0**
Clock Start/From: **10**
Clock To:
1st Value:
2nd Value:
Value Percent:
Continuous Index:
Within 8" of Joint: **YES**
Remarks:

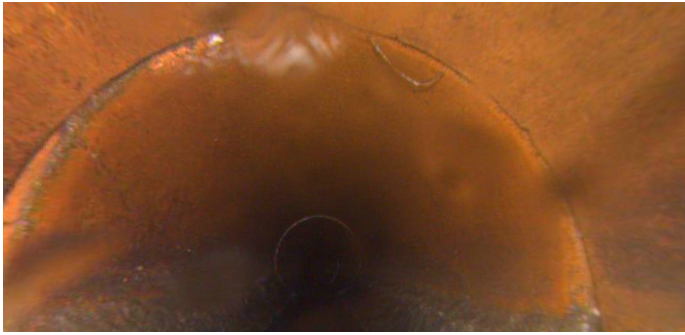
Code: **RFJ**
Description: **Roots Fine Joint**

Distance (ft): **137.4**
Structural Grade: **0**
O&M Grade: **1**
Clock Start/From: **12**
Clock To:
1st Value:
2nd Value:
Value Percent:
Continuous Index:
Within 8" of Joint: **YES**
Remarks:

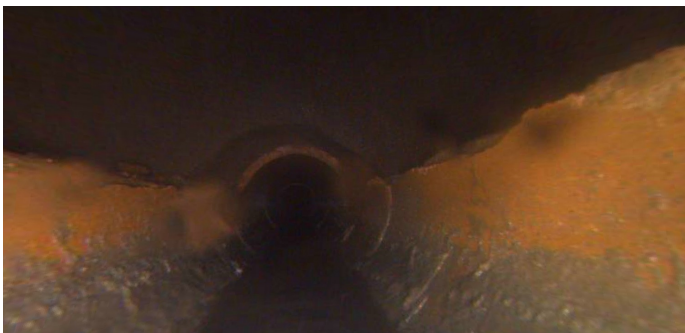
Code: **DAGS**
Description: **Deposits Attached Grease**

Distance (ft): **157.0**
Structural Grade: **0**
O&M Grade: **2**
Clock Start/From: **7**
Clock To: **5**
1st Value:
2nd Value:
Value Percent: **5.000**
Continuous Index: **F01**
Within 8" of Joint: **NO**
Remarks:
