Profile/Photo Observation Report

Date:	04/13/2018	Weather:		Coding:	PACP 4.2
Pipe Length (ft):	5.8	Owner:	City of Hobart	Pre Clean:	No Pre-Cleaning
P.O.#:	2004	Surveyor:	SAN	PSR:	P-803-039-059
Customer:	Red Zone	Clean Date:		Shape:	C

Street:	Rand St	Flow Control:	Not Controlled
City:	Hobart In	Year Renewed:	
Location:	Light Highway	Tape/Media #:	Deliverable 1
Purpose:	Routine Assessment	Dia/Height:	15"
Use:	Sanitary	Material:	VCP
Drain Area:	Northeast	Lining:	
Category:	NA		
Comment:	412-1/Reverse setup due to rocks.		
Location Details:	Center of street	Direction of Survey:	Downstream
US MH:	M-803-039	DS MH:	M-803-059
		Total Length Surveyed (ft):	2.0

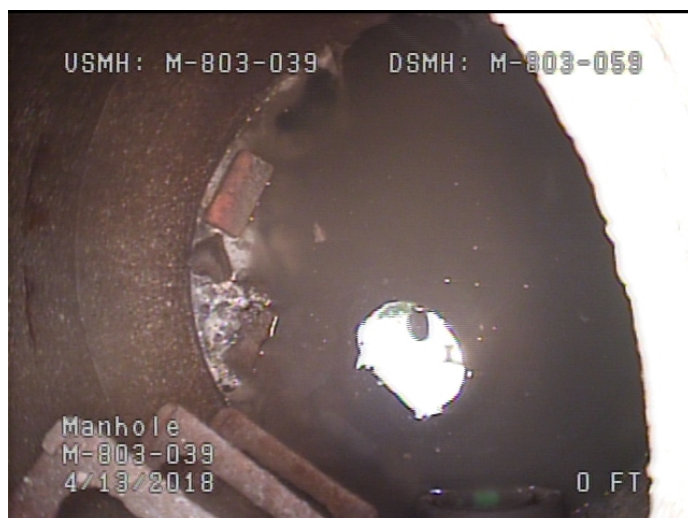
Code: **AMH**
Description: **Manhole**

Distance (ft): **.0**
Structural Grade: **0**
O&M Grade: **0**
Clock Start/From:
Clock To:
1st Value:
2nd Value:
Value Percent:
Continuous Index:
Within 8" of Joint: **NO**
Remarks: **M-803-039**

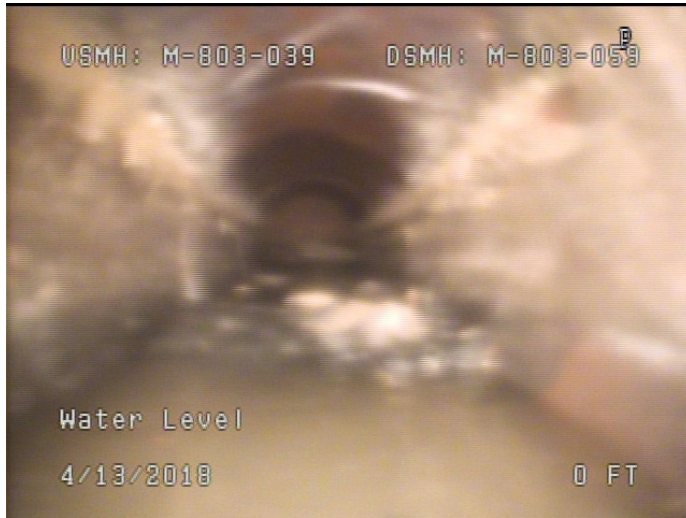
Code: **MWL**
Description: **Water Level**

Distance (ft): **.0**
Structural Grade: **0**
O&M Grade: **0**
Clock Start/From:
Clock To:
1st Value:
2nd Value:
Value Percent: **80.000**
Continuous Index:
Within 8" of Joint: **NO**
Remarks:

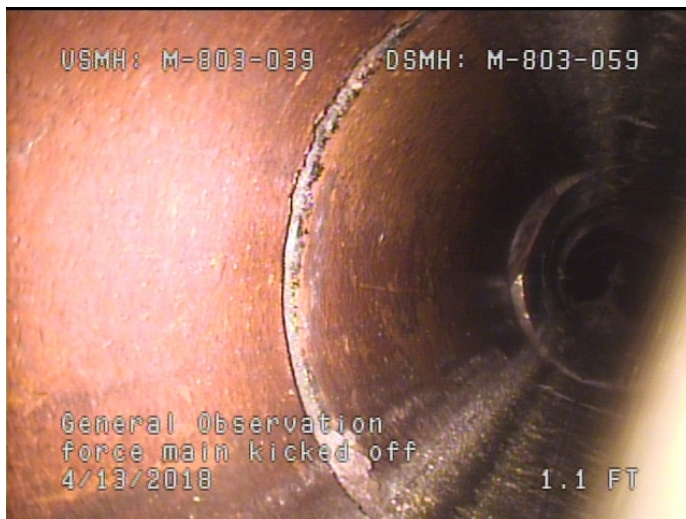
Code: **MGO**
Description: **General Observation**

Distance (ft): **1.1**
Structural Grade: **0**
O&M Grade: **0**
Clock Start/From:
Clock To:
1st Value:
2nd Value:
Value Percent:
Continuous Index:
Within 8" of Joint: **NO**
Remarks: **force main kicked off**

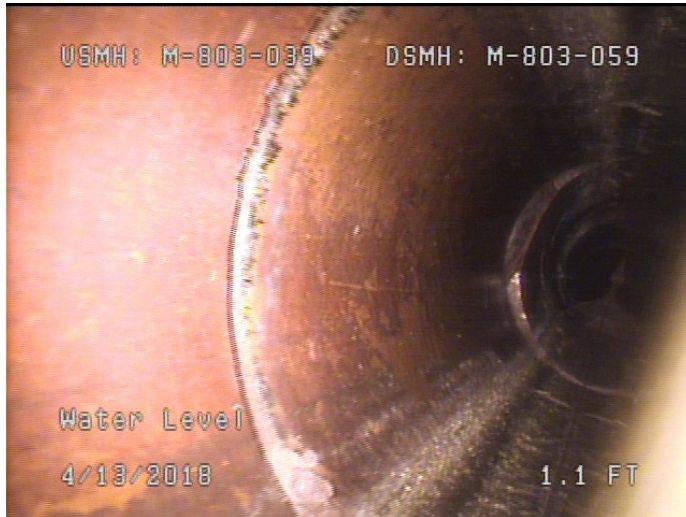
Code:	MWL
Description:	Water Level
Distance (ft):	1.1
Structural Grade:	0
O&M Grade:	0
Clock Start/From:	
Clock To:	
1st Value:	
2nd Value:	
Value Percent:	30.000
Continuous Index:	
Within 8" of Joint:	NO
Remarks:

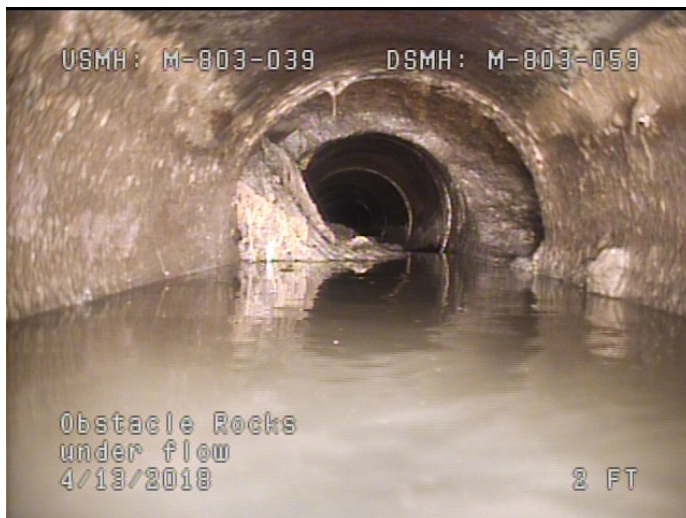
Code:	OBR
Description:	Obstacle Rocks
Distance (ft):	2.0
Structural Grade:	0
O&M Grade:	3
Clock Start/From:	5
Clock To:	7
1st Value:	
2nd Value:	
Value Percent:	20.000
Continuous Index:	
Within 8" of Joint:	NO
Remarks:	under flow

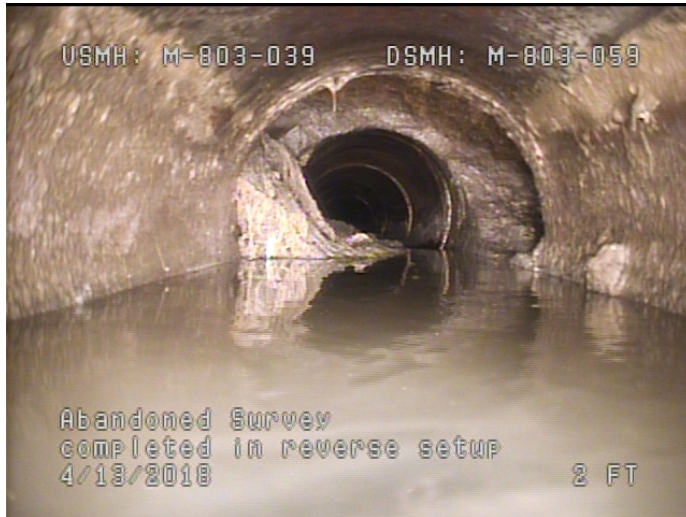
Code:	MSA
Description:	Abandoned Survey
Distance (ft):	2.0
Structural Grade:	0
O&M Grade:	0
Clock Start/From:	
Clock To:	
1st Value:	
2nd Value:	
Value Percent:	
Continuous Index:	
Within 8" of Joint:	NO
Remarks:	completed in reverse setup
