Profile/Photo Observation Report

Date:	04/04/2018	Weather:		Coding:	PACP 6.0
Pipe Length (ft):	175.2	Owner:	NA	Pre Clean:	Not Known
P.O.#:		Surveyor:	Jen Costello	PSR:	P-803-051-042
Customer:		Clean Date:	01/01/1900	Shape:	C

Street:	E 40TH AVE & N KELLY ST	Flow Control:	Not Controlled
City:	Hobart, IN	Year Renewed:	
Location:	Other	Tape/Media #:	
Purpose:	Not Known	Dia/Height:	12"
Use:	Sanitary	Material:	VCP
Drain Area:	NA	Lining:	
Category:	NA		
Comment:

Location Details:		Direction of Survey:	Upstream
US MH:	M-803-042	DS MH:	M-803-051
		Total Length Surveyed (ft):	15.9

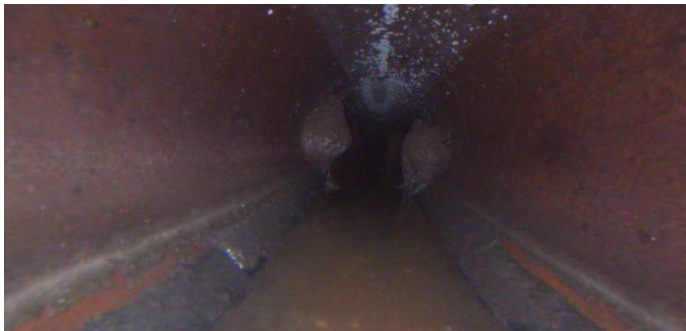
Code: **AMH**
Description: **Manhole**

Distance (ft): **.0**
Structural Grade: **0**
O&M Grade: **0**
Clock Start/From:
Clock To:
1st Value:
2nd Value:
Value Percent:
Continuous Index:
Within 8" of Joint: **NO**
Remarks: **M-803-051**

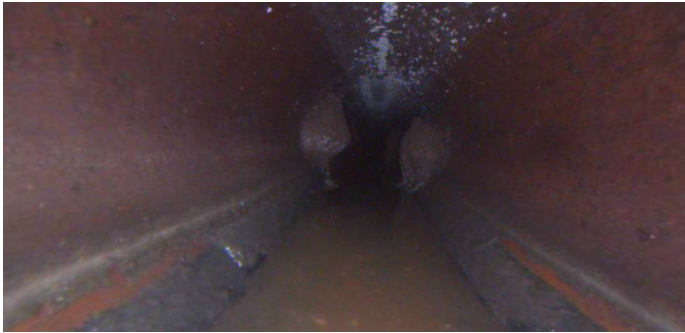
Code:	MWL
Description:	Water Level

Distance (ft):	.0
Structural Grade:	0
O&M Grade:	0
Clock Start/From:	
Clock To:	
1st Value:	
2nd Value:	
Value Percent:	10.000
Continuous Index:	
Within 8" of Joint:	NO
Remarks:

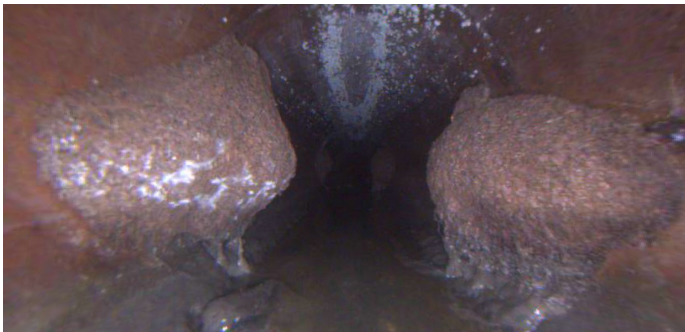
Code:	RMJ
Description:	Roots Medium Joint

Distance (ft):	2.7
Structural Grade:	0
O&M Grade:	3
Clock Start/From:	7
Clock To:	5
1st Value:	
2nd Value:	
Value Percent:	30.000
Continuous Index:	
Within 8" of Joint:	YES
Remarks:

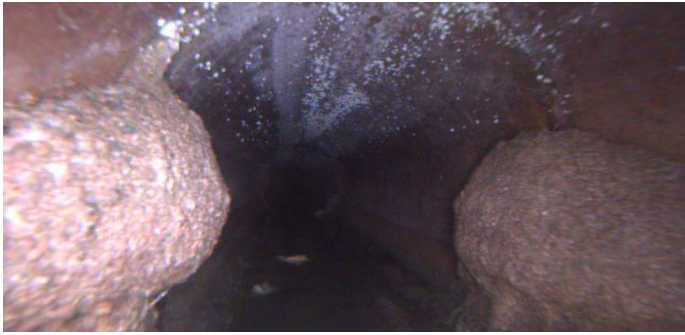
Code: **DAZ**
Description: **Deposits Attached Other**

Distance (ft): **5.6**
Structural Grade: **0**
O&M Grade: **4**
Clock Start/From: **7**
Clock To: **5**
1st Value:
2nd Value:
Value Percent: **30.000**
Continuous Index:
Within 8" of Joint: **YES**
Remarks:

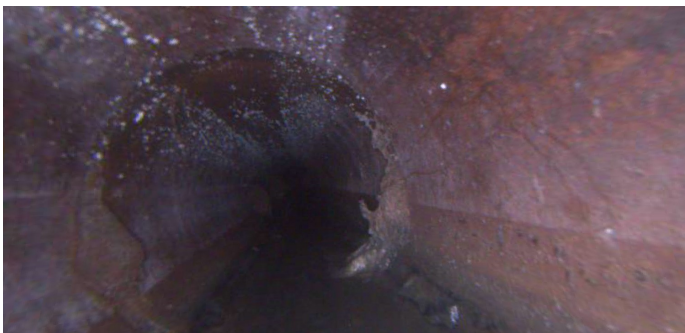
Code: **DAE**
Description: **Deposits Attached Encrustation**

Distance (ft): **8.1**
Structural Grade: **0**
O&M Grade: **2**
Clock Start/From: **8**
Clock To: **4**
1st Value:
2nd Value:
Value Percent: **5.000**
Continuous Index:
Within 8" of Joint: **YES**
Remarks:

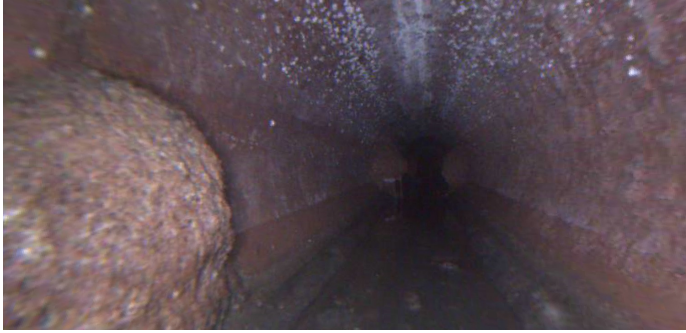
Code: **DAZ**
Description: **Deposits Attached Other**

Distance (ft): **11.5**
Structural Grade: **0**
O&M Grade: **2**
Clock Start/From: **7**
Clock To: **9**
1st Value:
2nd Value:
Value Percent: **10.000**
Continuous Index:
Within 8" of Joint: **YES**
Remarks:

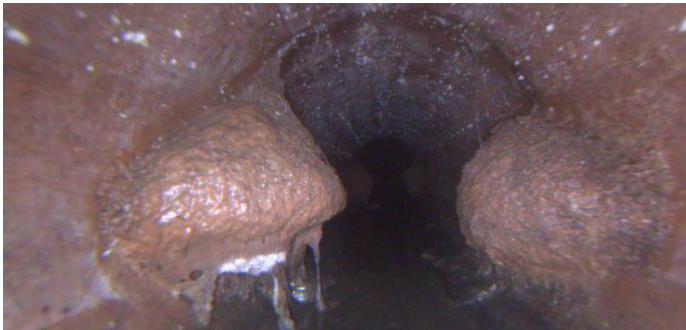
Code: **DAZ**
Description: **Deposits Attached Other**

Distance (ft): **13.9**
Structural Grade: **0**
O&M Grade: **4**
Clock Start/From: **7**
Clock To: **5**
1st Value:
2nd Value:
Value Percent: **30.000**
Continuous Index:
Within 8" of Joint: **YES**
Remarks:

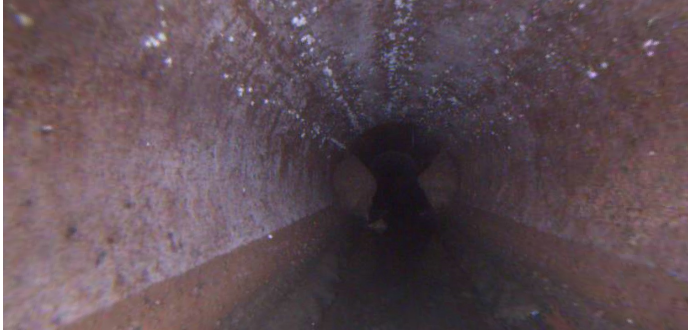
Code:	MSA
Description:	Abandoned Survey
Distance (ft):	15.9
Structural Grade:	0
O&M Grade:	0
Clock Start/From:	
Clock To:	
1st Value:	
2nd Value:	
Value Percent:	
Continuous Index:	
Within 8" of Joint:	NO
Remarks:	daz
