Profile/Photo Observation Report

Date:	04/04/2018	Weather:		Coding:	PACP 6.0
Pipe Length (ft):	175.2	Owner:	NA	Pre Clean:	Not Known
P.O.#:		Surveyor:	Jen Costello	PSR:	P-803-051-042
Customer:		Clean Date:	01/01/1900	Shape:	C

Street:	E 40th Ave.	Flow Control:	Not Controlled
City:	Hobart, IN	Year Renewed:	
Location:	Other	Tape/Media #:	
Purpose:	Not Known	Dia/Height:	12"
Use:	Sanitary	Material:	VCP
Drain Area:	NA	Lining:	
Category:	NA		
Comment:

Location Details:		Direction of Survey:	Upstream
US MH:	M-803-042	DS MH:	M-803-051
		Total Length Surveyed (ft):	15.9

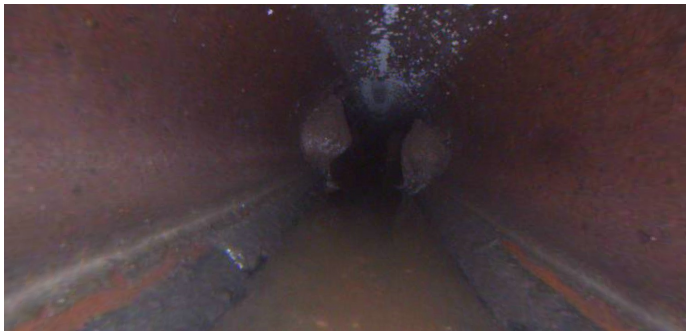
Code: **AMH**
Description: **Manhole**

Distance (ft): **.0**
Structural Grade: **0**
O&M Grade: **0**
Clock Start/From:
Clock To:
1st Value:
2nd Value:
Value Percent:
Continuous Index:
Within 8" of Joint: **NO**
Remarks: **M-803-051**

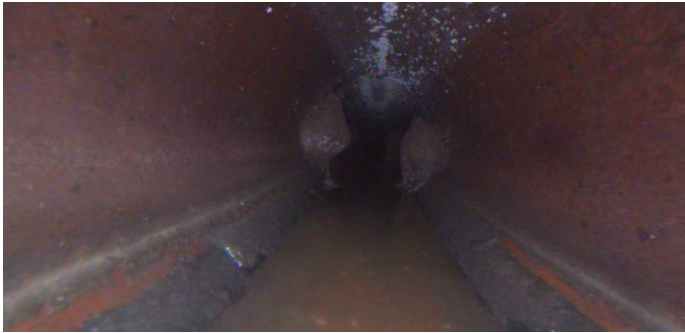
Code:	MWL
Description:	Water Level

Distance (ft):	.0
Structural Grade:	0
O&M Grade:	0
Clock Start/From:	
Clock To:	
1st Value:	
2nd Value:	
Value Percent:	10.000
Continuous Index:	
Within 8" of Joint:	NO
Remarks:

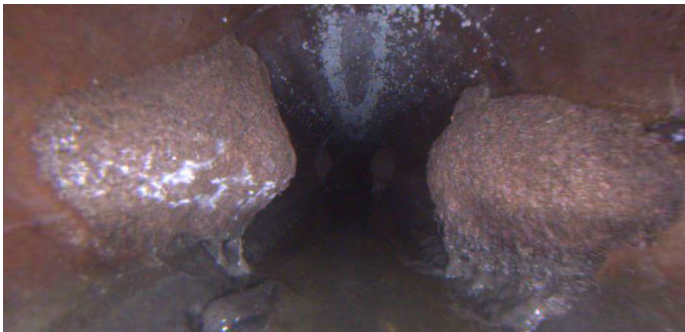
Code:	RMJ
Description:	Roots Medium Joint

Distance (ft):	2.7
Structural Grade:	0
O&M Grade:	3
Clock Start/From:	7
Clock To:	5
1st Value:	
2nd Value:	
Value Percent:	30.000
Continuous Index:	
Within 8" of Joint:	YES
Remarks:

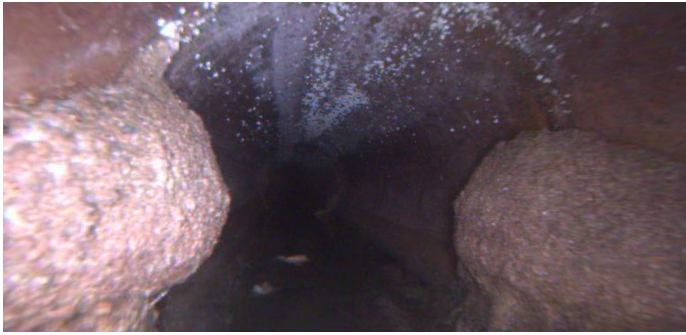
Code: **DAZ**
Description: **Deposits Attached Other**

Distance (ft): **5.6**
Structural Grade: **0**
O&M Grade: **4**
Clock Start/From: **7**
Clock To: **5**
1st Value:
2nd Value:
Value Percent: **30.000**
Continuous Index:
Within 8" of Joint: **YES**
Remarks:

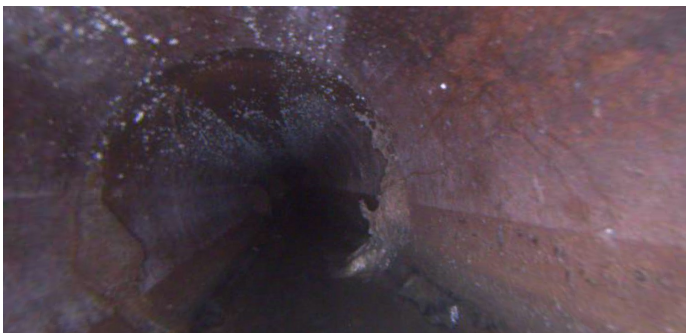
Code: **DAE**
Description: **Deposits Attached Encrustation**

Distance (ft): **8.1**
Structural Grade: **0**
O&M Grade: **2**
Clock Start/From: **8**
Clock To: **4**
1st Value:
2nd Value:
Value Percent: **5.000**
Continuous Index:
Within 8" of Joint: **YES**
Remarks:

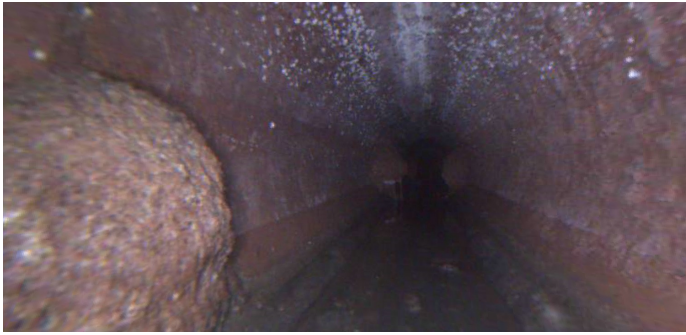
Code: **DAZ**
Description: **Deposits Attached Other**

Distance (ft): **11.5**
Structural Grade: **0**
O&M Grade: **2**
Clock Start/From: **7**
Clock To: **9**
1st Value:
2nd Value:
Value Percent: **10.000**
Continuous Index:
Within 8" of Joint: **YES**
Remarks:

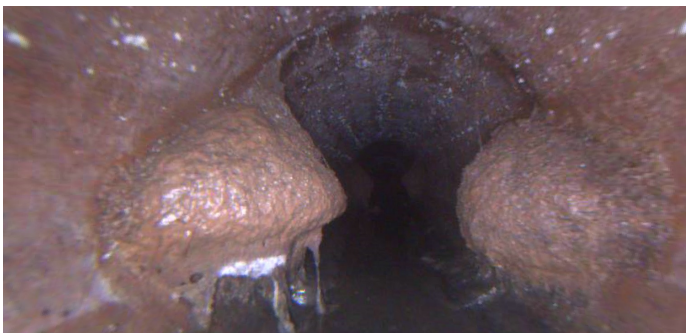
Code: **DAZ**
Description: **Deposits Attached Other**

Distance (ft): **13.9**
Structural Grade: **0**
O&M Grade: **4**
Clock Start/From: **7**
Clock To: **5**
1st Value:
2nd Value:
Value Percent: **30.000**
Continuous Index:
Within 8" of Joint: **YES**
Remarks:

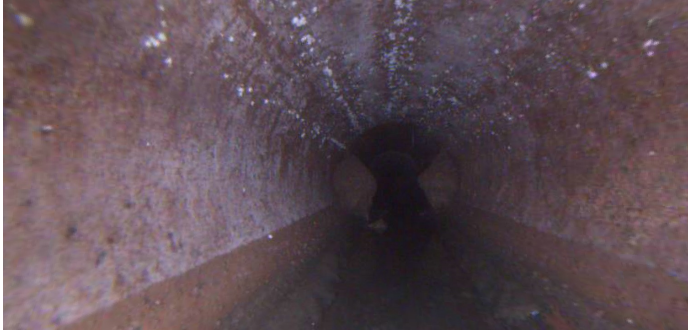
Code:	MSA
Description:	Abandoned Survey
Distance (ft):	15.9
Structural Grade:	0
O&M Grade:	0
Clock Start/From:	
Clock To:	
1st Value:	
2nd Value:	
Value Percent:	
Continuous Index:	
Within 8" of Joint:	NO
Remarks:	daz
