Profile/Photo Observation Report

Street:	E 40TH AVE & N KELLY ST	Flow Control:	Not Controlled
City:	Hobart, IN	Year Renewed:	
Location:	Other	Tape/Media #:	
Purpose:	Not Known	Dia/Height:	12"
Use:	Sanitary	Material:	VCP
Drain Area:	NA	Lining:	
Category:	NA		
Comment:			
Location Details:		Direction of Survey:	Downstream
US MH:	M-803-042	DS MH:	M-803-051
		Total Length Surveyed (ft):	106.8

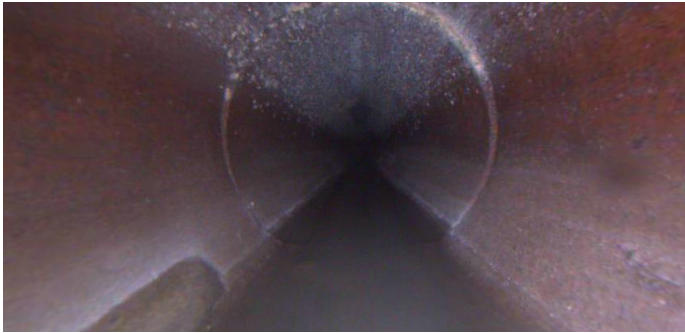
Code:	MWL
Description:	Water Level

Distance (ft):	.0
Structural Grade:	0
O&M Grade:	0
Clock Start/From:	
Clock To:	
1st Value:	
2nd Value:	
Value Percent:	5.000
Continuous Index:	
Within 8" of Joint:	NO
Remarks:

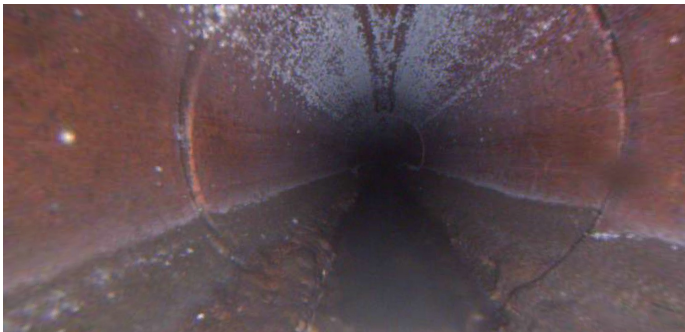
Code:	DAZ
Description:	Deposits Attached Other

Distance (ft):	13.0
Structural Grade:	0
O&M Grade:	2
Clock Start/From:	7
Clock To:	5
1st Value:	
2nd Value:	
Value Percent:	10.000
Continuous Index:	S01
Within 8" of Joint:	NO
Remarks:

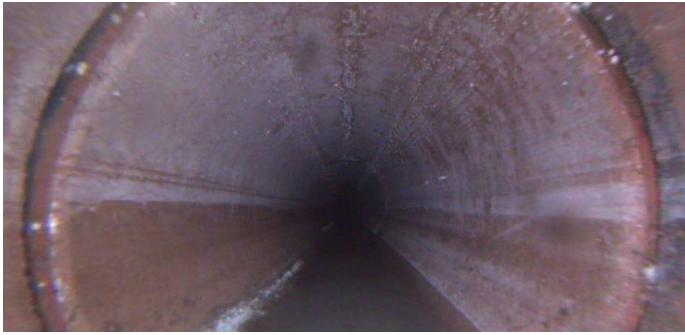
Code: **DAZ**
Description: **Deposits Attached Other**

Distance (ft): **42.6**
Structural Grade: **0**
O&M Grade: **2**
Clock Start/From: **7**
Clock To: **5**
1st Value:
2nd Value:
Value Percent: **10.000**
Continuous Index: **F01**
Within 8" of Joint: **NO**
Remarks:

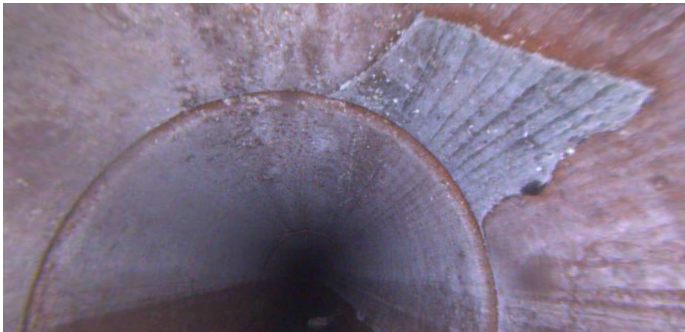
Code: **FM**
Description: **Fracture Multiple**

Distance (ft): **84.0**
Structural Grade: **4**
O&M Grade: **0**
Clock Start/From: **12**
Clock To: **3**
1st Value:
2nd Value:
Value Percent:
Continuous Index:
Within 8" of Joint: **YES**
Remarks:

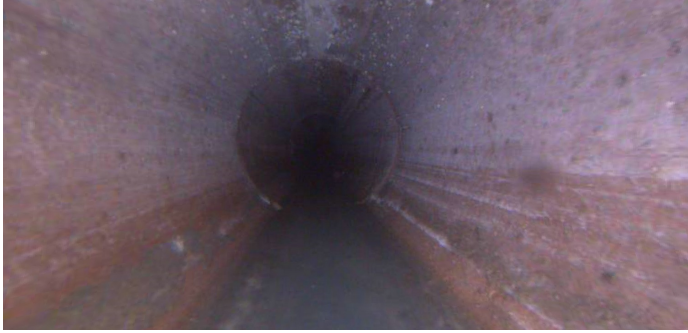
Code:	MSA
Description:	Abandoned Survey
Distance (ft):	106.8
Structural Grade:	0
O&M Grade:	0
Clock Start/From:	
Clock To:	
1st Value:	
2nd Value:	
Value Percent:	
Continuous Index:	
Within 8" of Joint:	NO
Remarks:	unknown
