Profile/Photo Observation Report

Date:	04/04/2018	Weather:		Coding:	PACP 6.0
Pipe Length (ft):	175.2	Owner:	NA	Pre Clean:	Not Known
P.O.#:		Surveyor:	Jen Costello	PSR:	P-803-051-042
Customer:		Clean Date:	01/01/1900	Shape:	C

Street:	E 40th Ave.	Flow Control:	Not Controlled
City:	Hobart, IN	Year Renewed:	
Location:	Other	Tape/Media #:	
Purpose:	Not Known	Dia/Height:	12"
Use:	Sanitary	Material:	VCP
Drain Area:	NA	Lining:	
Category:	NA		
Comment:

Location Details:		Direction of Survey:	Downstream
US MH:	M-803-042	DS MH:	M-803-051
		Total Length Surveyed (ft):	106.8

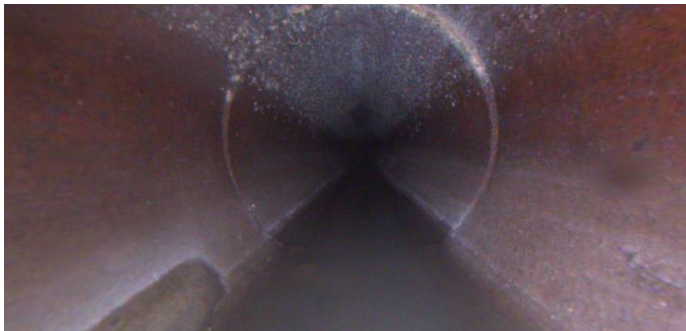
Code: **AMH**
Description: **Manhole**

Distance (ft): **.0**
Structural Grade: **0**
O&M Grade: **0**
Clock Start/From:
Clock To:
1st Value:
2nd Value:
Value Percent:
Continuous Index:
Within 8" of Joint: **NO**
Remarks: **M-803-042**

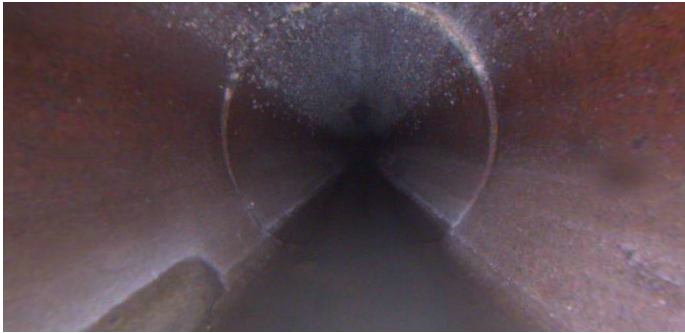
Code:	MWL
Description:	Water Level

Distance (ft):	.0
Structural Grade:	0
O&M Grade:	0
Clock Start/From:	
Clock To:	
1st Value:	
2nd Value:	
Value Percent:	5.000
Continuous Index:	
Within 8" of Joint:	NO
Remarks:

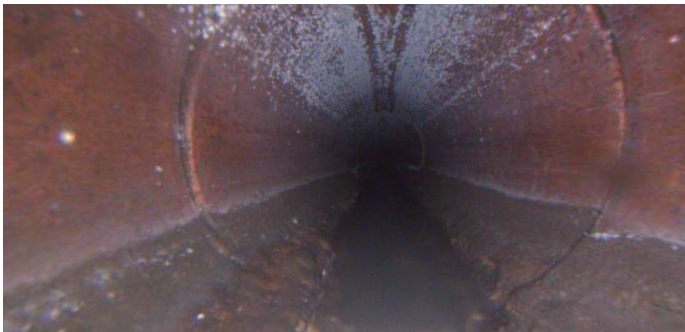
Code:	DAZ
Description:	Deposits Attached Other

Distance (ft):	13.0
Structural Grade:	0
O&M Grade:	2
Clock Start/From:	7
Clock To:	5
1st Value:	
2nd Value:	
Value Percent:	10.000
Continuous Index:	S01
Within 8" of Joint:	NO
Remarks:

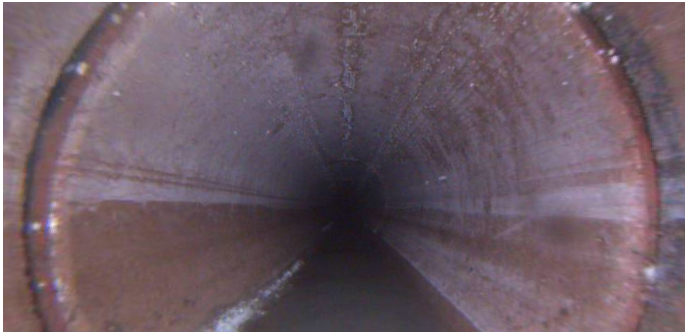
Code: **DAZ**
Description: **Deposits Attached Other**

Distance (ft): **42.6**
Structural Grade: **0**
O&M Grade: **2**
Clock Start/From: **7**
Clock To: **5**
1st Value:
2nd Value:
Value Percent: **10.000**
Continuous Index: **F01**
Within 8" of Joint: **NO**
Remarks:

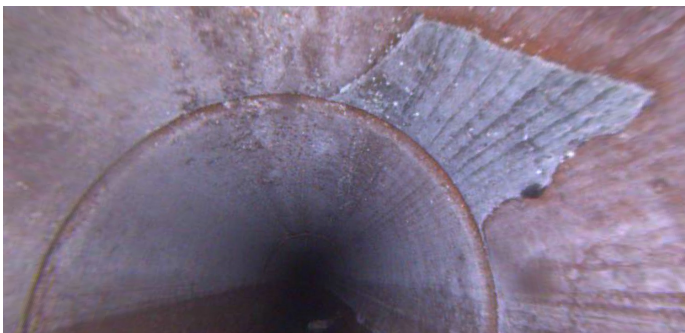
Code: **FM**
Description: **Fracture Multiple**

Distance (ft): **84.0**
Structural Grade: **4**
O&M Grade: **0**
Clock Start/From: **12**
Clock To: **3**
1st Value:
2nd Value:
Value Percent:
Continuous Index:
Within 8" of Joint: **YES**
Remarks:

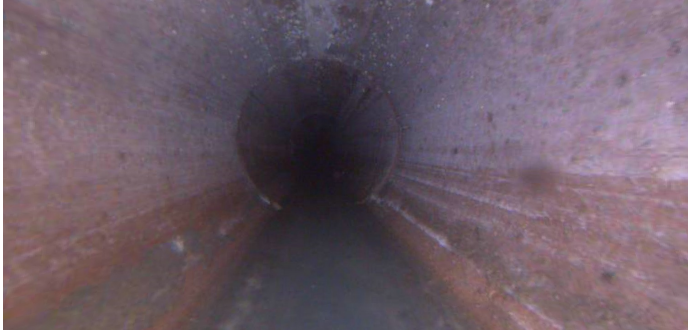
Code: **MSA**
Description: **Abandoned Survey**

Distance (ft): **106.8**
Structural Grade: **0**
O&M Grade: **0**
Clock Start/From:
Clock To:
1st Value:
2nd Value:
Value Percent:
Continuous Index:
Within 8" of Joint: **NO**
Remarks: **unknown**
