Profile/Photo Observation Report

Date:	10/02/2018	Weather:		Coding:	PACP 6.0
Pipe Length (ft):	175.2	Owner:	NA	Pre Clean:	Not Known
P.O.#:		Surveyor:	Justin Gonzales	PSR:	P-803-051-042
Customer:		Clean Date:	01/01/1900	Shape:	C

Street:	40th. Ave.	Flow Control:	Not Controlled
City:	Hobart, IN	Year Renewed:	
Location:	Light Highway	Tape/Media #:	
Purpose:	Routine Assessment	Dia/Height:	12"
Use:	Sanitary	Material:	VCP
Drain Area:	NA	Lining:	
Category:	NA		
Comment:

Location Details:		Direction of Survey:	Downstream
US MH:	M-803-042	DS MH:	M-803-051
		Total Length Surveyed (ft):	166.2

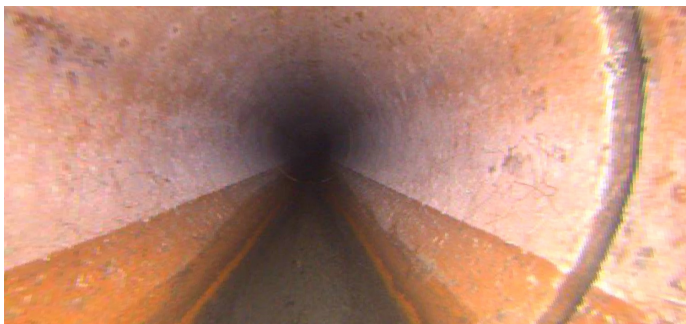
Code: **AMH**
Description: **Manhole**

Distance (ft): **.0**
Structural Grade: **0**
O&M Grade: **0**
Clock Start/From:
Clock To:
1st Value:
2nd Value:
Value Percent:
Continuous Index:
Within 8" of Joint: **NO**
Remarks: **M-803-042**

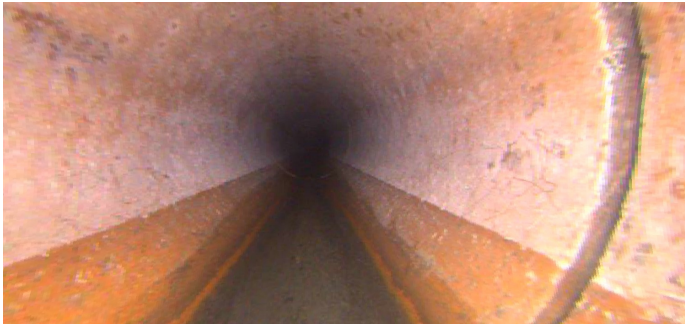
Code:	MWL
Description:	Water Level

Distance (ft):	.0
Structural Grade:	0
O&M Grade:	0
Clock Start/From:	
Clock To:	
1st Value:	
2nd Value:	
Value Percent:	5.000
Continuous Index:	
Within 8" of Joint:	NO
Remarks:

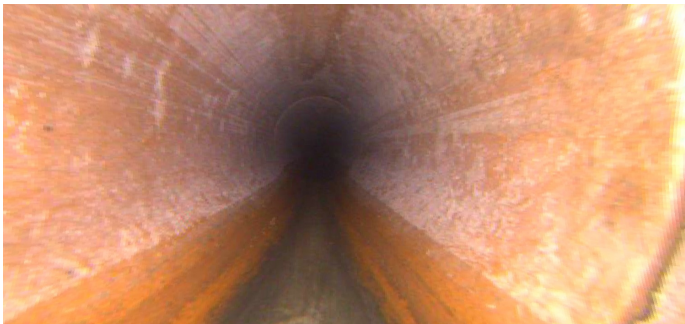
Code:	DAGS
Description:	Deposits Attached Grease

Distance (ft):	9.7
Structural Grade:	0
O&M Grade:	2
Clock Start/From:	7
Clock To:	5
1st Value:	
2nd Value:	
Value Percent:	5.000
Continuous Index:	S01
Within 8" of Joint:	YES
Remarks:	WANDER

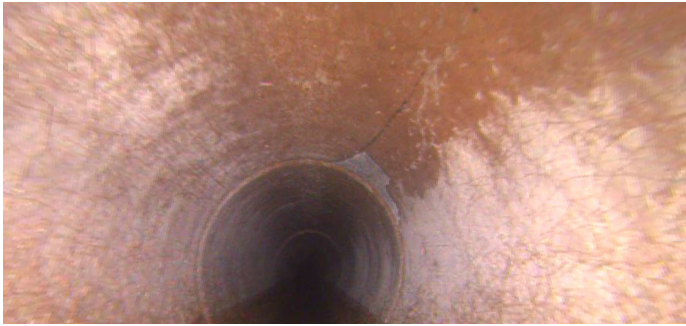
Code: **FL**
Description: **Fracture Longitudinal**

Distance (ft): **80.9**
Structural Grade: **3**
O&M Grade: **0**
Clock Start/From: **1**
Clock To:
1st Value:
2nd Value:
Value Percent:
Continuous Index:
Within 8" of Joint:
Remarks:

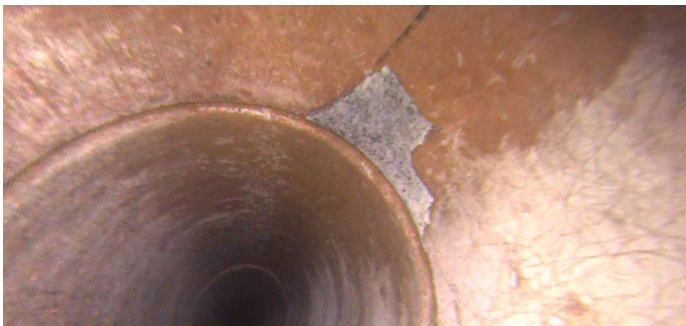
Code: **FS**
Description: **Fracture Spiral**

Distance (ft): **81.6**
Structural Grade: **3**
O&M Grade: **0**
Clock Start/From: **1**
Clock To: **3**
1st Value:
2nd Value:
Value Percent:
Continuous Index:
Within 8" of Joint: **YES**
Remarks:

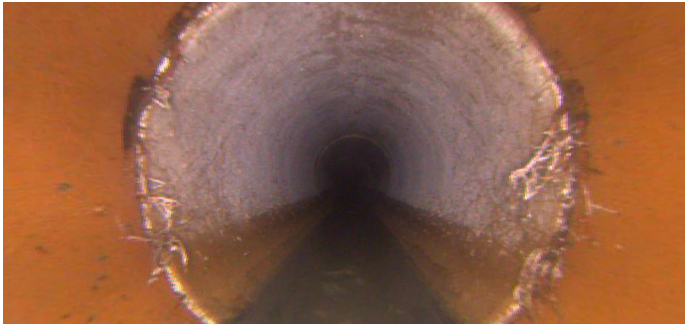
Code: **RFJ**
Description: **Roots Fine Joint**

Distance (ft): **145.4**
Structural Grade: **0**
O&M Grade: **1**
Clock Start/From: **7**
Clock To: **5**
1st Value:
2nd Value:
Value Percent:
Continuous Index:
Within 8" of Joint: **YES**
Remarks:

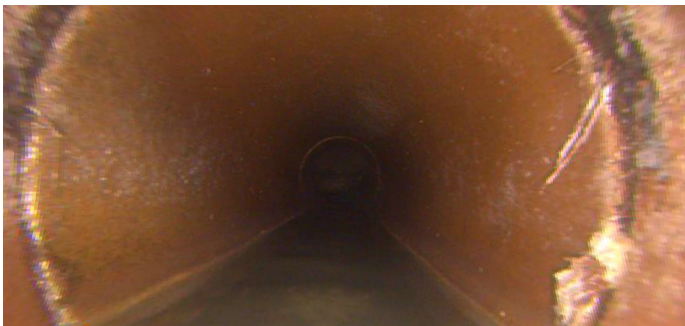
Code: **RFJ**
Description: **Roots Fine Joint**

Distance (ft): **160.1**
Structural Grade: **0**
O&M Grade: **1**
Clock Start/From: **7**
Clock To: **5**
1st Value:
2nd Value:
Value Percent:
Continuous Index:
Within 8" of Joint: **YES**
Remarks:

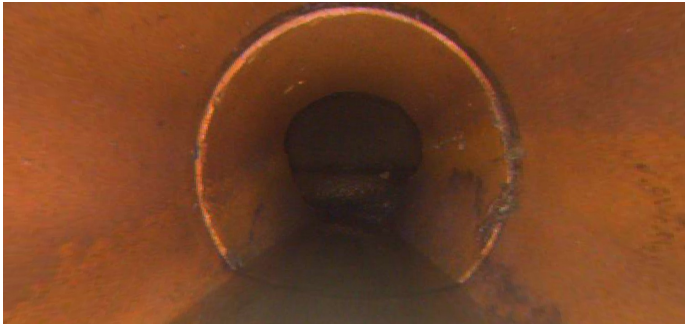
Code: **RFJ**
Description: **Roots Fine Joint**

Distance (ft): **162.6**
Structural Grade: **0**
O&M Grade: **1**
Clock Start/From: **8**
Clock To: **4**
1st Value:
2nd Value:
Value Percent:
Continuous Index:
Within 8" of Joint: **YES**
Remarks:

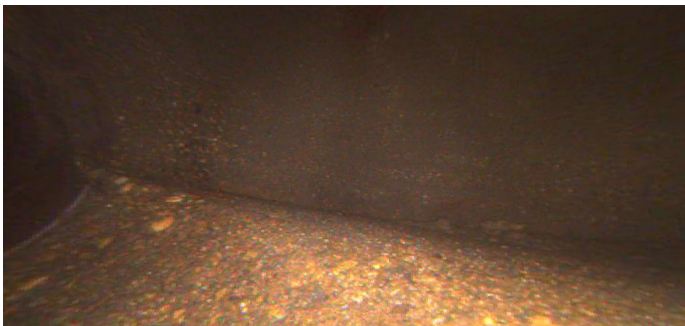
Code: **AMH**
Description: **Manhole**

Distance (ft): **166.2**
Structural Grade: **0**
O&M Grade: **0**
Clock Start/From:
Clock To:
1st Value:
2nd Value:
Value Percent:
Continuous Index:
Within 8" of Joint: **NO**
Remarks: **M-803-051**

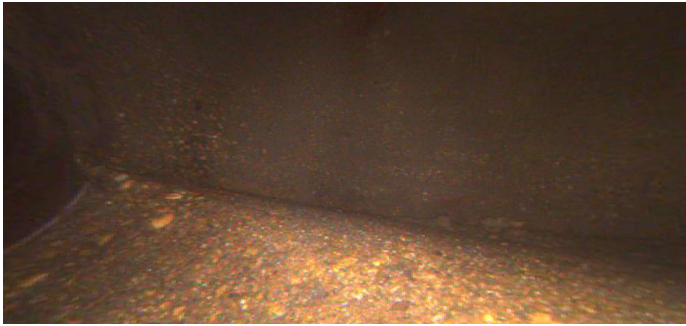
Code:	DAGS
Description:	Deposits Attached Grease
Distance (ft):	166.2
Structural Grade:	0
O&M Grade:	2
Clock Start/From:	7
Clock To:	5
1st Value:	
2nd Value:	
Value Percent:	5.000
Continuous Index:	F01
Within 8" of Joint:	YES
Remarks:	WANDER
