## Profile/Photo Observation Report

Date:	<b>04/18/2018</b>	Weather:		Coding:	<b>PACP 4.2</b>
Pipe Length (ft):	<b>234.6</b>	Owner:	<b>City of Hobart</b>	Pre Clean:	<b>No Pre-Cleaning</b>
P.O.#:	<b>2004</b>	Surveyor:	<b>SAN</b>	PSR:	<b>P-803-043-044</b>
Customer:	<b>Red Zone</b>	Clean Date:		Shape:	<b>C</b>

Street:	<b>439 Kelly st</b>	Flow Control:	<b>Not Controlled</b>
City:	<b>Hobart In</b>	Year Renewed:	
Location:	<b>Easement/Right of Way</b>	Tape/Media #:	<b>Deliverable 1</b>
Purpose:	<b>Routine Assessment</b>	Dia/Height:	<b>15"</b>
Use:	<b>Sanitary</b>	Material:	<b>VCP</b>
Drain Area:	<b>Northeast</b>	Lining:	
Category:	<b>NA</b>		
Comment:	<b>413-2</b>		
Location Details:	<b>Grass between homes</b>	Direction of Survey:	<b>Downstream</b>
US MH:	<b>M-803-043</b>	DS MH:	<b>M-803-044</b>
		Total Length Surveyed (ft):	<b>234.6</b>

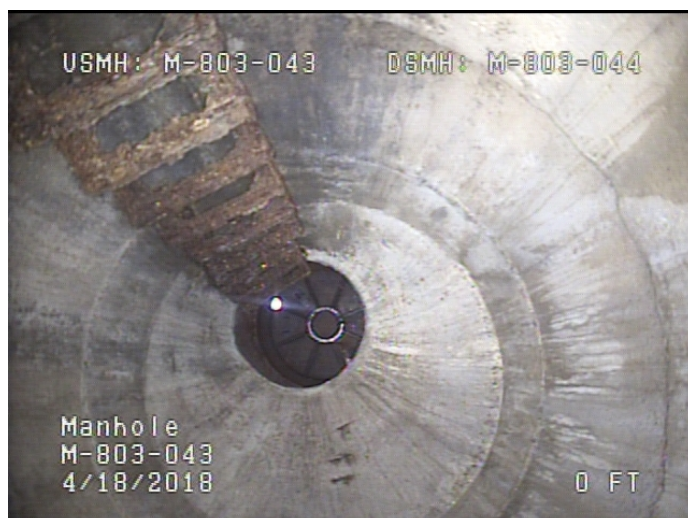
Code: **AMH**  
Description: **Manhole**

Distance (ft): **.0**  
Structural Grade: **0**  
O&M Grade: **0**  
Clock Start/From:  
Clock To:  
1st Value:  
2nd Value:  
Value Percent:  
Continuous Index:  
Within 8" of Joint: **NO**  
Remarks: **M-803-043**

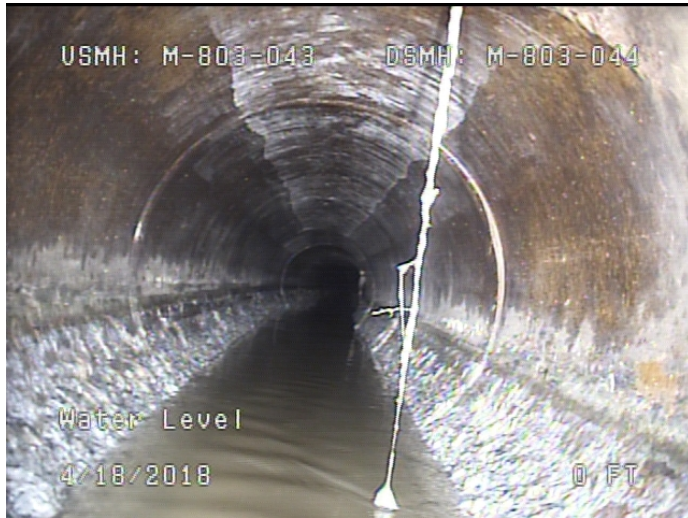
Code:	<b>MWL</b>
Description:	<b>Water Level</b>
Distance (ft):	<b>.0</b>
Structural Grade:	<b>0</b>
O&M Grade:	<b>0</b>
Clock Start/From:	
Clock To:	
1st Value:	
2nd Value:	
Value Percent:	<b>10.000</b>
Continuous Index:	
Within 8" of Joint:	<b>NO</b>
Remarks:

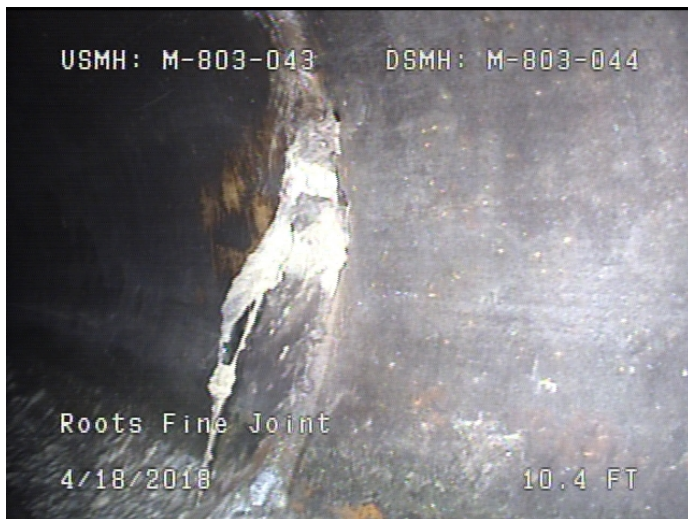
Code:	<b>RFJ</b>
Description:	<b>Roots Fine Joint</b>
Distance (ft):	<b>10.4</b>
Structural Grade:	<b>0</b>
O&M Grade:	<b>1</b>
Clock Start/From:	<b>2</b>
Clock To:	<b>3</b>
1st Value:	
2nd Value:	
Value Percent:	
Continuous Index:	
Within 8" of Joint:	<b>YES</b>
Remarks:

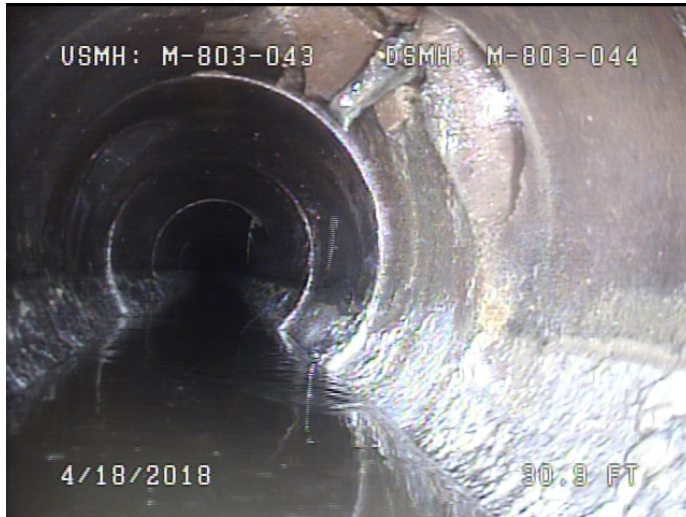
Code:	<b>TFA</b>
Description:	<b>Tap Factory Active</b>
Distance (ft):	<b>30.9</b>
Structural Grade:	<b>0</b>
O&M Grade:	<b>0</b>
Clock Start/From:	<b>2</b>
Clock To:	
1st Value:	<b>6.000</b>
2nd Value:	
Value Percent:	
Continuous Index:	
Within 8" of Joint:	<b>NO</b>
Remarks:	<b>soil in tap</b>

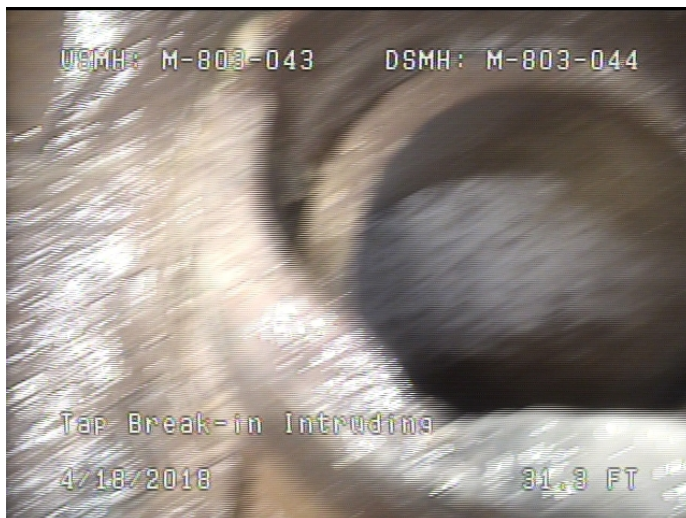
Code:	<b>TBI</b>
Description:	<b>Tap Break-in Intruding</b>
Distance (ft):	<b>31.3</b>
Structural Grade:	<b>0</b>
O&M Grade:	<b>2</b>
Clock Start/From:	<b>1</b>
Clock To:	
1st Value:	<b>6.000</b>
2nd Value:	<b>3.000</b>
Value Percent:	
Continuous Index:	
Within 8" of Joint:	<b>NO</b>
Remarks:

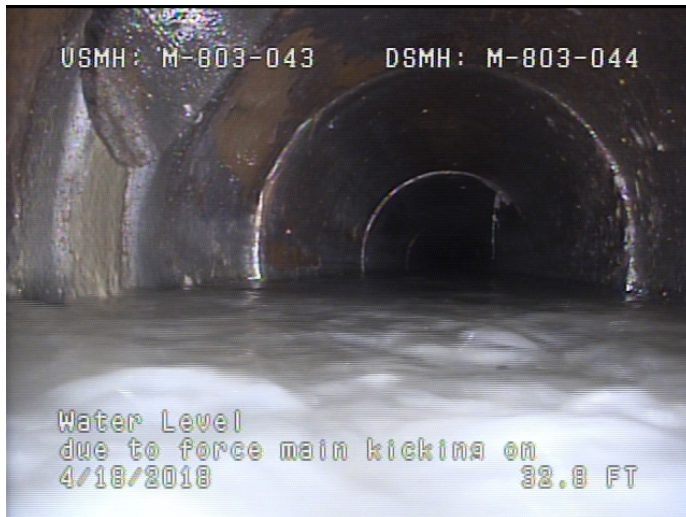
Code:	<b>MWL</b>
Description:	<b>Water Level</b>
Distance (ft):	<b>32.8</b>
Structural Grade:	<b>0</b>
O&M Grade:	<b>0</b>
Clock Start/From:	
Clock To:	
1st Value:	
2nd Value:	
Value Percent:	<b>35.000</b>
Continuous Index:	
Within 8" of Joint:	<b>NO</b>
Remarks:	<b>due to force main kicking on</b>

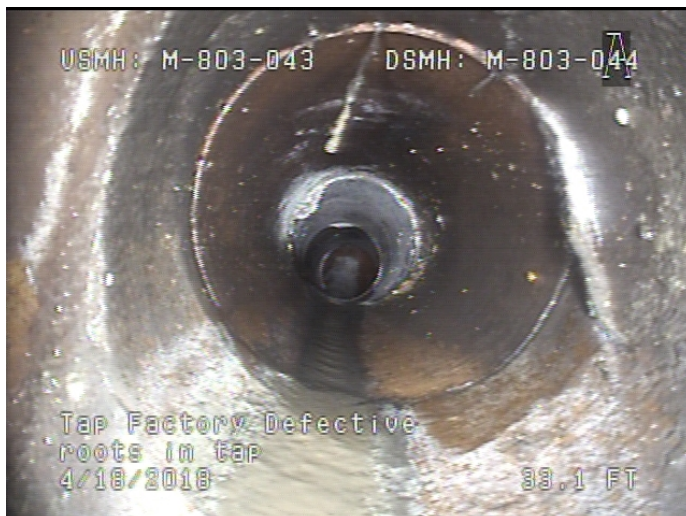
Code:	<b>TFD</b>
Description:	<b>Tap Factory Defective</b>
Distance (ft):	<b>33.1</b>
Structural Grade:	<b>0</b>
O&M Grade:	<b>2</b>
Clock Start/From:	<b>10</b>
Clock To:	
1st Value:	<b>6.000</b>
2nd Value:	
Value Percent:	
Continuous Index:	
Within 8" of Joint:	<b>NO</b>
Remarks:	<b>roots in tap</b>

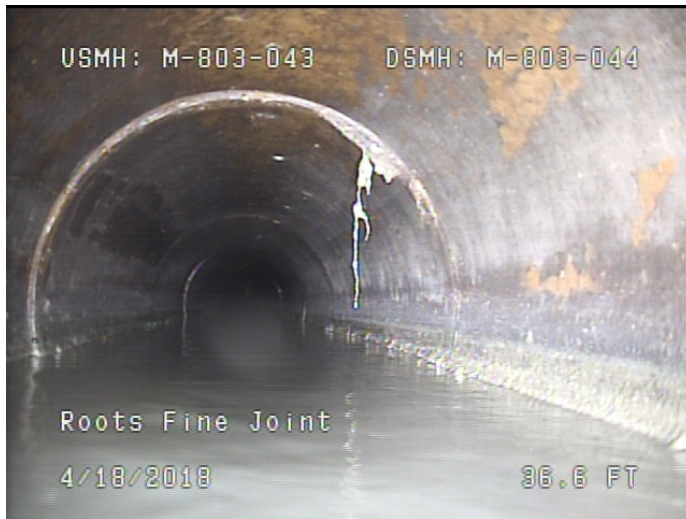
Code:	<b>RFJ</b>
Description:	<b>Roots Fine Joint</b>
Distance (ft):	<b>36.6</b>
Structural Grade:	<b>0</b>
O&M Grade:	<b>1</b>
Clock Start/From:	<b>1</b>
Clock To:	
1st Value:	
2nd Value:	
Value Percent:	
Continuous Index:	
Within 8" of Joint:	<b>YES</b>
Remarks:

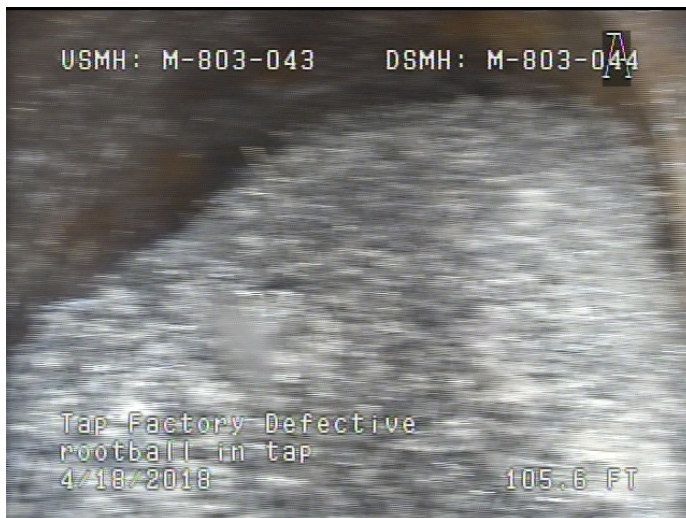
Code:	<b>TFD</b>
Description:	<b>Tap Factory Defective</b>
Distance (ft):	<b>105.6</b>
Structural Grade:	<b>0</b>
O&M Grade:	<b>2</b>
Clock Start/From:	<b>2</b>
Clock To:	
1st Value:	<b>6.000</b>
2nd Value:	
Value Percent:	
Continuous Index:	
Within 8" of Joint:	<b>NO</b>
Remarks:	<b>rootball in tap</b>

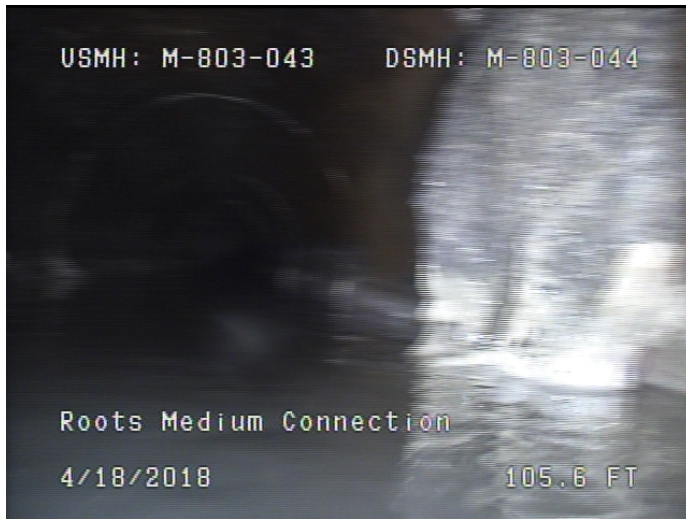
Code:	<b>RMC</b>
Description:	<b>Roots Medium Connection</b>
Distance (ft):	<b>105.6</b>
Structural Grade:	<b>0</b>
O&M Grade:	<b>3</b>
Clock Start/From:	<b>2</b>
Clock To:	<b>5</b>
1st Value:	
2nd Value:	
Value Percent:	<b>15.000</b>
Continuous Index:	
Within 8" of Joint:	<b>NO</b>
Remarks:

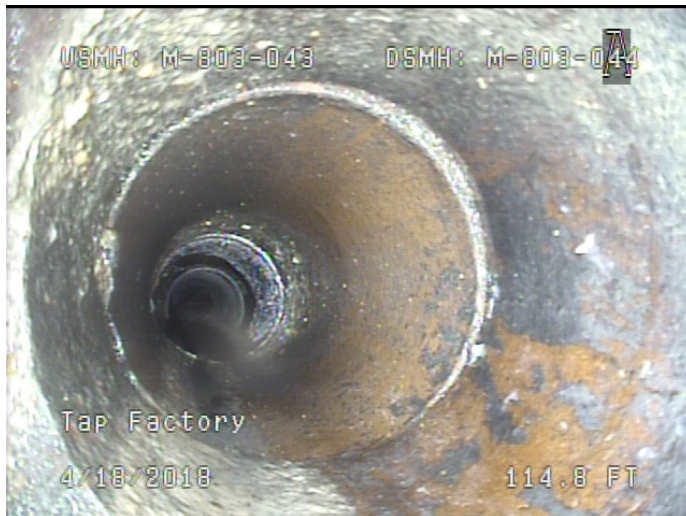
Code:	<b>TF</b>
Description:	<b>Tap Factory</b>
Distance (ft):	<b>114.8</b>
Structural Grade:	<b>0</b>
O&M Grade:	<b>0</b>
Clock Start/From:	<b>10</b>
Clock To:	
1st Value:	<b>6.000</b>
2nd Value:	
Value Percent:	
Continuous Index:	
Within 8" of Joint:	<b>NO</b>
Remarks:

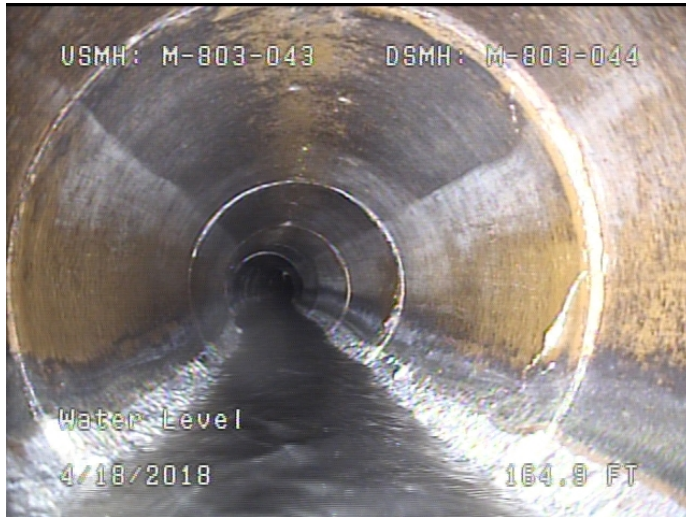
Code: **MWL**  
 Description: **Water Level**

Distance (ft): **164.9**  
 Structural Grade: **0**  
 O&M Grade: **0**  
 Clock Start/From:  
 Clock To:  
 1st Value:  
 2nd Value:  
 Value Percent: **10.000**  
 Continuous Index:  
 Within 8" of Joint: **NO**  
 Remarks:

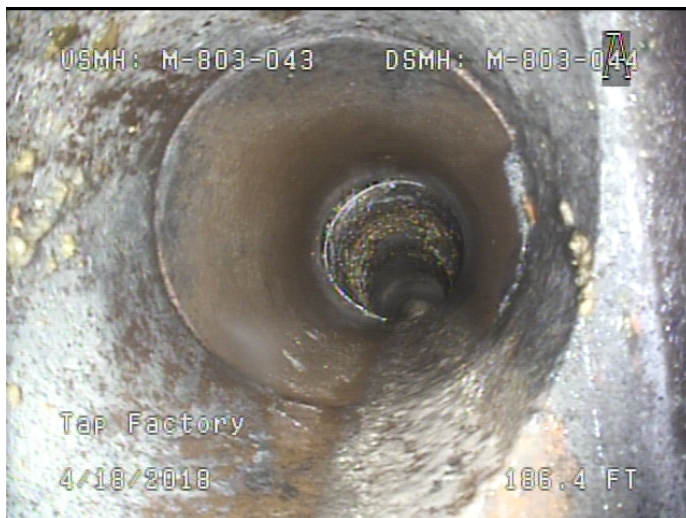
Code: **TF**  
 Description: **Tap Factory**

Distance (ft): **186.4**  
 Structural Grade: **0**  
 O&M Grade: **0**  
 Clock Start/From: **2**  
 Clock To:  
 1st Value: **6.000**  
 2nd Value:  
 Value Percent:  
 Continuous Index:  
 Within 8" of Joint: **NO**  
 Remarks:

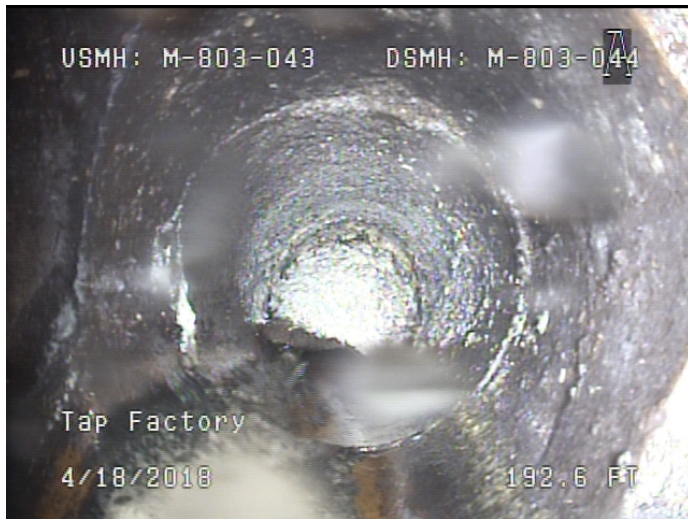
Code:	<b>TF</b>
Description:	<b>Tap Factory</b>
Distance (ft):	<b>192.6</b>
Structural Grade:	<b>0</b>
O&M Grade:	<b>0</b>
Clock Start/From:	<b>10</b>
Clock To:	
1st Value:	<b>4.000</b>
2nd Value:	
Value Percent:	
Continuous Index:	
Within 8" of Joint:	<b>NO</b>
Remarks:

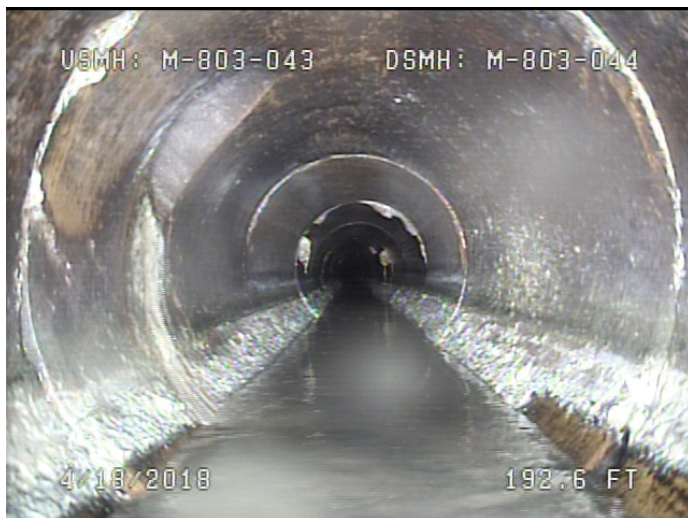
Code:	<b>TFD</b>
Description:	<b>Tap Factory Defective</b>
Distance (ft):	<b>192.6</b>
Structural Grade:	<b>0</b>
O&M Grade:	<b>2</b>
Clock Start/From:	<b>10</b>
Clock To:	
1st Value:	<b>6.000</b>
2nd Value:	
Value Percent:	
Continuous Index:	
Within 8" of Joint:	<b>NO</b>
Remarks:	<b>roots in tap</b>

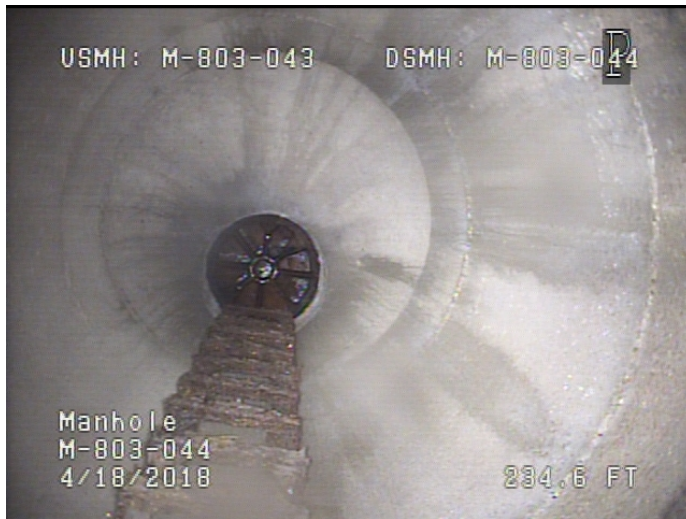
Code:	AMH
Description:	Manhole
Distance (ft):	234.6
Structural Grade:	0
O&M Grade:	0
Clock Start/From:	
Clock To:	
1st Value:	
2nd Value:	
Value Percent:	
Continuous Index:	
Within 8" of Joint:	NO
Remarks:	M-803-044
