Profile/Photo Observation Report

Date: 04/18/2018 Weather: **PACP 4.2** Coding: Pipe Length (ft): 230.7 Owner: **City of Hobart** Pre Clean: No Pre-Cleaning P.O.#: 2004 PSR: P-803-044-045 Surveyor: SAN **Red Zone** Customer: Clean Date: Shape: 415 Kelly st Flow Control: **Not Controlled** Street: City: **Hobart In** Year Renewed: Easement/Right of Way Tape/Media #: Deliverable 1 Location: Purpose: **Routine Assessment** Dia/Height: 15" Use: Sanitary Material: **VCP** Northeast Drain Area: Lining: NA Category: Comment: 413-3 **Location Details: Grass between homes** Direction of Survey: **Downstream** M-803-044 US MH: DS MH: M-803-045 Total Length Surveyed (ft): 230.7 1.02 211H 48.00 O&M Index: O&M Quick: O&M Rating: 0.00 0000 0.00

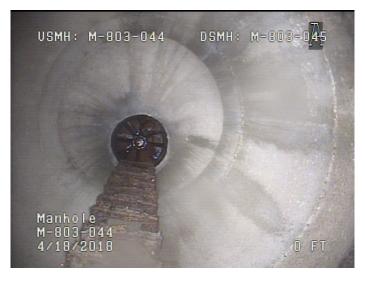
Code:	АМН
Description:	Manhole
Distance (ft):	.0
Structural Grade:	0
O&M Grade:	0
Clock Start/From:	
Clock To:	
1st Value:	
2nd Value:	
Value Percent:	
Continuous Index:	
Within 8" of Joint:	NO
Remarks:	M-803-044

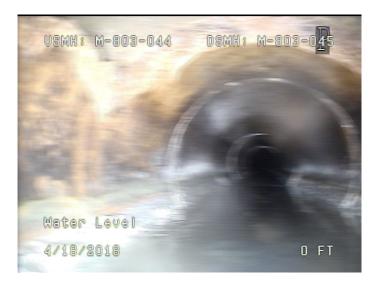
Code: MWL Description: **Water Level**

Distance (ft): .0 Structural Grade: 0 O&M Grade: 0

Value Percent: 15.000

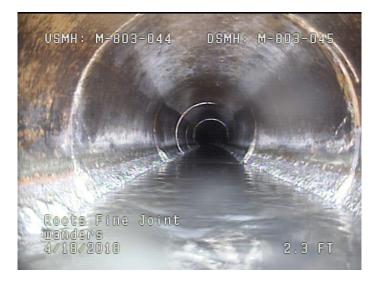
Code: RFJ

Description: **Roots Fine Joint**

Distance (ft): 2.3 Structural Grade: 0 O&M Grade: 1 Clock Start/From: 8

Continuous Index: **S01** Within 8" of Joint: YES

Remarks: wanders

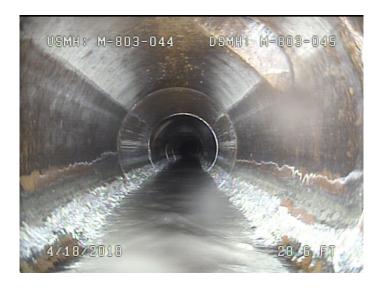
Code: **TF**

Description: Tap Factory

Distance (ft): 28.6
Structural Grade: 0

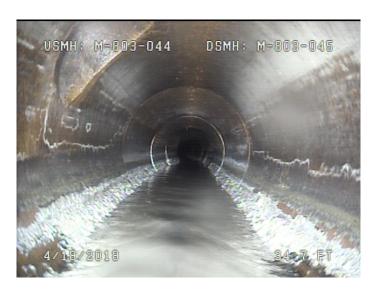
Code: TF

Description: Tap Factory

Distance (ft): 34.7
Structural Grade: 0

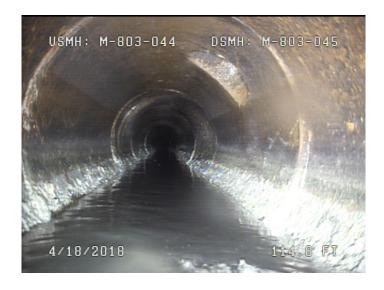
Code: **TFD**

Description: Tap Factory Defective

Distance (ft): 114.8
Structural Grade: 0
O&M Grade: 2
Clock Start/From: 2

Remarks: roots in tap

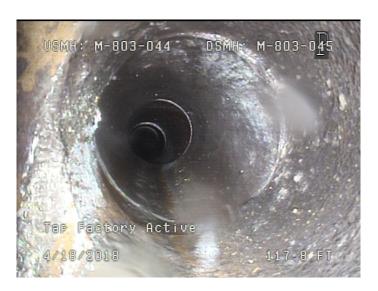
Code: TFA

Description: Tap Factory Active

Distance (ft): 117.8
Structural Grade: 0
O&M Grade: 0
Clock Start/From: 11

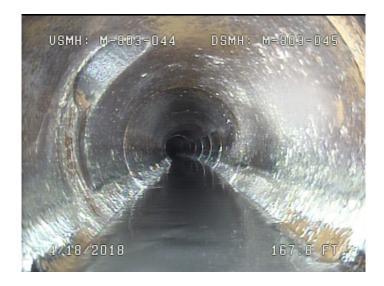
Code: **TF**

Description: Tap Factory

Distance (ft): 167.8
Structural Grade: 0
O&M Grade: 0
Clock Start/From: 11

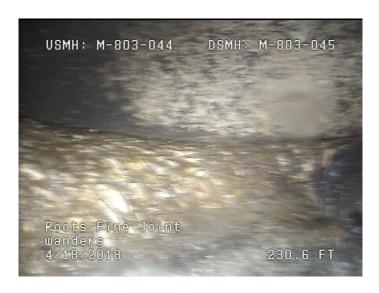
Code: RFJ

Description: Roots Fine Joint

Distance (ft): 230.6
Structural Grade: 0
O&M Grade: 1
Clock Start/From: 8

Continuous Index: F01
Within 8" of Joint: YES

Remarks: wanders

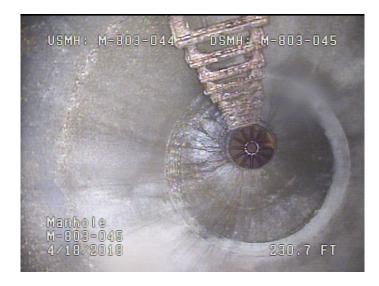
Code: AMH
Description: Manhole

Distance (ft): 230.7
Structural Grade: 0
O&M Grade: 0

Within 8" of Joint: NO
Remarks: M-803-045
