## Profile/Photo Observation Report

Street:	<b>HIGH ST &amp; N KELLY ST</b>	Flow Control:	<b>Not Controlled</b>
City:	<b>Hobart, IN</b>	Year Renewed:	
Location:	<b>Other</b>	Tape/Media #:	
Purpose:	<b>Not Known</b>	Dia/Height:	<b>12"</b>
Use:	<b>Sanitary</b>	Material:	<b>VCP</b>
Drain Area:	<b>NA</b>	Lining:	
Category:	<b>NA</b>		
Comment:

Location Details:		Direction of Survey:	<b>Upstream</b>
US MH:	<b>M-803-046</b>	DS MH:	<b>M-804-056</b>
		Total Length Surveyed (ft):	<b>14.9</b>

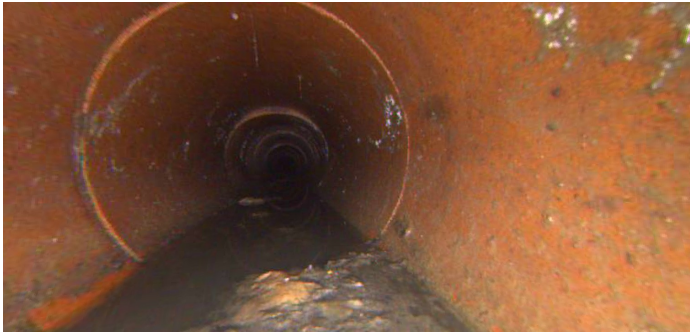
AMH

Manhole

M-804-056

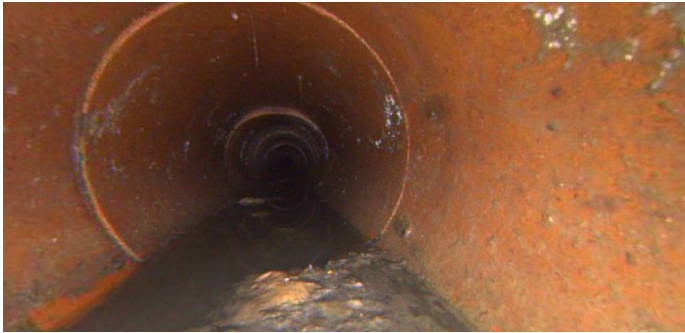
Code:	<b>MWL</b>
Description:	<b>Water Level</b>

Distance (ft):	<b>.0</b>
Structural Grade:	<b>0</b>
O&M Grade:	<b>0</b>
Clock Start/From:	
Clock To:	
1st Value:	
2nd Value:	
Value Percent:	<b>20.000</b>
Continuous Index:	
Within 8" of Joint:	<b>NO</b>
Remarks:

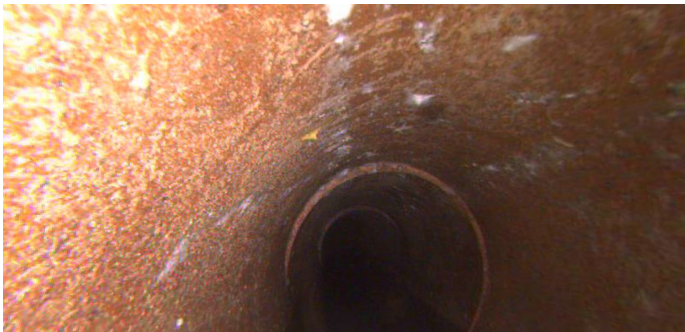
Code:	<b>MSA</b>
Description:	<b>Abandoned Survey</b>

Distance (ft):	<b>14.9</b>
Structural Grade:	<b>0</b>
O&M Grade:	<b>0</b>
Clock Start/From:	
Clock To:	
1st Value:	
2nd Value:	
Value Percent:	
Continuous Index:	
Within 8" of Joint:	<b>NO</b>
Remarks:	<b>UNKNOWN</b>
