Profile/Ph	oto Observatio	n Report			RedZon R 0 B 0 T I C S
Date:	04/04/2018	Weather:		Coding:	PACP 6.0
Pipe Length (ft): 235.7	Owner:	NA	Pre Clean:	Not Known
P.O.#:		Surveyor:	Jen Costello	PSR:	P-803-046-056
Customer:		Clean Date:	01/01/1900	Shape:	с
Street:	HIGH ST & N KELL	Y ST	Flow Control:	Not Controlled	
City:	Hobart, IN		Year Renewed:		
Location:	Other		Tape/Media #:		
Purpose:	Not Known		Dia/Height:	12"	
Use:	Sanitary		Material:	VCP	
Drain Area:	NA		Lining:		
Category:	NA				
Comment:					
Location Detail	ls:		Direction of Survey	: Downstream	
US MH:	M-803-046	DS MH:	M-804-056	Total Length Surveyed (ft):	3.5
0&M Index:	3.00	O&M Quick:	3100	O&M Rating:	3.00
tructural Index:	3.00	Structural Qu	ick: 3100	Structural Rating:	3.00
Overall Index:	3.00	Overall Quick		Overall Rating:	6.00

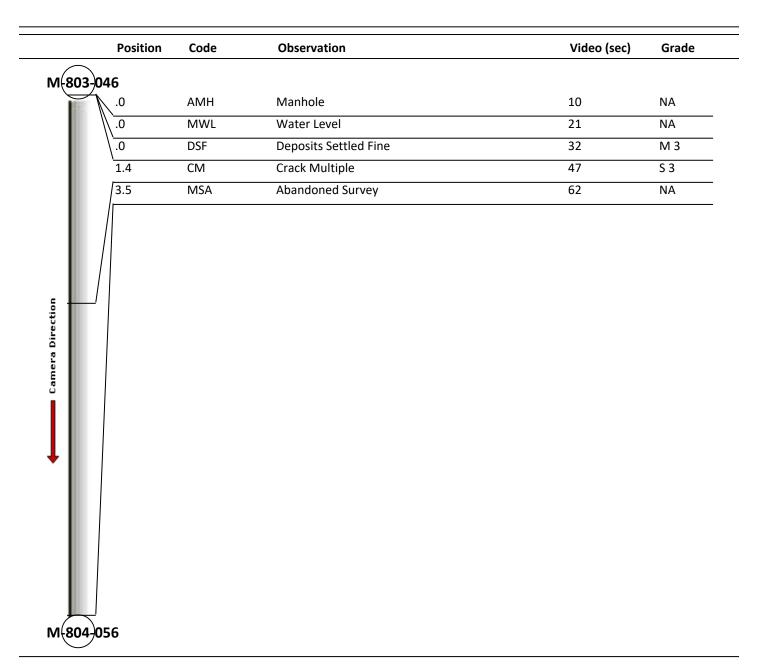
Code: Description:	AMH Manhole
Distance (ft):	.0
Structural Grade:	0
O&M Grade:	0
Clock Start/From:	
Clock To:	
1st Value:	
2nd Value:	
Value Percent:	
Continuous Index:	
Within 8" of Joint:	NO
Remarks:	M-803-046
