Profile/Photo Observation Report

Date:	04/04/2018	Weather:		Coding:	PACP 6.0
Pipe Length (ft):	208.2	Owner:	NA	Pre Clean:	Not Known
P.O.#:		Surveyor:	Jen Costello	PSR:	P-803-048-046
Customer:		Clean Date:	01/01/1900	Shape:	C

Street:	N KELLY ST	Flow Control:	Not Controlled
City:	Hobart, IN	Year Renewed:	
Location:	Other	Tape/Media #:	
Purpose:	Not Known	Dia/Height:	12"
Use:	Sanitary	Material:	VCP
Drain Area:	NA	Lining:	
Category:	NA		
Comment:

Location Details:		Direction of Survey:	Downstream
US MH:	M-803-048	DS MH:	M-803-046
		Total Length Surveyed (ft):	3.7

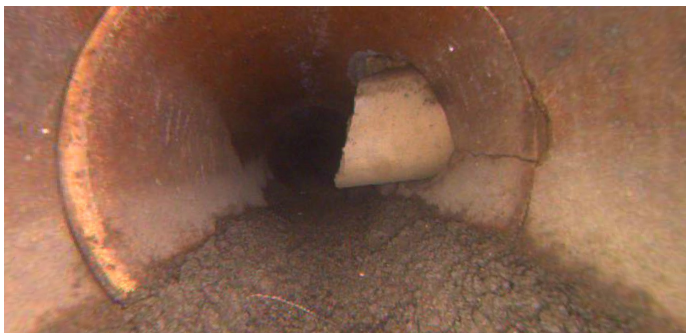
Code: **AMH**
Description: **Manhole**

Distance (ft): **.0**
Structural Grade: **0**
O&M Grade: **0**
Clock Start/From:
Clock To:
1st Value:
2nd Value:
Value Percent:
Continuous Index:
Within 8" of Joint: **NO**
Remarks: **M-803-048**

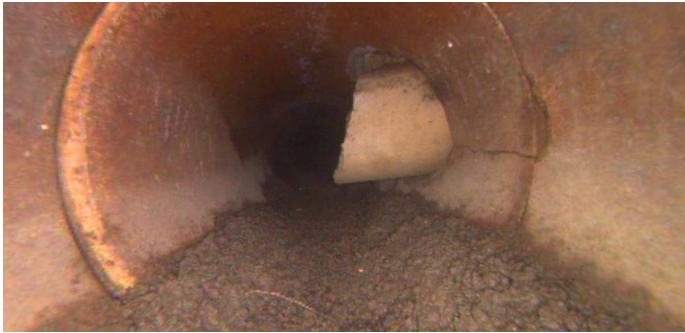
Code:	MWL
Description:	Water Level

Distance (ft):	.0
Structural Grade:	0
O&M Grade:	0
Clock Start/From:	
Clock To:	
1st Value:	
2nd Value:	
Value Percent:	0.000
Continuous Index:	
Within 8" of Joint:	NO
Remarks:

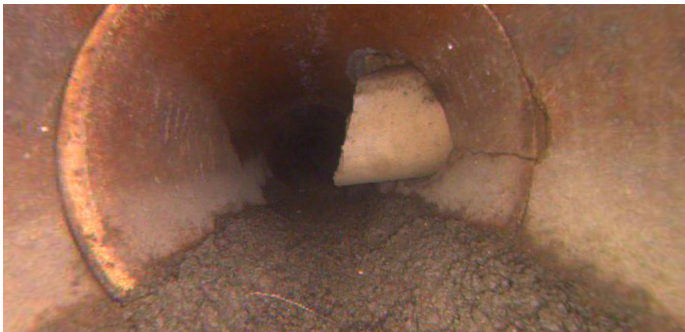
Code:	DSF
Description:	Deposits Settled Fine

Distance (ft):	.0
Structural Grade:	0
O&M Grade:	2
Clock Start/From:	4
Clock To:	8
1st Value:	
2nd Value:	
Value Percent:	10.000
Continuous Index:	
Within 8" of Joint:	NO
Remarks:

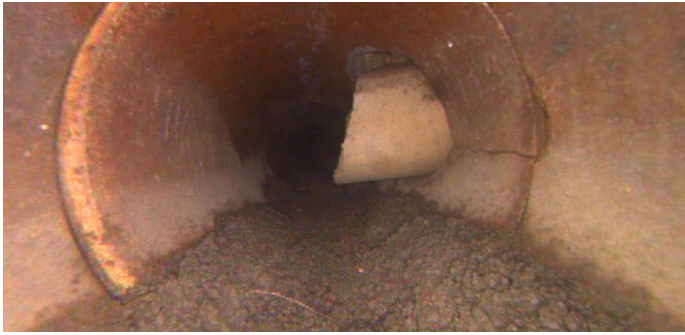
Code: **FL**
Description: **Fracture Longitudinal**

Distance (ft): **.0**
Structural Grade: **3**
O&M Grade: **0**
Clock Start/From: **3**
Clock To:
1st Value:
2nd Value:
Value Percent:
Continuous Index:
Within 8" of Joint: **YES**
Remarks:

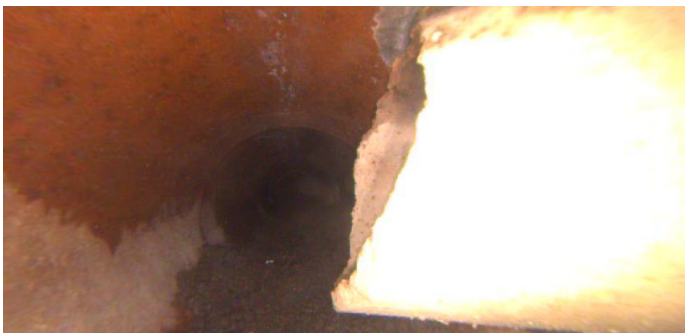
Code: **TBI**
Description: **Tap Break-in Intruding**

Distance (ft): **2.4**
Structural Grade: **0**
O&M Grade: **2**
Clock Start/From: **3**
Clock To:
1st Value: **4.000**
2nd Value: **3.000**
Value Percent:
Continuous Index:
Within 8" of Joint:
Remarks:

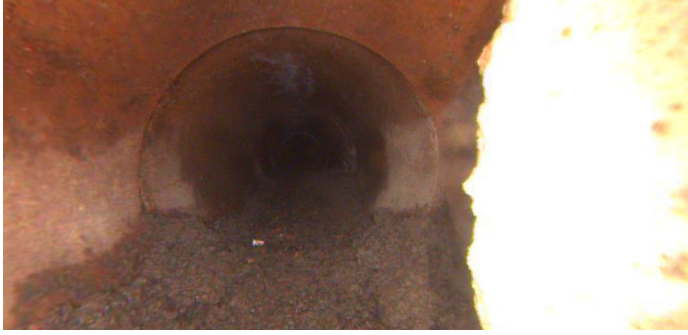
Code:	MSA
Description:	Abandoned Survey
Distance (ft):	3.7
Structural Grade:	0
O&M Grade:	0
Clock Start/From:	
Clock To:	
1st Value:	
2nd Value:	
Value Percent:	
Continuous Index:	
Within 8" of Joint:	NO
Remarks:	TBI
