Profile/Photo Observation Report

| Street: | N Kelly Ave. | Flow Control: | Not Controlled |
| City: | Hobart, IN | Year Renewed: | |

| US MH: | M-803-048 | DS MH: | M-803-046 |

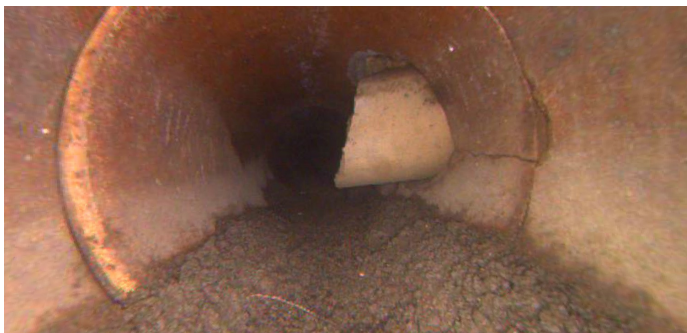
Code: **AMH**
Description: **Manhole**

Distance (ft): **.0**
Structural Grade: **0**
O&M Grade: **0**
Clock Start/From:
Clock To:
1st Value:
2nd Value:
Value Percent:
Continuous Index:
Within 8" of Joint: **NO**
Remarks: **M-803-048**

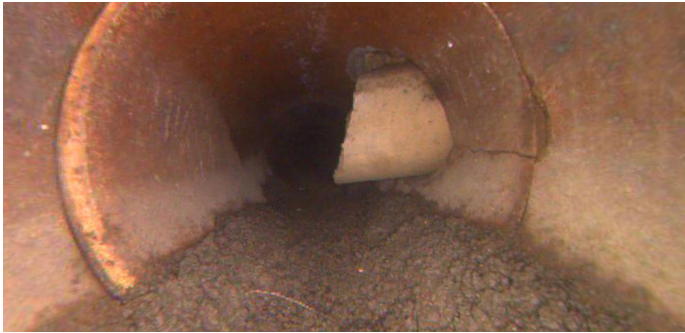
| Code: | MWL |
| Description: | Water Level |

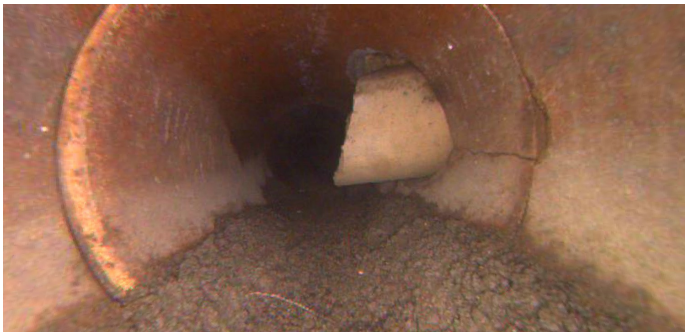
| Code: | DSF |
| Description: | Deposits Settled Fine |

| O&M Grade: | 2 |
| Clock Start/From: | 4 |
| Clock To: | 8 |
| Value Percent: | 10.000 |

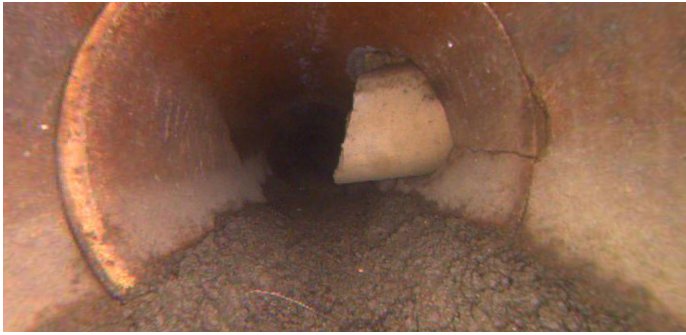
Code: **FL**
Description: **Fracture Longitudinal**

Distance (ft): **.0**
Structural Grade: **3**
O&M Grade: **0**
Clock Start/From: **3**
Clock To:
1st Value:
2nd Value:
Value Percent:
Continuous Index:
Within 8" of Joint: **YES**
Remarks:

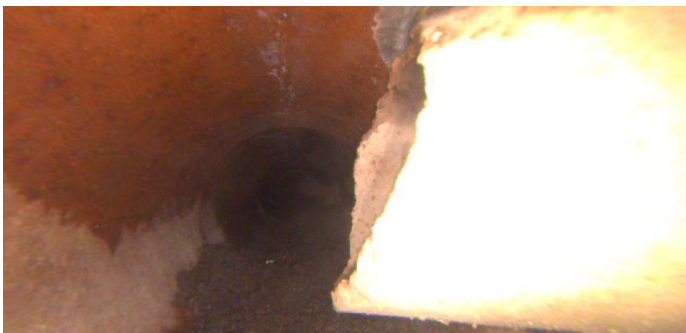
Code: **TBI**
Description: **Tap Break-in Intruding**

Distance (ft): **2.4**
Structural Grade: **0**
O&M Grade: **2**
Clock Start/From: **3**
Clock To:
1st Value: **4.000**
2nd Value: **3.000**
Value Percent:
Continuous Index:
Within 8" of Joint:
Remarks:

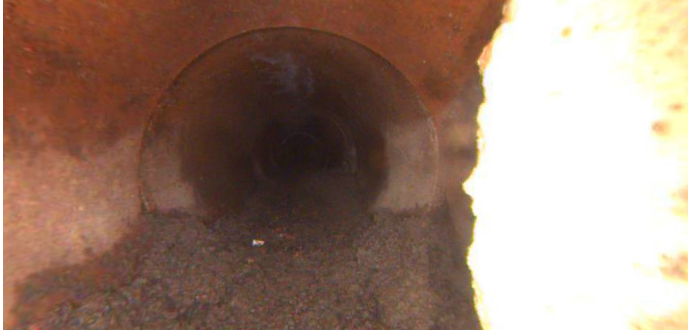
| Code: | MSA |
| Description: | Abandoned Survey |
| Remarks: | TBI |
