## Profile/Photo Observation Report

Date:	<b>04/04/2018</b>	Weather:		Coding:	<b>PACP 6.0</b>
Pipe Length (ft):	<b>198.7</b>	Owner:	<b>NA</b>	Pre Clean:	<b>Not Known</b>
P.O.#:		Surveyor:	<b>Jen Costello</b>	PSR:	<b>P-803-049-050</b>
Customer:		Clean Date:	<b>01/01/1900</b>	Shape:	<b>C</b>

Street:	<b>N KELLY ST</b>	Flow Control:	<b>Not Controlled</b>
City:	<b>Hobart, IN</b>	Year Renewed:	
Location:	<b>Other</b>	Tape/Media #:	
Purpose:	<b>Not Known</b>	Dia/Height:	<b>10"</b>
Use:	<b>Sanitary</b>	Material:	<b>VCP</b>
Drain Area:	<b>NA</b>	Lining:	
Category:	<b>NA</b>		
Comment:

Location Details:		Direction of Survey:	<b>Upstream</b>
US MH:	<b>M-803-050</b>	DS MH:	<b>M-803-049</b>
		Total Length Surveyed (ft):	<b>3.3</b>

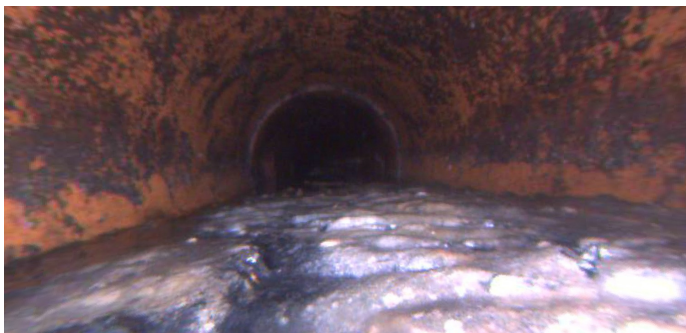
Code: **AMH**  
Description: **Manhole**

Distance (ft): **.0**  
Structural Grade: **0**  
O&M Grade: **0**  
Clock Start/From:  
Clock To:  
1st Value:  
2nd Value:  
Value Percent:  
Continuous Index:  
Within 8" of Joint: **NO**  
Remarks: **M-803-049**

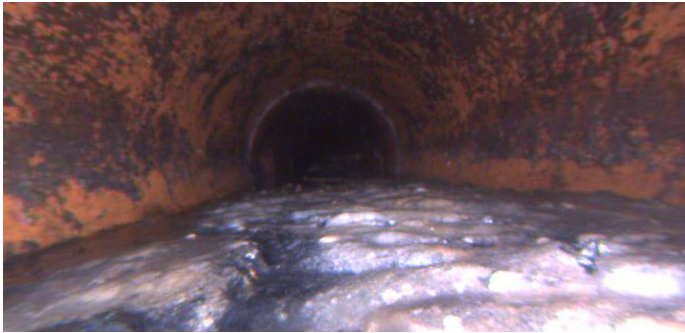
Code:	<b>MWL</b>
Description:	<b>Water Level</b>

Distance (ft):	<b>.0</b>
Structural Grade:	<b>0</b>
O&M Grade:	<b>0</b>
Clock Start/From:	
Clock To:	
1st Value:	
2nd Value:	
Value Percent:	<b>40.000</b>
Continuous Index:	
Within 8" of Joint:	<b>NO</b>
Remarks:

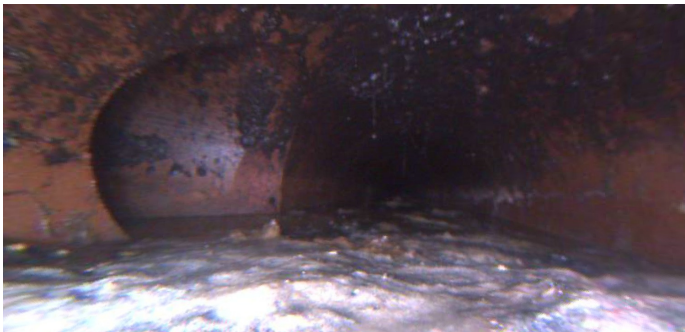
Code:	<b>TFA</b>
Description:	<b>Tap Factory Active</b>

Distance (ft):	<b>2.3</b>
Structural Grade:	<b>0</b>
O&M Grade:	<b>0</b>
Clock Start/From:	<b>9</b>
Clock To:	
1st Value:	<b>4.000</b>
2nd Value:	
Value Percent:	
Continuous Index:	
Within 8" of Joint:	
Remarks:

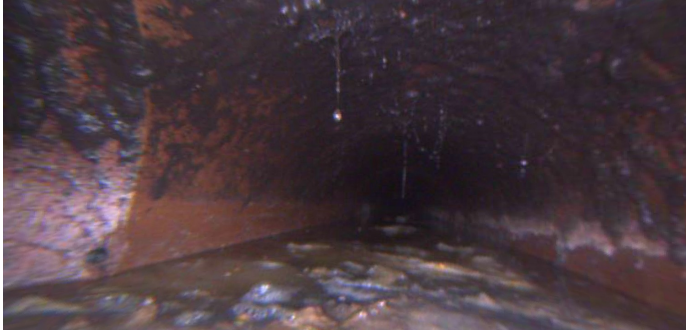
Code: **DAGS**  
Description: **Deposits Attached Grease**

Distance (ft): **2.7**  
Structural Grade: **0**  
O&M Grade: **2**  
Clock Start/From: **8**  
Clock To: **4**  
1st Value:  
2nd Value:  
Value Percent: **5.000**  
Continuous Index:  
Within 8" of Joint: **NO**  
Remarks:
