## Profile/Photo Observation Report

Street:	<b>N KELLY ST</b>	Flow Control:	<b>Not Controlled</b>
City:	<b>Hobart, IN</b>	Year Renewed:	
Location:	<b>Other</b>	Tape/Media #:	
Purpose:	<b>Not Known</b>	Dia/Height:	<b>10"</b>
Use:	<b>Sanitary</b>	Material:	<b>VCP</b>
Drain Area:	<b>NA</b>	Lining:	
Category:	<b>NA</b>		
Comment:

Location Details:		Direction of Survey:	<b>Downstream</b>
US MH:	<b>M-803-051</b>	DS MH:	<b>M-803-050</b>
		Total Length Surveyed (ft):	<b>7.8</b>

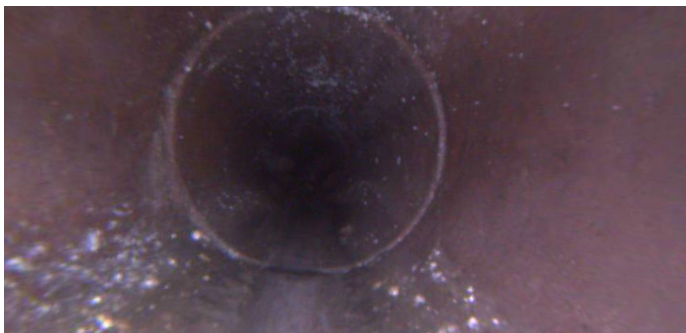
Code: **AMH**  
Description: **Manhole**

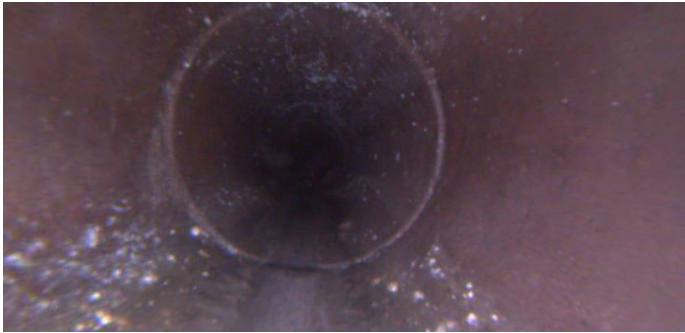
Code:	<b>MWL</b>
Description:	<b>Water Level</b>

Distance (ft):	<b>.0</b>
Structural Grade:	<b>0</b>
O&M Grade:	<b>0</b>
Clock Start/From:	
Clock To:	
1st Value:	
2nd Value:	
Value Percent:	<b>5.000</b>
Continuous Index:	
Within 8" of Joint:	<b>NO</b>
Remarks:

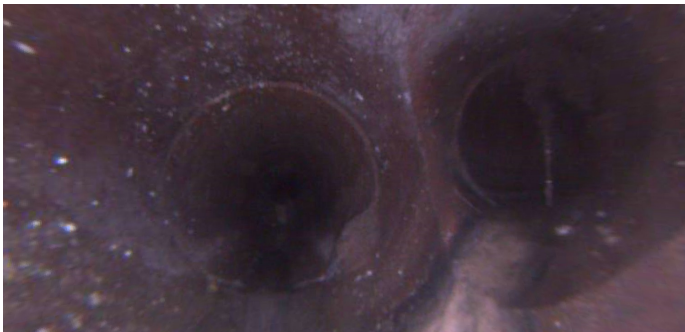
Code:	<b>TFA</b>
Description:	<b>Tap Factory Active</b>

Distance (ft):	<b>3.8</b>
Structural Grade:	<b>0</b>
O&M Grade:	<b>0</b>
Clock Start/From:	<b>3</b>
Clock To:	
1st Value:	<b>4.000</b>
2nd Value:	
Value Percent:	
Continuous Index:	
Within 8" of Joint:	
Remarks:

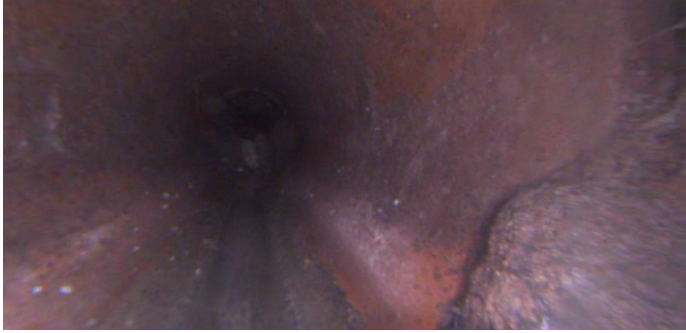
Code:	<b>DAZ</b>
Description:	<b>Deposits Attached Other</b>

Distance (ft):	<b>4.8</b>
Structural Grade:	<b>0</b>
O&M Grade:	<b>2</b>
Clock Start/From:	<b>3</b>
Clock To:	<b>4</b>
1st Value:	
2nd Value:	
Value Percent:	<b>10.000</b>
Continuous Index:	
Within 8" of Joint:	<b>YES</b>
Remarks:

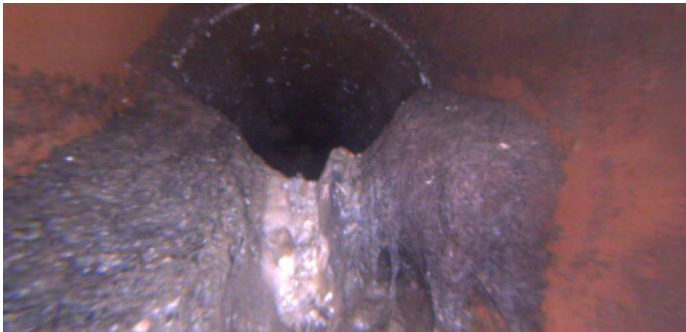
Code:	<b>RMJ</b>
Description:	<b>Roots Medium Joint</b>

Distance (ft):	<b>7.1</b>
Structural Grade:	<b>0</b>
O&M Grade:	<b>3</b>
Clock Start/From:	<b>3</b>
Clock To:	<b>9</b>
1st Value:	
2nd Value:	
Value Percent:	<b>45.000</b>
Continuous Index:	
Within 8" of Joint:	<b>YES</b>
Remarks:

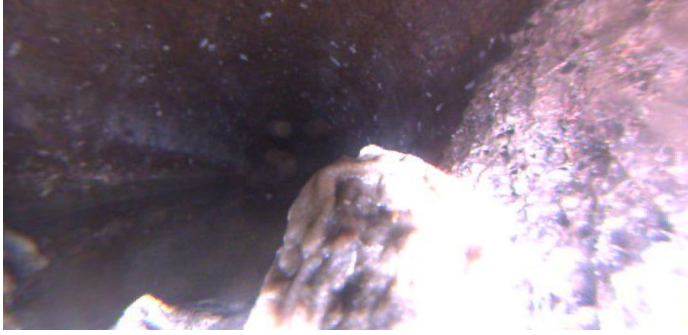
Code:	<b>MSA</b>
Description:	<b>Abandoned Survey</b>
Distance (ft):	<b>7.8</b>
Structural Grade:	<b>0</b>
O&M Grade:	<b>0</b>
Clock Start/From:	
Clock To:	
1st Value:	
2nd Value:	
Value Percent:	
Continuous Index:	
Within 8" of Joint:	<b>NO</b>
Remarks:	<b>roots</b>
