## Profile/Photo Observation Report

Date:	<b>04/13/2018</b>	Weather:		Coding:	<b>PACP 4.2</b>
Pipe Length (ft):	<b>174.4</b>	Owner:	<b>City of Hobart</b>	Pre Clean:	<b>No Pre-Cleaning</b>
P.O.#:	<b>2004</b>	Surveyor:	<b>SAN</b>	PSR:	<b>P-803-052-053</b>
Customer:	<b>Red Zone</b>	Clean Date:		Shape:	<b>C</b>

Street:	<b>910 High St</b>	Flow Control:	<b>Not Controlled</b>
City:	<b>Hobart In</b>	Year Renewed:	
Location:	<b>Light Highway</b>	Tape/Media #:	<b>Deliverable 1</b>
Purpose:	<b>Routine Assessment</b>	Dia/Height:	<b>15"</b>
Use:	<b>Sanitary</b>	Material:	<b>VCP</b>
Drain Area:	<b>Northeast</b>	Lining:

US MH: **M-803-052** DS MH: **M-803-053** Total Length Surveyed (ft): **174.4**

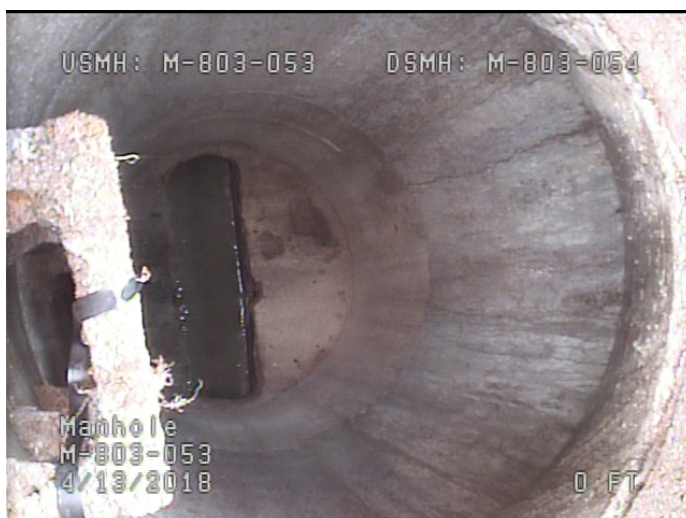
Code: **AMH**  
 Description: **Manhole**

Distance (ft): **.0**  
 Structural Grade: **0**  
 O&M Grade: **0**  
 Clock Start/From:  
 Clock To:  
 1st Value:  
 2nd Value:  
 Value Percent:  
 Continuous Index:  
 Within 8" of Joint: **NO**  
 Remarks: **M-803-053**

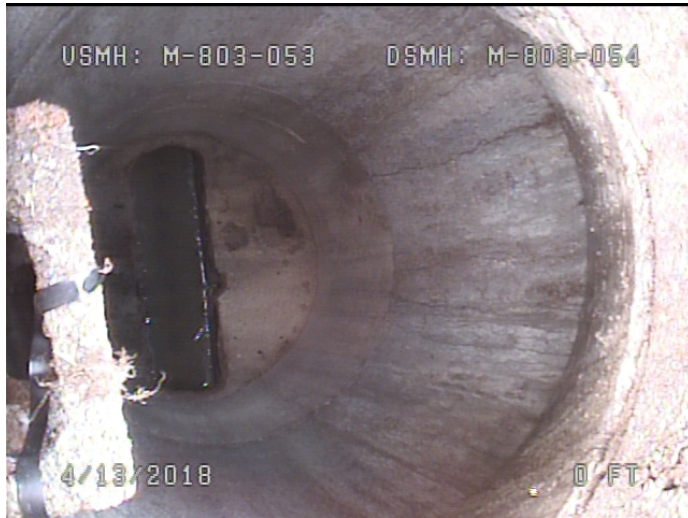
Code:	<b>MWL</b>
Description:	<b>Water Level</b>
Distance (ft):	<b>.0</b>
Structural Grade:	<b>0</b>
O&M Grade:	<b>0</b>
Clock Start/From:	
Clock To:	
1st Value:	
2nd Value:	
Value Percent:	<b>10.000</b>
Continuous Index:	
Within 8" of Joint:	<b>NO</b>
Remarks:

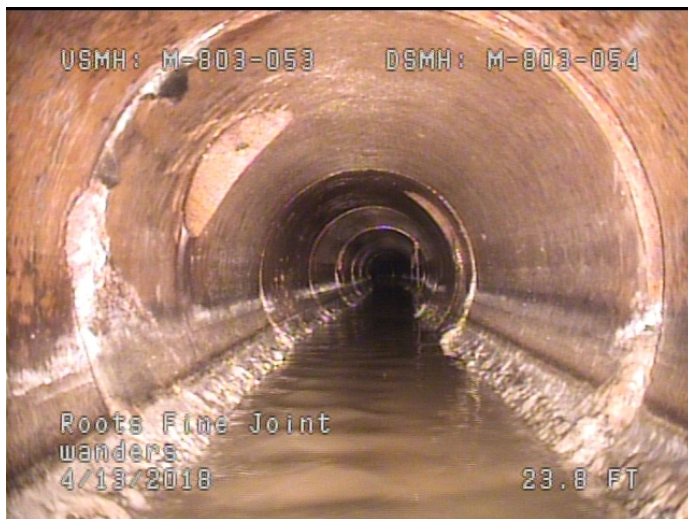
Code:	<b>RFJ</b>
Description:	<b>Roots Fine Joint</b>
Distance (ft):	<b>23.8</b>
Structural Grade:	<b>0</b>
O&M Grade:	<b>1</b>
Clock Start/From:	<b>9</b>
Clock To:	<b>4</b>
1st Value:	
2nd Value:	
Value Percent:	
Continuous Index:	<b>S01</b>
Within 8" of Joint:	<b>YES</b>
Remarks:	<b>wanders</b>

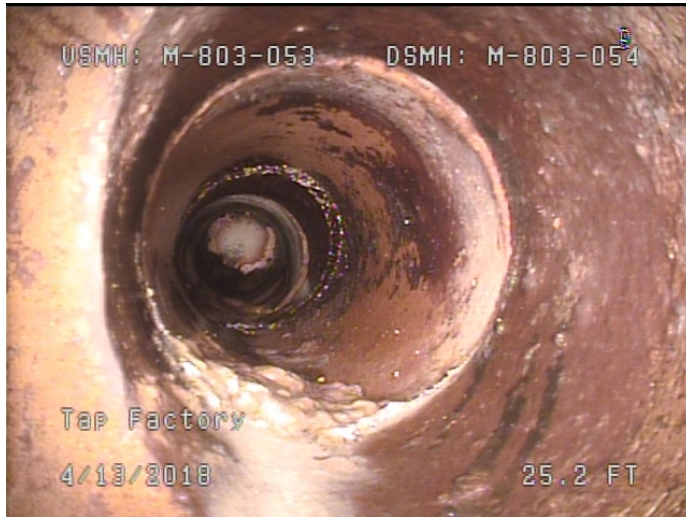
Code: **TF**  
 Description: **Tap Factory**

Distance (ft): **25.2**  
 Structural Grade: **0**  
 O&M Grade: **0**  
 Clock Start/From: **11**  
 Clock To:  
 1st Value: **6.000**  
 2nd Value:  
 Value Percent:  
 Continuous Index:  
 Within 8" of Joint: **NO**  
 Remarks:

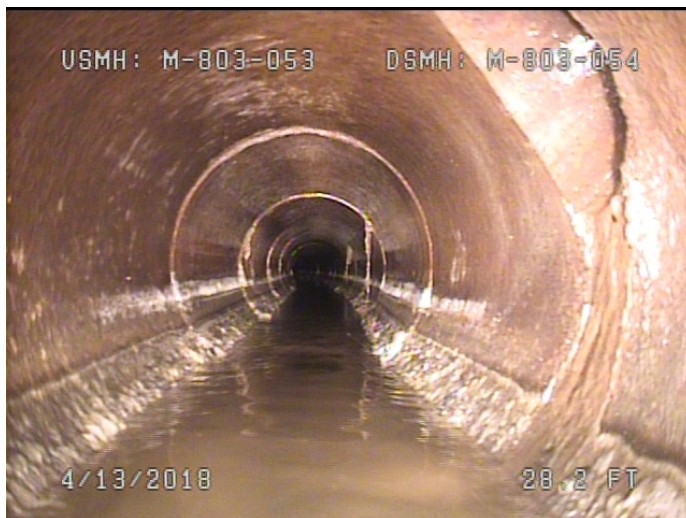
Code: **TF**  
 Description: **Tap Factory**

Distance (ft): **28.2**  
 Structural Grade: **0**  
 O&M Grade: **0**  
 Clock Start/From: **2**  
 Clock To:  
 1st Value: **6.000**  
 2nd Value:  
 Value Percent:  
 Continuous Index:  
 Within 8" of Joint: **NO**  
 Remarks:

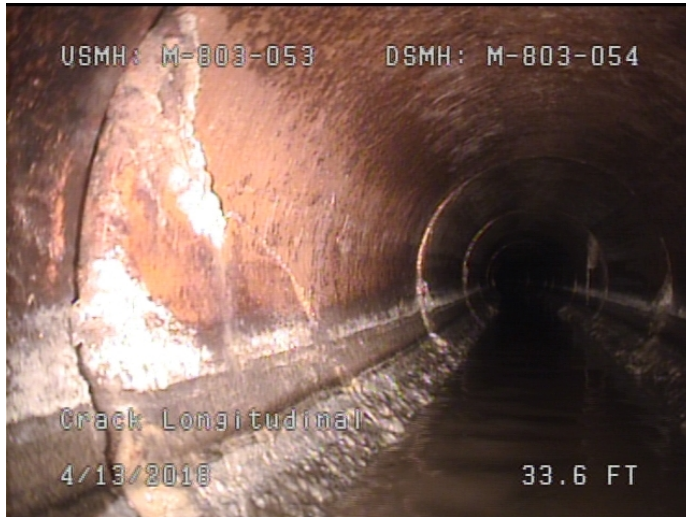
Code: **CL**  
 Description: **Crack Longitudinal**

Distance (ft): **33.6**  
 Structural Grade: **2**  
 O&M Grade: **0**  
 Clock Start/From: **9**  
 Clock To:  
 1st Value:  
 2nd Value:  
 Value Percent:  
 Continuous Index:  
 Within 8" of Joint: **YES**  
 Remarks:

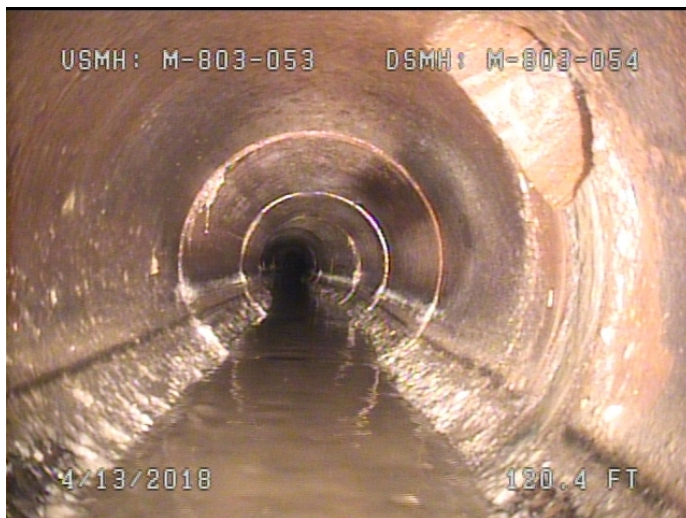
Code: **TF**  
 Description: **Tap Factory**

Distance (ft): **120.4**  
 Structural Grade: **0**  
 O&M Grade: **0**  
 Clock Start/From: **2**  
 Clock To:  
 1st Value: **6.000**  
 2nd Value:  
 Value Percent:  
 Continuous Index:  
 Within 8" of Joint: **NO**  
 Remarks:

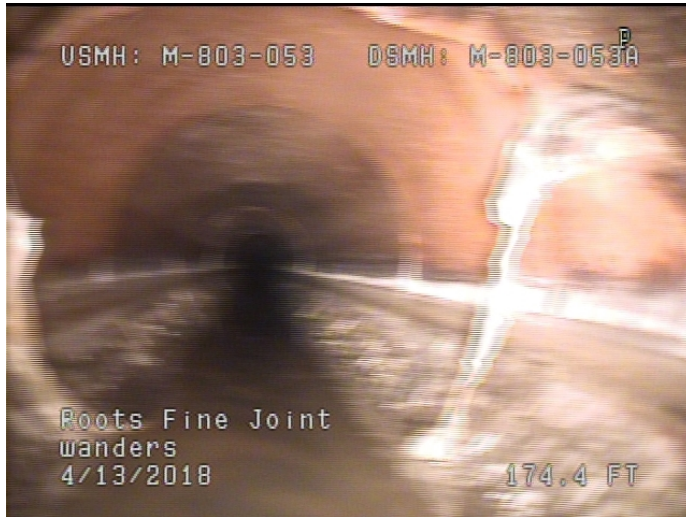
Code:	<b>RFJ</b>
Description:	<b>Roots Fine Joint</b>
Distance (ft):	<b>174.4</b>
Structural Grade:	<b>0</b>
O&M Grade:	<b>1</b>
Clock Start/From:	<b>9</b>
Clock To:	<b>4</b>
1st Value:	
2nd Value:	
Value Percent:	
Continuous Index:	<b>F01</b>
Within 8" of Joint:	<b>YES</b>
Remarks:	<b>wanders</b>

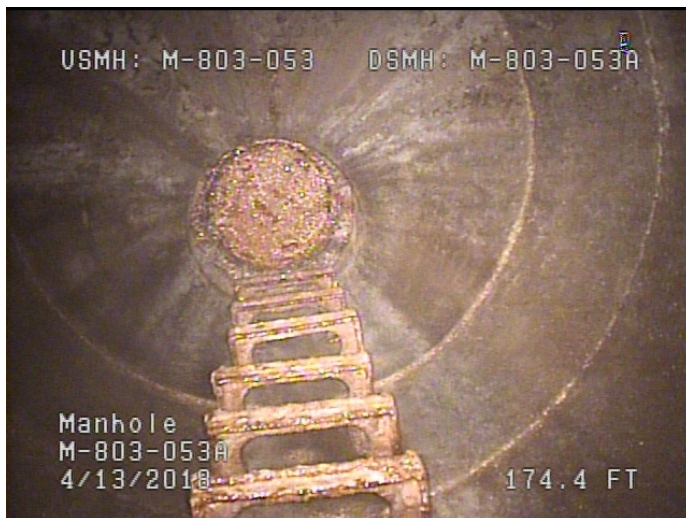
Code:	<b>AMH</b>
Description:	<b>Manhole</b>
Distance (ft):	<b>174.4</b>
Structural Grade:	<b>0</b>
O&M Grade:	<b>0</b>
Clock Start/From:	
Clock To:	
1st Value:	
2nd Value:	
Value Percent:	
Continuous Index:	
Within 8" of Joint:	<b>NO</b>
Remarks:	<b>M-803-053A</b>
