## Profile/Photo Observation Report

Street:	<b>N LIBERTY CT</b>	Flow Control:	<b>Not Controlled</b>
City:	<b>Hobart, IN</b>	Year Renewed:	
Location:	<b>Other</b>	Tape/Media #:	
Purpose:	<b>Not Known</b>	Dia/Height:	<b>10"</b>
Use:	<b>Sanitary</b>	Material:	<b>VCP</b>
Drain Area:	<b>NA</b>	Lining:	
Category:	<b>NA</b>		
Comment:

Location Details:		Direction of Survey:	<b>Downstream</b>
US MH:	<b>M-803-055</b>	DS MH:	<b>M-803-029</b>
		Total Length Surveyed (ft):	<b>153.6</b>

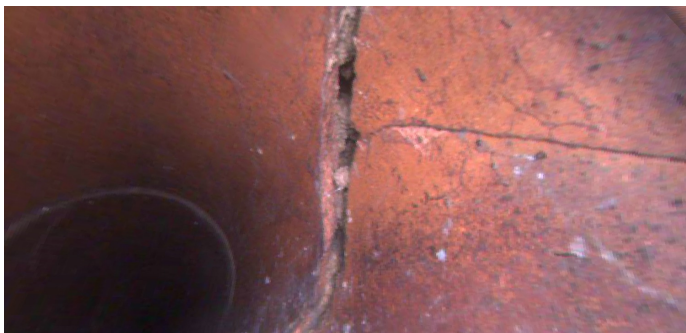
Code: **FM**  
Description: **Fracture Multiple**

Distance (ft): **.0**  
Structural Grade: **4**  
O&M Grade: **0**  
Clock Start/From: **12**  
Clock To: **5**  
1st Value:  
2nd Value:  
Value Percent:  
Continuous Index:  
Within 8" of Joint:  
Remarks:

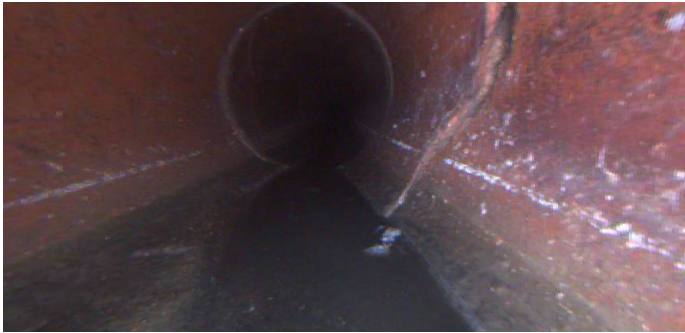
Code:	<b>AMH</b>
Description:	<b>Manhole</b>

Distance (ft):	<b>.0</b>
Structural Grade:	<b>0</b>
O&M Grade:	<b>0</b>
Clock Start/From:	
Clock To:	
1st Value:	
2nd Value:	
Value Percent:	
Continuous Index:	
Within 8" of Joint:	<b>NO</b>
Remarks:	<b>M-803-055</b>

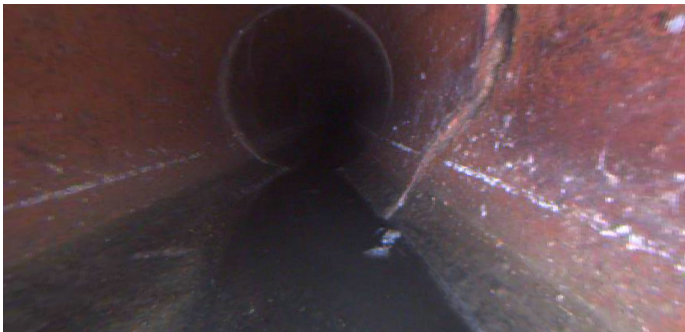
Code:	<b>MWL</b>
Description:	<b>Water Level</b>

Distance (ft):	<b>.0</b>
Structural Grade:	<b>0</b>
O&M Grade:	<b>0</b>
Clock Start/From:	
Clock To:	
1st Value:	
2nd Value:	
Value Percent:	<b>5.000</b>
Continuous Index:	
Within 8" of Joint:	<b>NO</b>
Remarks:

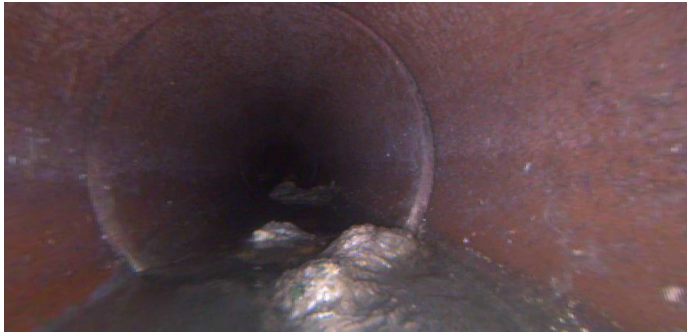
Code:	<b>MGO</b>
Description:	<b>General Observation</b>
Distance (ft):	<b>46.3</b>
Structural Grade:	<b>0</b>
O&M Grade:	<b>0</b>
Clock Start/From:	
Clock To:	
1st Value:	
2nd Value:	
Value Percent:	
Continuous Index:	
Within 8" of Joint:	<b>NO</b>
Remarks:	<b>TOILET TISSUE</b>

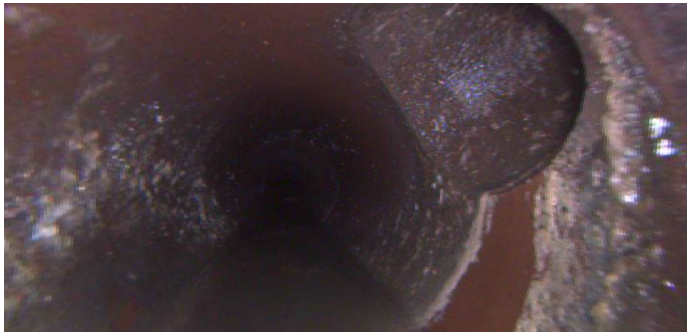
Code:	<b>TF</b>
Description:	<b>Tap Factory</b>
Distance (ft):	<b>82.9</b>
Structural Grade:	<b>0</b>
O&M Grade:	<b>0</b>
Clock Start/From:	<b>2</b>
Clock To:	
1st Value:	<b>4.000</b>
2nd Value:	
Value Percent:	
Continuous Index:	
Within 8" of Joint:	
Remarks:

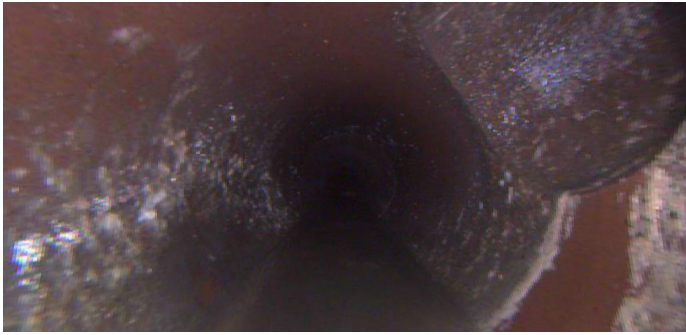
Code: **DAZ**  
Description: **Deposits Attached Other**

Distance (ft): **82.9**  
Structural Grade: **0**  
O&M Grade: **2**  
Clock Start/From: **7**  
Clock To: **10**  
1st Value:  
2nd Value:  
Value Percent: **5.000**  
Continuous Index:  
Within 8" of Joint: **NO**  
Remarks:

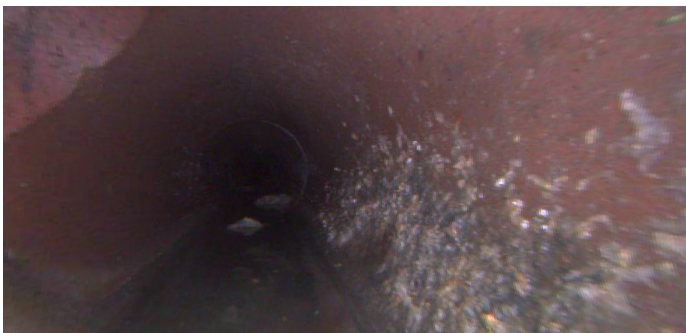
Code: **DAZ**  
Description: **Deposits Attached Other**

Distance (ft): **94.7**  
Structural Grade: **0**  
O&M Grade: **2**  
Clock Start/From: **3**  
Clock To: **5**  
1st Value:  
2nd Value:  
Value Percent: **5.000**  
Continuous Index:  
Within 8" of Joint: **NO**  
Remarks:

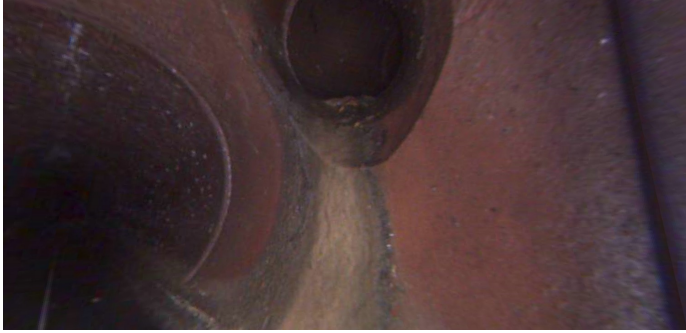
Code: **TFA**  
Description: **Tap Factory Active**

Distance (ft): **95.8**  
Structural Grade: **0**  
O&M Grade: **0**  
Clock Start/From: **10**  
Clock To:  
1st Value: **4.000**  
2nd Value:  
Value Percent:  
Continuous Index:  
Within 8" of Joint:  
Remarks:

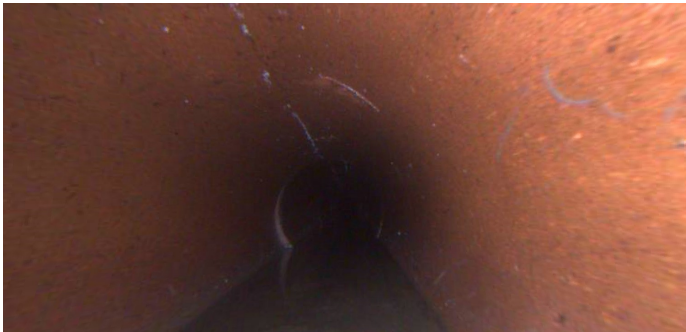
Code: **FL**  
Description: **Fracture Longitudinal**

Distance (ft): **136.1**  
Structural Grade: **3**  
O&M Grade: **0**  
Clock Start/From: **12**  
Clock To:  
1st Value:  
2nd Value:  
Value Percent:  
Continuous Index: **S01**  
Within 8" of Joint: **YES**  
Remarks:

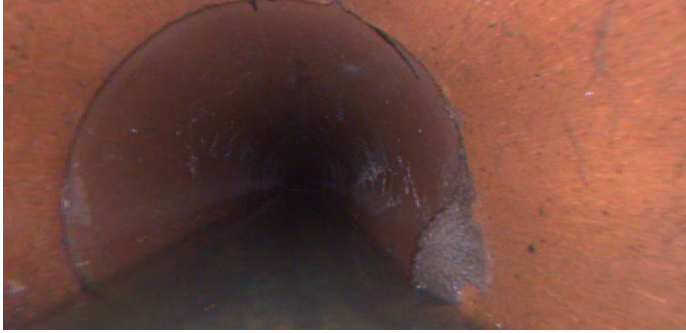
Code: **DAZ**  
Description: **Deposits Attached Other**

Distance (ft): **143.9**  
Structural Grade: **0**  
O&M Grade: **2**  
Clock Start/From: **4**  
Clock To: **5**  
1st Value:  
2nd Value:  
Value Percent: **5.000**  
Continuous Index:  
Within 8" of Joint: **YES**  
Remarks: **MUD**

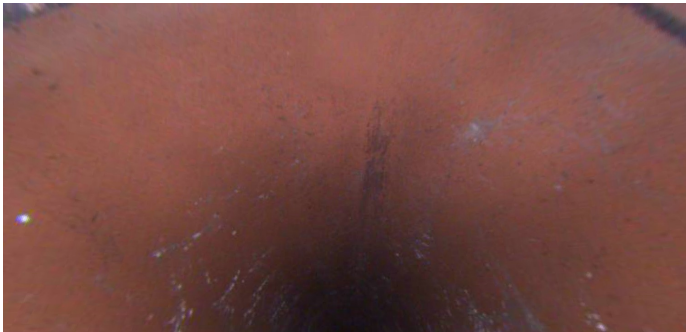
Code: **FL**  
Description: **Fracture Longitudinal**

Distance (ft): **144.5**  
Structural Grade: **3**  
O&M Grade: **0**  
Clock Start/From: **12**  
Clock To:  
1st Value:  
2nd Value:  
Value Percent:  
Continuous Index: **F01**  
Within 8" of Joint: **YES**  
Remarks:

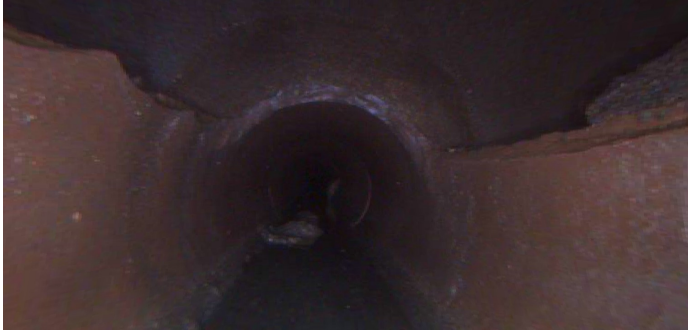
Code:	<b>AMH</b>
Description:	<b>Manhole</b>
Distance (ft):	<b>153.6</b>
Structural Grade:	<b>0</b>
O&M Grade:	<b>0</b>
Clock Start/From:	
Clock To:	
1st Value:	
2nd Value:	
Value Percent:	
Continuous Index:	
Within 8" of Joint:	<b>NO</b>
Remarks:	<b>M-803-029</b>
