Profile/Photo Observation Report

Date:	03/20/2018	Weather:		Coding:	PACP 6.0
Pipe Length (ft):	136.0	Owner:	NA	Pre Clean:	Not Known
P.O.#:		Surveyor:	Justin Gonzales	PSR:	P-803-060-061
Customer:		Clean Date:	01/01/1900	Shape:	C

Street:	OFF E 37TH AVE	Flow Control:	Not Controlled
City:	Hobart, IN	Year Renewed:	
Location:	Other	Tape/Media #:	
Purpose:	Not Known	Dia/Height:	10"
Use:	Sanitary	Material:	PVC
Drain Area:	NA	Lining:	
Category:	NA		
Comment:	REV - NULL - CNL MH-SNM-1702-012

Location Details:		Direction of Survey:	Upstream
US MH:	M-803-060	DS MH:	M-803-061
		Total Length Surveyed (ft):	131.5

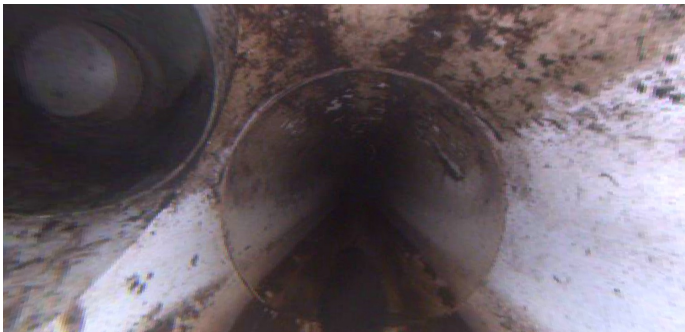
Code:	TFC
Description:	Tap Factory Capped

Distance (ft):	70.6
Structural Grade:	0
O&M Grade:	0
Clock Start/From:	9
Clock To:	
1st Value:	4.000
2nd Value:	
Value Percent:	
Continuous Index:	
Within 8" of Joint:	
Remarks:

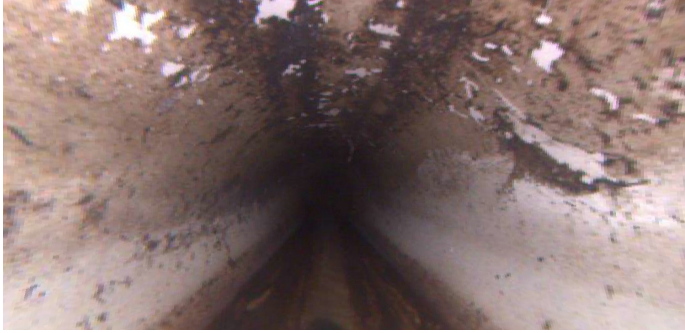
Code: **DAZ**
Description: **Deposits Attached Other**

Distance (ft): **71.2**
Structural Grade: **0**
O&M Grade: **2**
Clock Start/From: **7**
Clock To: **5**
1st Value:
2nd Value:
Value Percent: **5.000**
Continuous Index: **S01**
Within 8" of Joint: **YES**
Remarks: **WANDER**

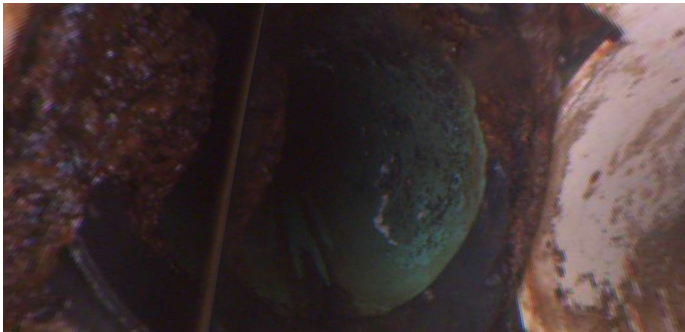
Code: **TBD**
Description: **Tap Break-in Defective**

Distance (ft): **75.0**
Structural Grade: **0**
O&M Grade: **3**
Clock Start/From: **9**
Clock To:
1st Value: **4.000**
2nd Value:
Value Percent:
Continuous Index:
Within 8" of Joint:
Remarks: **DAE SURROUNDING MOUTH OF TAP**

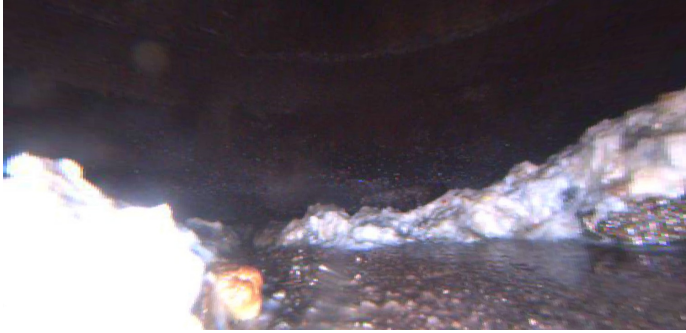
Code: **DAZ**
Description: **Deposits Attached Other**

Distance (ft): **131.5**
Structural Grade: **0**
O&M Grade: **2**
Clock Start/From: **7**
Clock To: **5**
1st Value:
2nd Value:
Value Percent: **5.000**
Continuous Index: **F01**
Within 8" of Joint: **YES**
Remarks: **WANDER**
