## Profile/Photo Observation Report

Street:	<b>e 37th ave</b>	Flow Control:	<b>Not Controlled</b>
City:	<b>Hobart, IN</b>	Year Renewed:	
Location:	<b>Other</b>	Tape/Media #:	
Purpose:	<b>Not Known</b>	Dia/Height:	<b>10"</b>
Use:	<b>Sanitary</b>	Material:	<b>PVC</b>
Drain Area:	<b>NA</b>	Lining:	
Category:	<b>NA</b>		
Comment:	<b>REV - NULL - CNL MH-SNM-1702-012</b>

Location Details:		Direction of Survey:	<b>Upstream</b>
US MH:	<b>M-803-060</b>	DS MH:	<b>M-803-061</b>
		Total Length Surveyed (ft):	<b>131.5</b>

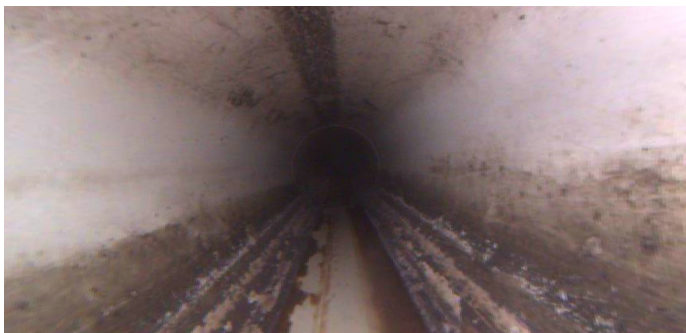
Code: **AMH**  
Description: **Manhole**

Distance (ft): **.0**  
Structural Grade: **0**  
O&M Grade: **0**  
Clock Start/From:  
Clock To:  
1st Value:  
2nd Value:  
Value Percent:  
Continuous Index:  
Within 8" of Joint: **NO**  
Remarks: **M-803-061**

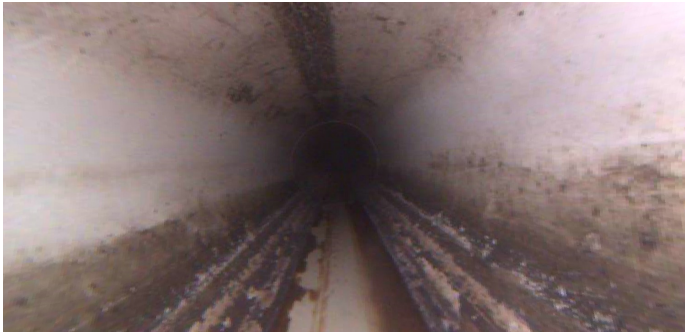
Code:	<b>MWL</b>
Description:	<b>Water Level</b>

Distance (ft):	<b>.0</b>
Structural Grade:	<b>0</b>
O&M Grade:	<b>0</b>
Clock Start/From:	
Clock To:	
1st Value:	
2nd Value:	
Value Percent:	<b>5.000</b>
Continuous Index:	
Within 8" of Joint:	<b>NO</b>
Remarks:

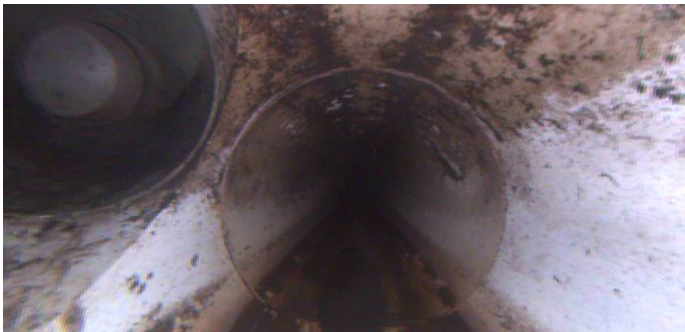
Code:	<b>TFC</b>
Description:	<b>Tap Factory Capped</b>

Distance (ft):	<b>70.6</b>
Structural Grade:	<b>0</b>
O&M Grade:	<b>0</b>
Clock Start/From:	<b>9</b>
Clock To:	
1st Value:	<b>4.000</b>
2nd Value:	
Value Percent:	
Continuous Index:	
Within 8" of Joint:	
Remarks:

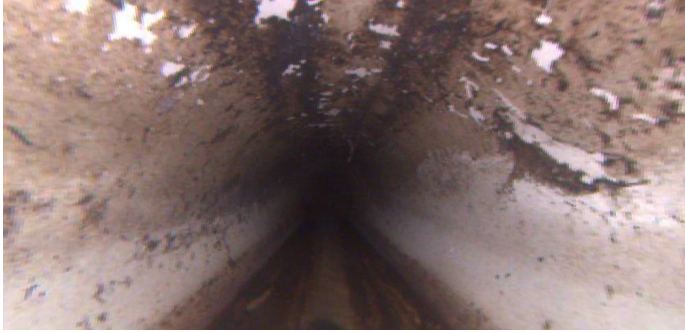
Code: **DAZ**  
Description: **Deposits Attached Other**

Distance (ft): **71.2**  
Structural Grade: **0**  
O&M Grade: **2**  
Clock Start/From: **7**  
Clock To: **5**  
1st Value:  
2nd Value:  
Value Percent: **5.000**  
Continuous Index: **S01**  
Within 8" of Joint: **YES**  
Remarks: **WANDER**

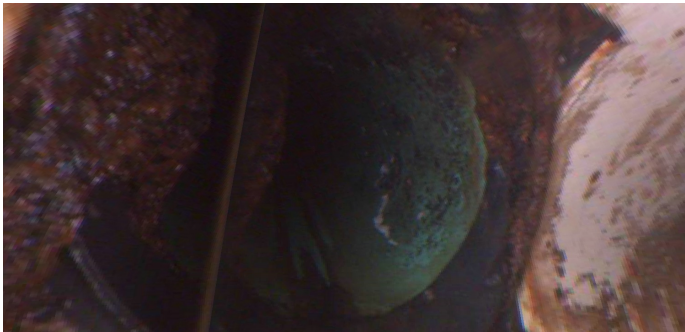
Code: **TBD**  
Description: **Tap Break-in Defective**

Distance (ft): **75.0**  
Structural Grade: **0**  
O&M Grade: **3**  
Clock Start/From: **9**  
Clock To:  
1st Value: **4.000**  
2nd Value:  
Value Percent:  
Continuous Index:  
Within 8" of Joint:  
Remarks: **DAE SURROUNDING MOUTH OF TAP**

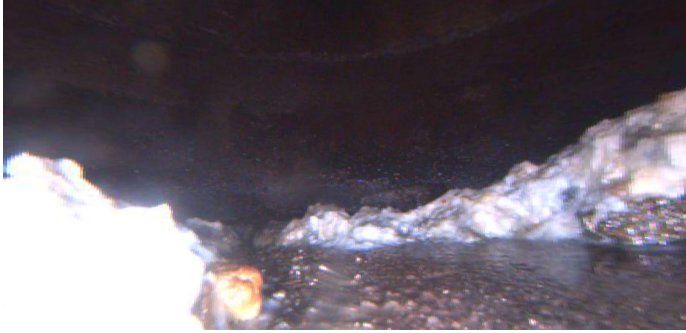
Code: **DAZ**  
Description: **Deposits Attached Other**

Distance (ft): **131.5**  
Structural Grade: **0**  
O&M Grade: **2**  
Clock Start/From: **7**  
Clock To: **5**  
1st Value:  
2nd Value:  
Value Percent: **5.000**  
Continuous Index: **F01**  
Within 8" of Joint: **YES**  
Remarks: **WANDER**

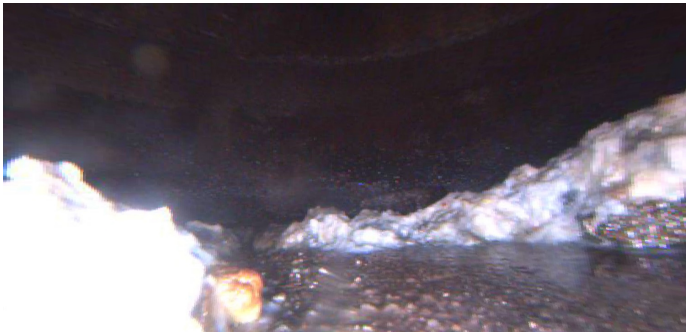
Code: **AMH**  
Description: **Manhole**

Distance (ft): **131.5**  
Structural Grade: **0**  
O&M Grade: **0**  
Clock Start/From:  
Clock To:  
1st Value:  
2nd Value:  
Value Percent:  
Continuous Index:  
Within 8" of Joint: **NO**  
Remarks: **M-803-060**
