Profile/Photo Observation Report

Date:	03/20/2018	Weather:		Coding:	PACP 6.0
Pipe Length (ft):	200.4	Owner:	NA	Pre Clean:	Not Known
P.O.#:		Surveyor:	JUSTIN GONZALES	PSR:	P-803-061-063
Customer:		Clean Date:	01/01/1900	Shape:	C

Street:	OFF E 37TH AVE	Flow Control:	Not Controlled
City:	Hobart, IN	Year Renewed:	
Location:	Other	Tape/Media #:	
Purpose:	Not Known	Dia/Height:	10"
Use:	Sanitary	Material:	PVC
Drain Area:	NA	Lining:	
Category:	NA		
Comment:

Location Details:		Direction of Survey:	Upstream
US MH:	M-803-063	DS MH:	M-803-061
		Total Length Surveyed (ft):	202.0

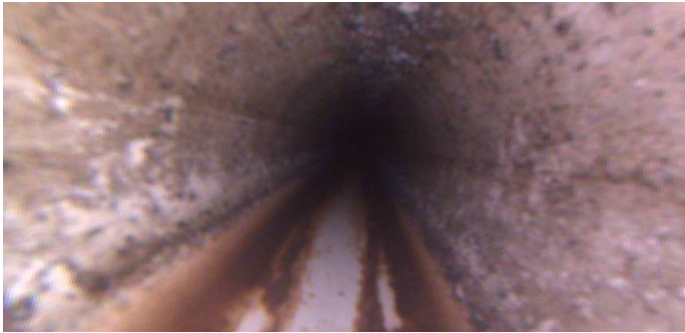
Code:	MWL
Description:	Water Level

Distance (ft):	.0
Structural Grade:	0
O&M Grade:	0
Clock Start/From:	
Clock To:	
1st Value:	
2nd Value:	
Value Percent:	5.000
Continuous Index:	
Within 8" of Joint:	NO
Remarks:

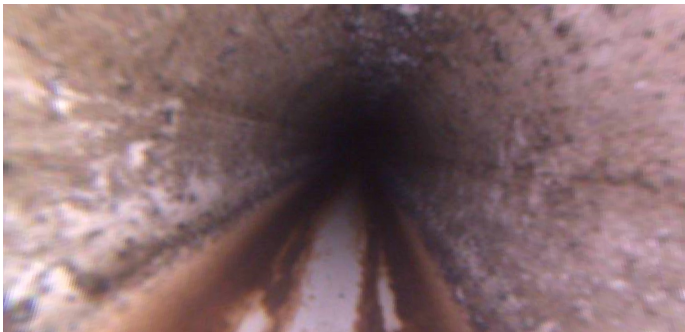
Code:	DAZ
Description:	Deposits Attached Other

Distance (ft):	.0
Structural Grade:	0
O&M Grade:	2
Clock Start/From:	7
Clock To:	5
1st Value:	
2nd Value:	
Value Percent:	5.000
Continuous Index:	S01
Within 8" of Joint:	YES
Remarks:	WANDER

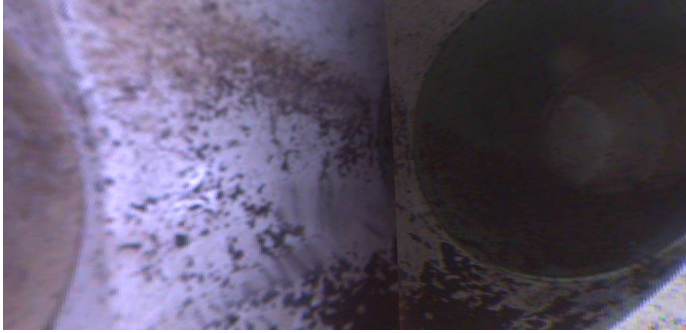
Code: **TFC**
Description: **Tap Factory Capped**

Distance (ft): **71.2**
Structural Grade: **0**
O&M Grade: **0**
Clock Start/From: **3**
Clock To:
1st Value: **4.000**
2nd Value:
Value Percent:
Continuous Index:
Within 8" of Joint:
Remarks:

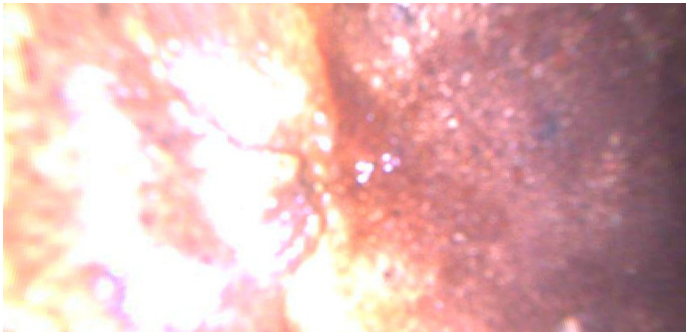
Code: **AMH**
Description: **Manhole**

Distance (ft): **202.0**
Structural Grade: **0**
O&M Grade: **0**
Clock Start/From:
Clock To:
1st Value:
2nd Value:
Value Percent:
Continuous Index:
Within 8" of Joint: **NO**
Remarks: **M-803-063**

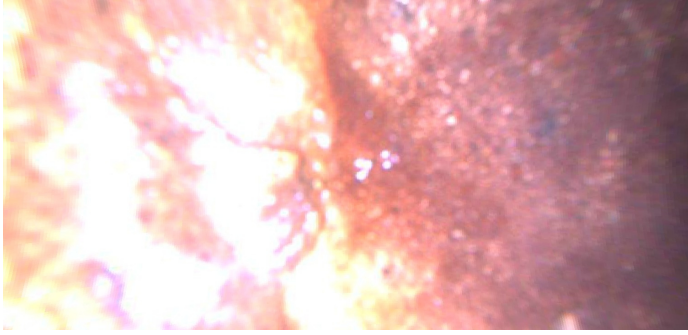
Code:	DAZ
Description:	Deposits Attached Other
Distance (ft):	202.0
Structural Grade:	0
O&M Grade:	2
Clock Start/From:	7
Clock To:	5
1st Value:	
2nd Value:	
Value Percent:	5.000
Continuous Index:	F01
Within 8" of Joint:	YES
Remarks:	WANDER
