Profile/Photo Observation Report

Date:	03/20/2018	Weather:		Coding:	PACP 6.0
Pipe Length (ft):	200.4	Owner:	NA	Pre Clean:	Not Known
P.O.#:		Surveyor:	JUSTIN GONZALES	PSR:	P-803-061-063
Customer:		Clean Date:	01/01/1900	Shape:	C

Street:	e 37th ave	Flow Control:	Not Controlled
City:	Hobart, IN	Year Renewed:	
Location:	Other	Tape/Media #:	
Purpose:	Not Known	Dia/Height:	10"
Use:	Sanitary	Material:	PVC
Drain Area:	NA	Lining:	
Category:	NA		
Comment:

Location Details:		Direction of Survey:	Upstream
US MH:	M-803-063	DS MH:	M-803-061
		Total Length Surveyed (ft):	202.0

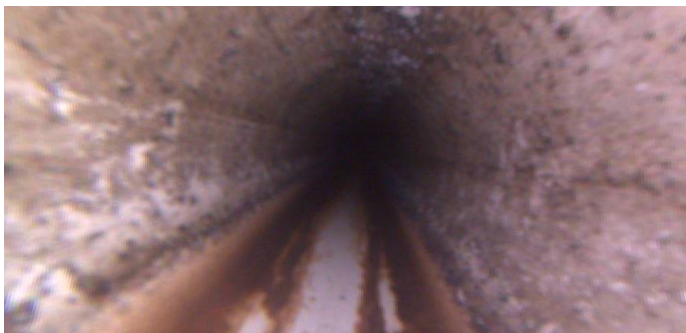
Code: **AMH**
Description: **Manhole**

Distance (ft): **.0**
Structural Grade: **0**
O&M Grade: **0**
Clock Start/From:
Clock To:
1st Value:
2nd Value:
Value Percent:
Continuous Index:
Within 8" of Joint: **NO**
Remarks: **M-803-061**

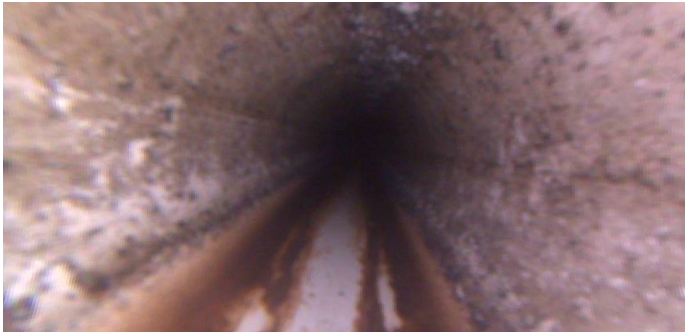
Code:	MWL
Description:	Water Level

Distance (ft):	.0
Structural Grade:	0
O&M Grade:	0
Clock Start/From:	
Clock To:	
1st Value:	
2nd Value:	
Value Percent:	5.000
Continuous Index:	
Within 8" of Joint:	NO
Remarks:

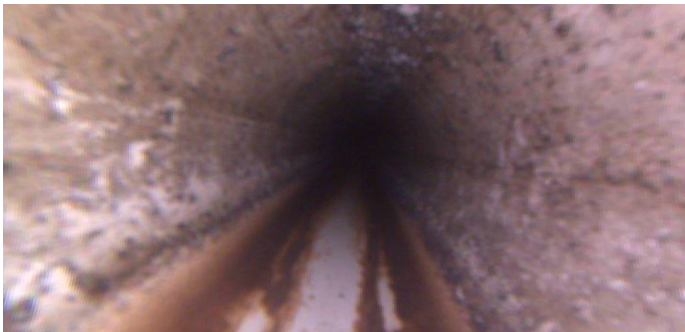
Code:	DAZ
Description:	Deposits Attached Other

Distance (ft):	.0
Structural Grade:	0
O&M Grade:	2
Clock Start/From:	7
Clock To:	5
1st Value:	
2nd Value:	
Value Percent:	5.000
Continuous Index:	S01
Within 8" of Joint:	YES
Remarks:	WANDER

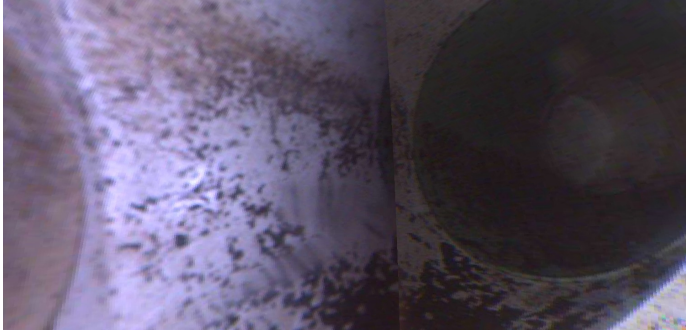
Code: **TFC**
Description: **Tap Factory Capped**

Distance (ft): **71.2**
Structural Grade: **0**
O&M Grade: **0**
Clock Start/From: **3**
Clock To:
1st Value: **4.000**
2nd Value:
Value Percent:
Continuous Index:
Within 8" of Joint:
Remarks:

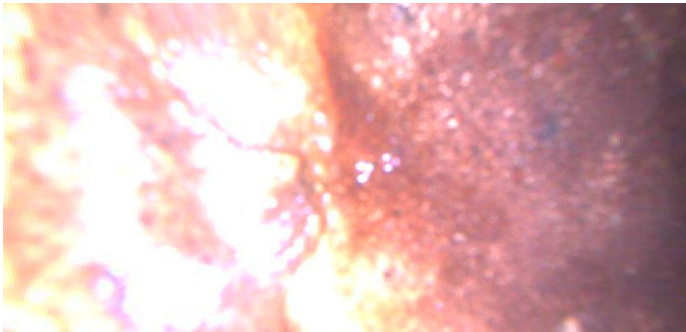
Code: **AMH**
Description: **Manhole**

Distance (ft): **202.0**
Structural Grade: **0**
O&M Grade: **0**
Clock Start/From:
Clock To:
1st Value:
2nd Value:
Value Percent:
Continuous Index:
Within 8" of Joint: **NO**
Remarks: **M-803-063**

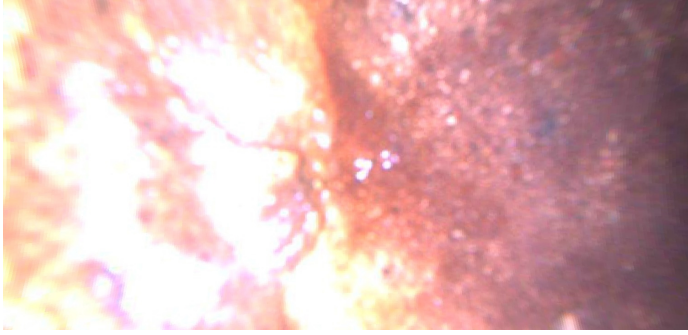
Code:	DAZ
Description:	Deposits Attached Other
Distance (ft):	202.0
Structural Grade:	0
O&M Grade:	2
Clock Start/From:	7
Clock To:	5
1st Value:	
2nd Value:	
Value Percent:	5.000
Continuous Index:	F01
Within 8" of Joint:	YES
Remarks:	WANDER
