Profile/Photo Observation Report

Street:	E 37TH AVE & N COLONIAL DR	Flow Control:	Not Controlled
City:	Hobart, IN	Year Renewed:	
Location:	Light Highway	Tape/Media #:	
Purpose:	Routine Assessment	Dia/Height:	10"
Use:	Sanitary	Material:	PVC
Drain Area:	NA	Lining:	
Category:	NA		
Comment:

Location Details:		Direction of Survey:	Downstream
US MH:	M-803-068	DS MH:	M-803-067
		Total Length Surveyed (ft):	117.4

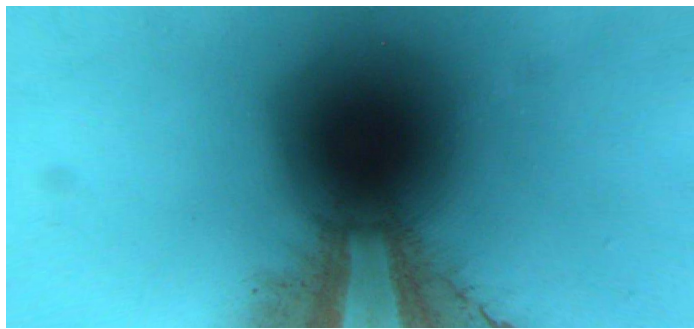
Code: **AMH**
Description: **Manhole**

Distance (ft): **.0**
Structural Grade: **0**
O&M Grade: **0**
Clock Start/From:
Clock To:
1st Value:
2nd Value:
Value Percent:
Continuous Index:
Within 8" of Joint: **NO**
Remarks: **M-803-068**

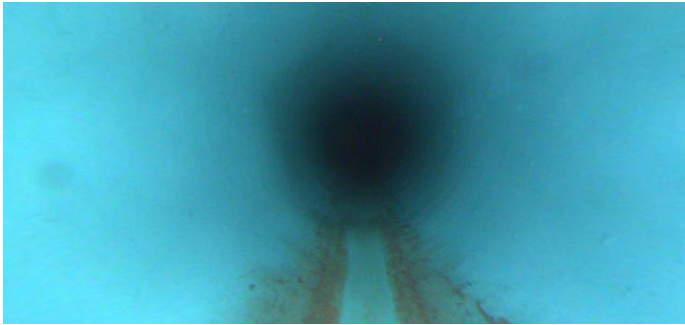
Code:	MWL
Description:	Water Level

Distance (ft):	.0
Structural Grade:	0
O&M Grade:	0
Clock Start/From:	
Clock To:	
1st Value:	
2nd Value:	
Value Percent:	5.000
Continuous Index:	
Within 8" of Joint:	NO
Remarks:

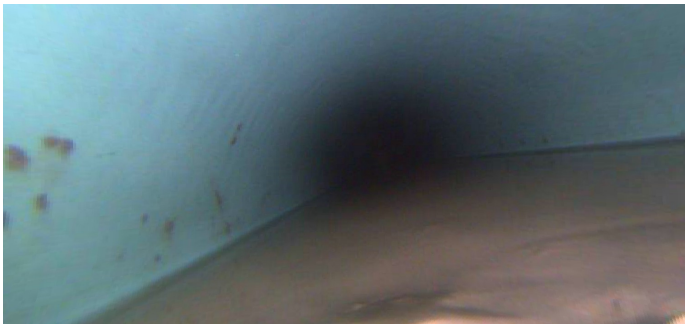
Code:	AMH
Description:	Manhole

Distance (ft):	117.4
Structural Grade:	0
O&M Grade:	0
Clock Start/From:	
Clock To:	
1st Value:	
2nd Value:	
Value Percent:	
Continuous Index:	
Within 8" of Joint:	NO
Remarks:	M-803-067
