## Profile/Photo Observation Report

Street:	<b>Colonial Dr.</b>	Flow Control:	<b>Not Controlled</b>
City:	<b>Hobart, IN</b>	Year Renewed:	
Location:	<b>Light Highway</b>	Tape/Media #:	
Purpose:	<b>Routine Assessment</b>	Dia/Height:	<b>10"</b>
Use:	<b>Sanitary</b>	Material:	<b>PVC</b>
Drain Area:	<b>NA</b>	Lining:	
Category:	<b>NA</b>		
Comment:

Location Details:		Direction of Survey:	<b>Downstream</b>
US MH:	<b>M-803-068</b>	DS MH:	<b>M-803-067</b>
		Total Length Surveyed (ft):	<b>117.4</b>

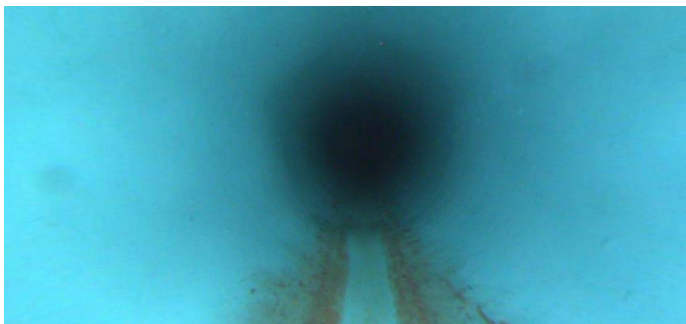
Code: **AMH**  
Description: **Manhole**

Distance (ft): **.0**  
Structural Grade: **0**  
O&M Grade: **0**  
Clock Start/From:  
Clock To:  
1st Value:  
2nd Value:  
Value Percent:  
Continuous Index:  
Within 8" of Joint: **NO**  
Remarks: **M-803-068**

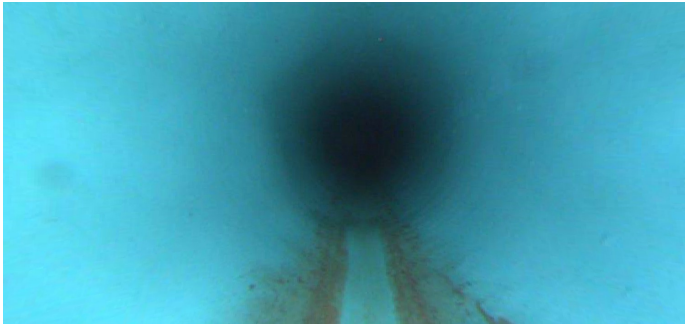
Code:	<b>MWL</b>
Description:	<b>Water Level</b>

Distance (ft):	<b>.0</b>
Structural Grade:	<b>0</b>
O&M Grade:	<b>0</b>
Clock Start/From:	
Clock To:	
1st Value:	
2nd Value:	
Value Percent:	<b>5.000</b>
Continuous Index:	
Within 8" of Joint:	<b>NO</b>
Remarks:

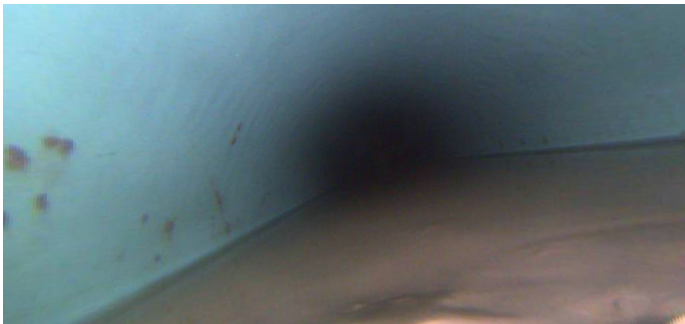
Code:	<b>AMH</b>
Description:	<b>Manhole</b>

Distance (ft):	<b>117.4</b>
Structural Grade:	<b>0</b>
O&M Grade:	<b>0</b>
Clock Start/From:	
Clock To:	
1st Value:	
2nd Value:	
Value Percent:	
Continuous Index:	
Within 8" of Joint:	<b>NO</b>
Remarks:	<b>M-803-067</b>
