## Profile/Photo Observation Report

Street:	<b>N COLONIAL DR</b>	Flow Control:	<b>Not Controlled</b>
City:	<b>Hobart, IN</b>	Year Renewed:	
Location:	<b>Other</b>	Tape/Media #:	
Purpose:	<b>Not Known</b>	Dia/Height:	<b>10"</b>
Use:	<b>Sanitary</b>	Material:	<b>PVC</b>
Drain Area:	<b>NA</b>	Lining:	
Category:	<b>NA</b>		
Comment:

Location Details:		Direction of Survey:	<b>Downstream</b>
US MH:	<b>M-803-070</b>	DS MH:	<b>M-803-069</b>
		Total Length Surveyed (ft):	<b>235.4</b>

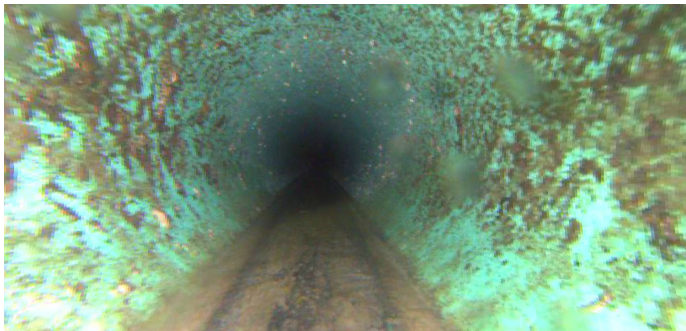
Code: **AMH**  
Description: **Manhole**

Distance (ft): **.0**  
Structural Grade: **0**  
O&M Grade: **0**  
Clock Start/From:  
Clock To:  
1st Value:  
2nd Value:  
Value Percent:  
Continuous Index:  
Within 8" of Joint: **NO**  
Remarks: **M-803-070**

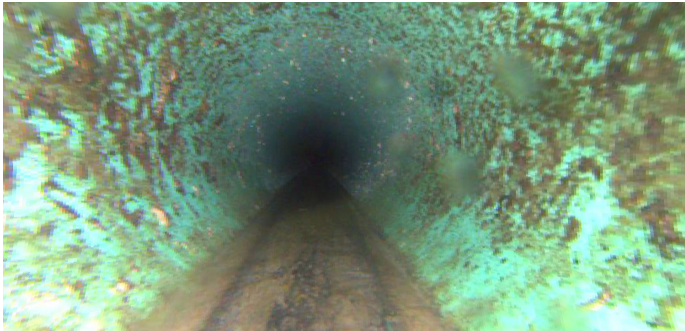
Code:	<b>MWL</b>
Description:	<b>Water Level</b>

Distance (ft):	<b>.0</b>
Structural Grade:	<b>0</b>
O&M Grade:	<b>0</b>
Clock Start/From:	
Clock To:	
1st Value:	
2nd Value:	
Value Percent:	<b>5.000</b>
Continuous Index:	
Within 8" of Joint:	<b>NO</b>
Remarks:

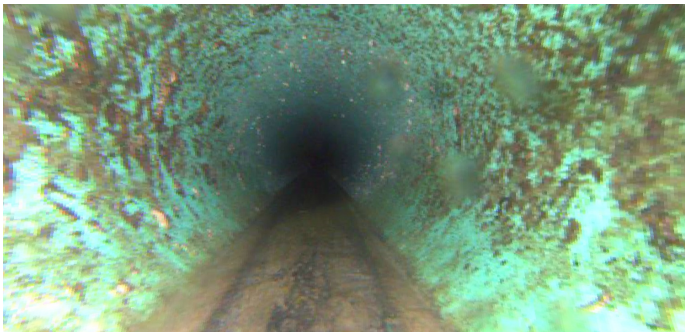
Code:	<b>DAZ</b>
Description:	<b>Deposits Attached Other</b>

Distance (ft):	<b>.0</b>
Structural Grade:	<b>0</b>
O&M Grade:	<b>2</b>
Clock Start/From:	<b>7</b>
Clock To:	<b>5</b>
1st Value:	
2nd Value:	
Value Percent:	<b>5.000</b>
Continuous Index:	<b>S01</b>
Within 8" of Joint:	<b>YES</b>
Remarks:	<b>WANDER</b>

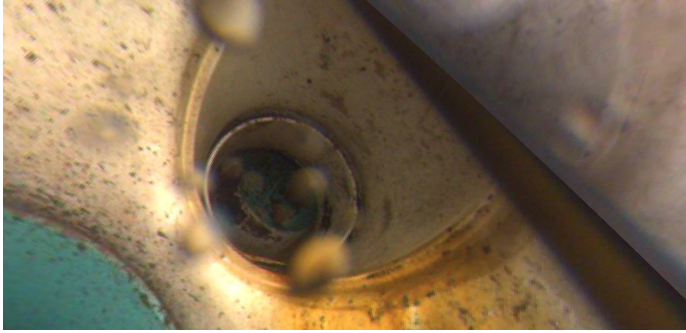
Code: **TF**  
Description: **Tap Factory**

Distance (ft): **18.2**  
Structural Grade: **0**  
O&M Grade: **0**  
Clock Start/From: **2**  
Clock To:  
1st Value: **4.000**  
2nd Value:  
Value Percent:  
Continuous Index:  
Within 8" of Joint:  
Remarks:

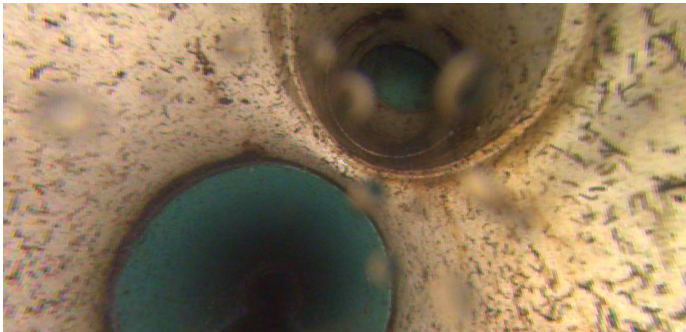
Code: **TF**  
Description: **Tap Factory**

Distance (ft): **142.0**  
Structural Grade: **0**  
O&M Grade: **0**  
Clock Start/From: **2**  
Clock To:  
1st Value: **4.000**  
2nd Value:  
Value Percent:  
Continuous Index:  
Within 8" of Joint:  
Remarks:

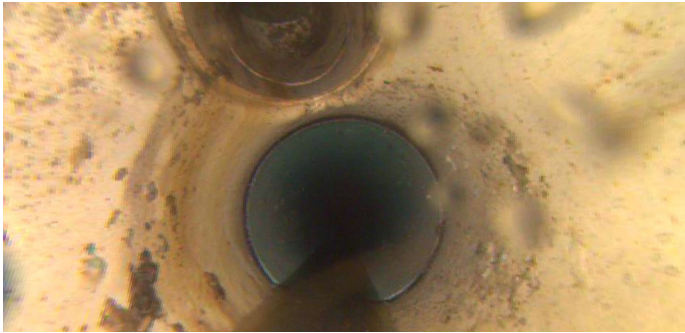
Code: **TF**  
Description: **Tap Factory**

Distance (ft): **148.8**  
Structural Grade: **0**  
O&M Grade: **0**  
Clock Start/From: **10**  
Clock To:  
1st Value: **4.000**  
2nd Value:  
Value Percent:  
Continuous Index:  
Within 8" of Joint:  
Remarks:

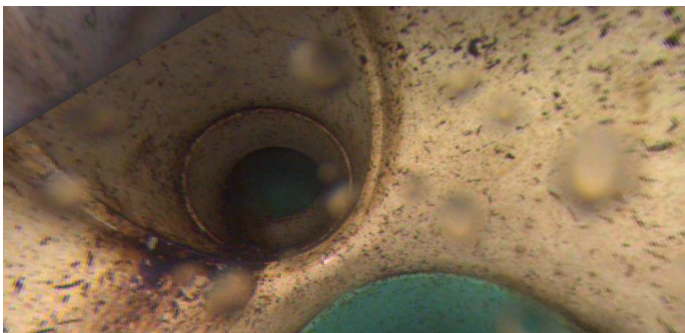
Code: **TF**  
Description: **Tap Factory**

Distance (ft): **171.0**  
Structural Grade: **0**  
O&M Grade: **0**  
Clock Start/From: **10**  
Clock To:  
1st Value: **4.000**  
2nd Value:  
Value Percent:  
Continuous Index:  
Within 8" of Joint:  
Remarks:

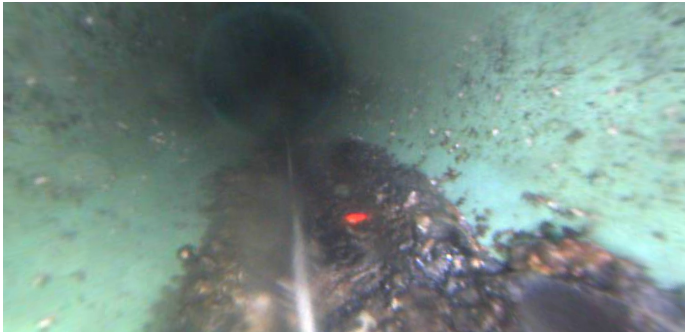
Code: **DSZ**  
Description: **Deposits Settled Other**

Distance (ft): **211.3**  
Structural Grade: **0**  
O&M Grade: **2**  
Clock Start/From: **5**  
Clock To: **7**  
1st Value:  
2nd Value:  
Value Percent: **10.000**  
Continuous Index:  
Within 8" of Joint: **NO**  
Remarks: **misc**

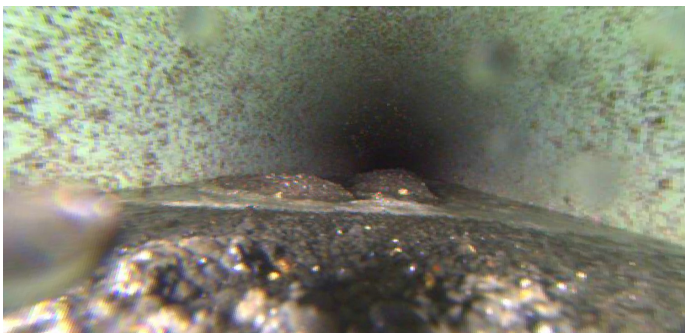
Code: **MWLS**  
Description: **Water Level Sag**

Distance (ft): **232.6**  
Structural Grade: **3**  
O&M Grade: **3**  
Clock Start/From:  
Clock To:  
1st Value:  
2nd Value:  
Value Percent: **45.000**  
Continuous Index:  
Within 8" of Joint: **NO**  
Remarks:
