Profile/Photo Observation Report

Date:	03/27/2018	Weather:		Coding:	PACP 6.0
Pipe Length (ft):	293.8	Owner:	NA	Pre Clean:	Not Known
P.O.#:		Surveyor:	Jen Costello	PSR:	P-803-069-070
Customer:		Clean Date:	01/01/1900	Shape:	C

Street:	N COLONIAL DR	Flow Control:	Not Controlled
City:	Hobart, IN	Year Renewed:	
Location:	Other	Tape/Media #:	
Purpose:	Not Known	Dia/Height:	10"
Use:	Sanitary	Material:	PVC
Drain Area:	NA	Lining:	
Category:	NA		
Comment:

Location Details:		Direction of Survey:	Upstream
US MH:	M-803-070	DS MH:	M-803-069
		Total Length Surveyed (ft):	7.3

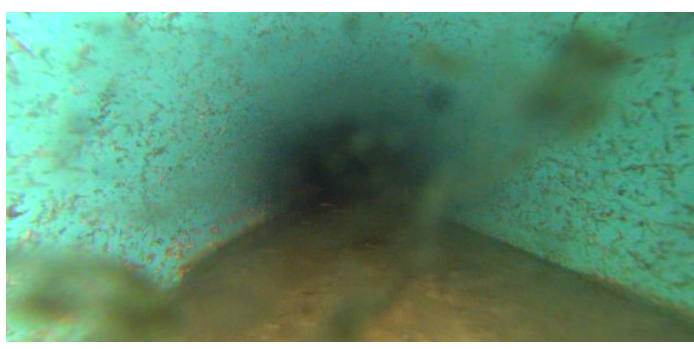
Code: **AMH**
Description: **Manhole**

Distance (ft): **.0**
Structural Grade: **0**
O&M Grade: **0**
Clock Start/From:
Clock To:
1st Value:
2nd Value:
Value Percent:
Continuous Index:
Within 8" of Joint: **NO**
Remarks: **M-803-069**

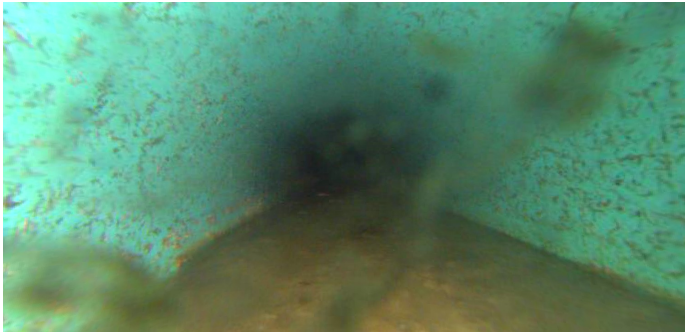
Code:	MWL
Description:	Water Level

Distance (ft):	.0
Structural Grade:	0
O&M Grade:	0
Clock Start/From:	
Clock To:	
1st Value:	
2nd Value:	
Value Percent:	40.000
Continuous Index:	
Within 8" of Joint:	NO
Remarks:

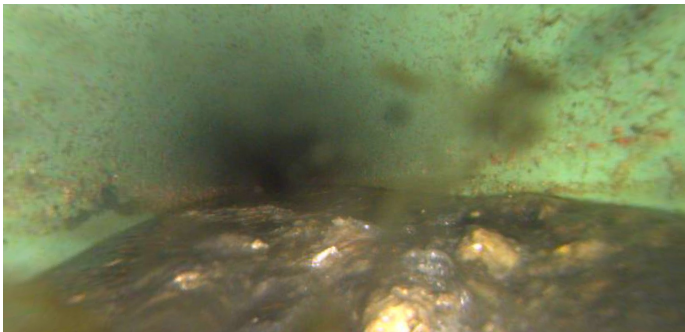
Code:	MSA
Description:	Abandoned Survey

Distance (ft):	7.3
Structural Grade:	0
O&M Grade:	0
Clock Start/From:	
Clock To:	
1st Value:	
2nd Value:	
Value Percent:	
Continuous Index:	
Within 8" of Joint:	NO
Remarks:	debris under water
