## Profile/Photo Observation Report

Street:	<b>N COLONIAL DR</b>	Flow Control:	<b>Not Controlled</b>
City:	<b>Hobart, IN</b>	Year Renewed:	
Location:	<b>Light Highway</b>	Tape/Media #:	
Purpose:	<b>Routine Assessment</b>	Dia/Height:	<b>10"</b>
Use:	<b>Sanitary</b>	Material:	<b>PVC</b>
Drain Area:	<b>NA</b>	Lining:	
Category:	<b>NA</b>		
Comment:

Location Details:		Direction of Survey:	<b>Upstream</b>
US MH:	<b>M-803-070</b>	DS MH:	<b>M-803-069</b>
		Total Length Surveyed (ft):	<b>7.1</b>

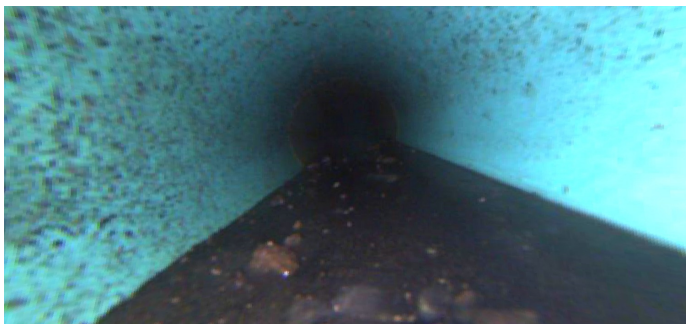
Code: **AMH**  
Description: **Manhole**

Distance (ft): **.0**  
Structural Grade: **0**  
O&M Grade: **0**  
Clock Start/From:  
Clock To:  
1st Value:  
2nd Value:  
Value Percent:  
Continuous Index:  
Within 8" of Joint: **NO**  
Remarks: **M-803-069**

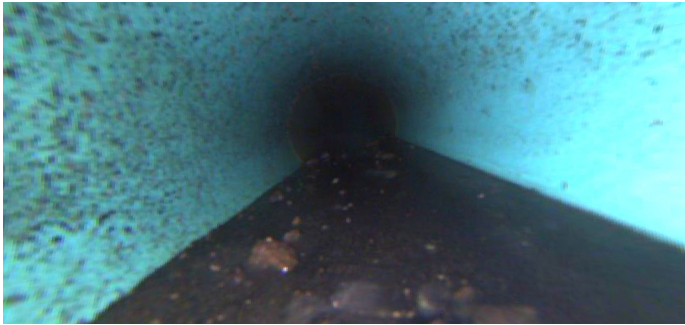
Code:	<b>MWL</b>
Description:	<b>Water Level</b>

Distance (ft):	<b>.0</b>
Structural Grade:	<b>0</b>
O&M Grade:	<b>0</b>
Clock Start/From:	
Clock To:	
1st Value:	
2nd Value:	
Value Percent:	<b>5.000</b>
Continuous Index:	
Within 8" of Joint:	<b>NO</b>
Remarks:

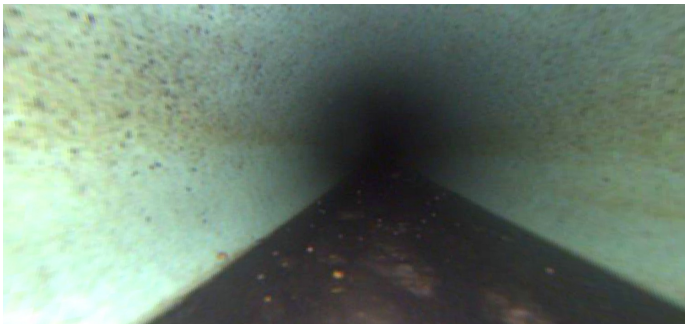
Code:	<b>MSA</b>
Description:	<b>Abandoned Survey</b>

Distance (ft):	<b>7.1</b>
Structural Grade:	<b>0</b>
O&M Grade:	<b>0</b>
Clock Start/From:	
Clock To:	
1st Value:	
2nd Value:	
Value Percent:	
Continuous Index:	
Within 8" of Joint:	<b>NO</b>
Remarks:	<b>camera stopped</b>
