Profile/Photo Observation Report

Street:	Colonial Dr.	Flow Control:	Not Controlled
City:	Hobart, IN	Year Renewed:	
Location:	Light Highway	Tape/Media #:	
Purpose:	Routine Assessment	Dia/Height:	10"
Use:	Sanitary	Material:	PVC
Drain Area:	NA	Lining:	
Category:	NA		
Comment:

Location Details:		Direction of Survey:	Upstream
US MH:	M-803-070	DS MH:	M-803-069
		Total Length Surveyed (ft):	7.1

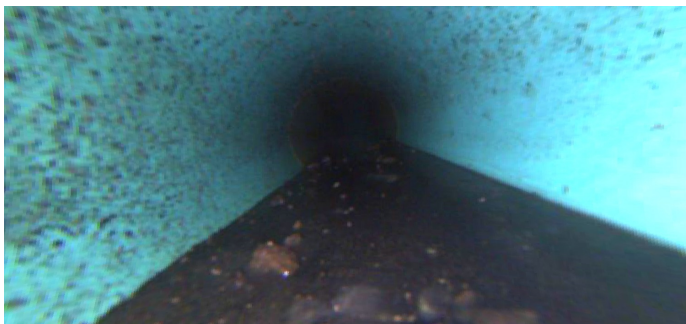
Code: **AMH**
Description: **Manhole**

Distance (ft): **.0**
Structural Grade: **0**
O&M Grade: **0**
Clock Start/From:
Clock To:
1st Value:
2nd Value:
Value Percent:
Continuous Index:
Within 8" of Joint: **NO**
Remarks: **M-803-069**

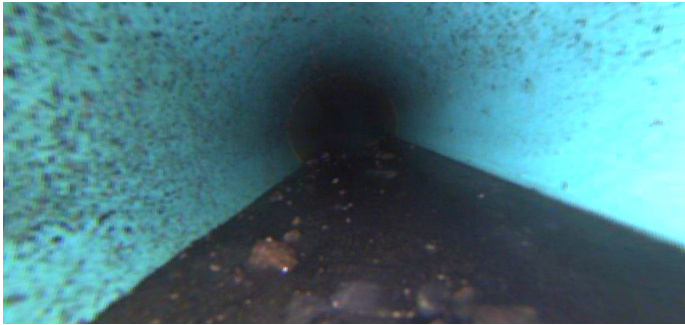
Code:	MWL
Description:	Water Level

Distance (ft):	.0
Structural Grade:	0
O&M Grade:	0
Clock Start/From:	
Clock To:	
1st Value:	
2nd Value:	
Value Percent:	5.000
Continuous Index:	
Within 8" of Joint:	NO
Remarks:

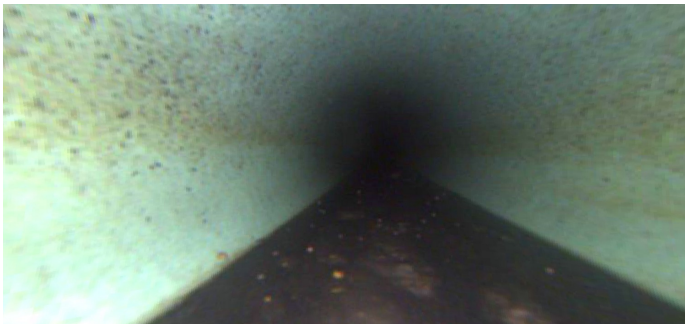
Code:	MSA
Description:	Abandoned Survey

Distance (ft):	7.1
Structural Grade:	0
O&M Grade:	0
Clock Start/From:	
Clock To:	
1st Value:	
2nd Value:	
Value Percent:	
Continuous Index:	
Within 8" of Joint:	NO
Remarks:	camera stopped
