## Profile/Photo Observation Report

| P.O.#: | | Surveyor: | <b>Jen Costello</b> | PSR: | <b>P-803-070-071</b> |

| Street: | <b>N COLONIAL DR</b> | Flow Control: | <b>Not Controlled</b> |
| City: | <b>Hobart, IN</b> | Year Renewed: | |

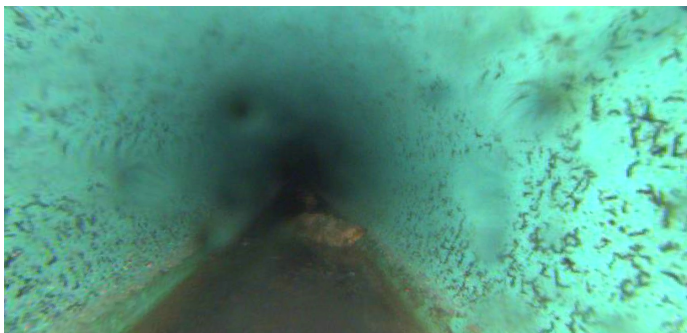
Code: **AMH**  
 Description: **Manhole**  
 Distance (ft): **.0**  
 Structural Grade: **0**  
 O&M Grade: **0**  
 Clock Start/From:  
 Clock To:  
 1st Value:  
 2nd Value:  
 Value Percent:  
 Continuous Index:  
 Within 8" of Joint: **NO**  
 Remarks: **M-803-070**

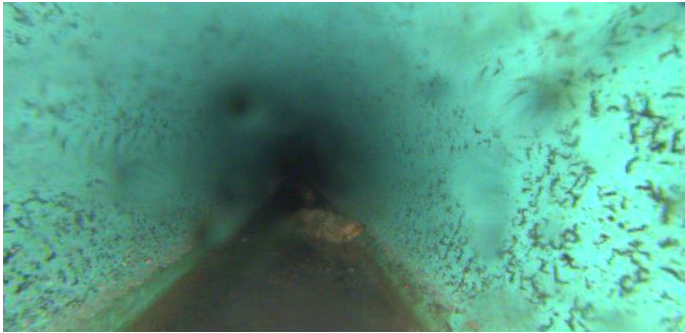
| Code: | <b>MWL</b> |
| Description: | <b>Water Level</b> |

| Distance (ft): | <b>.0</b> |
| Value Percent: | <b>5.000</b> |

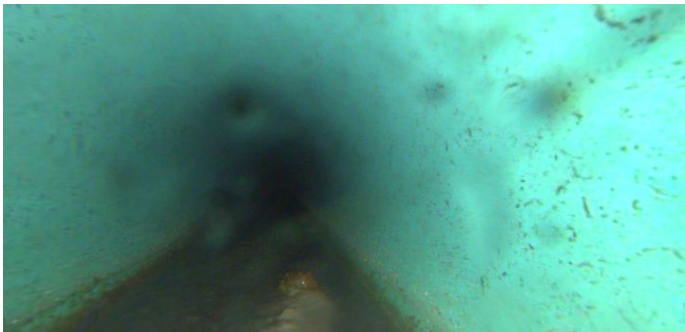
| Code: | <b>MSA</b> |
| Description: | <b>Abandoned Survey</b> |

| Distance (ft): | <b>12.5</b> |
| Remarks: | <b>UNKNOWN</b> |
