## Profile/Photo Observation Report

Street:	<b>N COLONIAL DR</b>	Flow Control:	<b>Not Controlled</b>
City:	<b>Hobart, IN</b>	Year Renewed:	
Location:	<b>Light Highway</b>	Tape/Media #:	
Purpose:	<b>Routine Assessment</b>	Dia/Height:	<b>10"</b>
Use:	<b>Sanitary</b>	Material:	<b>PVC</b>
Drain Area:	<b>NA</b>	Lining:	
Category:	<b>NA</b>		
Comment:

Location Details:		Direction of Survey:	<b>Upstream</b>
US MH:	<b>M-803-071</b>	DS MH:	<b>M-803-070</b>
		Total Length Surveyed (ft):	<b>50.5</b>

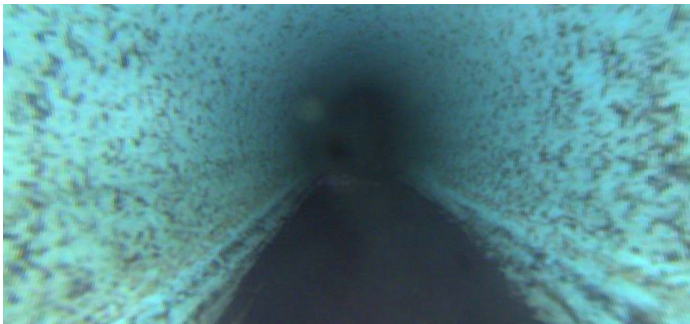
Remarks: M-803-070

Code: AMH

Description: Manhole

Distance (ft): .0

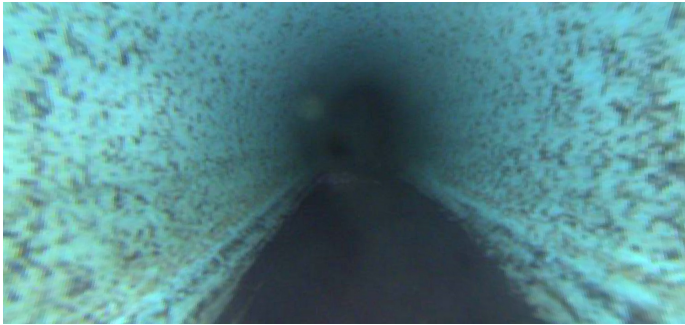
Code:	<b>MWL</b>
Description:	<b>Water Level</b>

Distance (ft):	<b>.0</b>
Structural Grade:	<b>0</b>
O&M Grade:	<b>0</b>
Clock Start/From:	
Clock To:	
1st Value:	
2nd Value:	
Value Percent:	<b>5.000</b>
Continuous Index:	
Within 8" of Joint:	<b>NO</b>
Remarks:

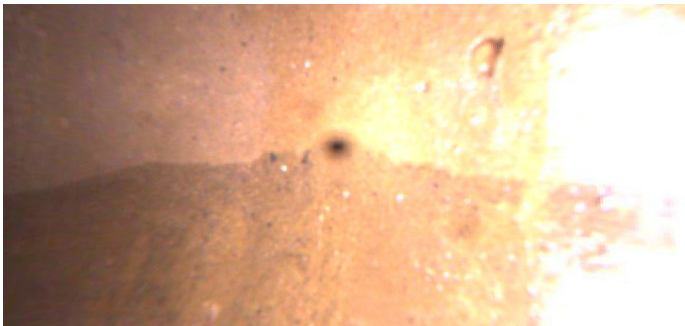
Code:	<b>AMH</b>
Description:	<b>Manhole</b>

Distance (ft):	<b>50.5</b>
Structural Grade:	<b>0</b>
O&M Grade:	<b>0</b>
Clock Start/From:	
Clock To:	
1st Value:	
2nd Value:	
Value Percent:	
Continuous Index:	
Within 8" of Joint:	<b>NO</b>
Remarks:	<b>M-803-071</b>
