Profile/Photo Observation Report

Street:	Colonial Dr.	Flow Control:	Not Controlled
City:	Hobart, IN	Year Renewed:	
Location:	Light Highway	Tape/Media #:	
Purpose:	Routine Assessment	Dia/Height:	10"
Use:	Sanitary	Material:	PVC
Drain Area:	NA	Lining:	
Category:	NA		
Comment:

Location Details:		Direction of Survey:	Upstream
US MH:	M-803-071	DS MH:	M-803-070
		Total Length Surveyed (ft):	50.5

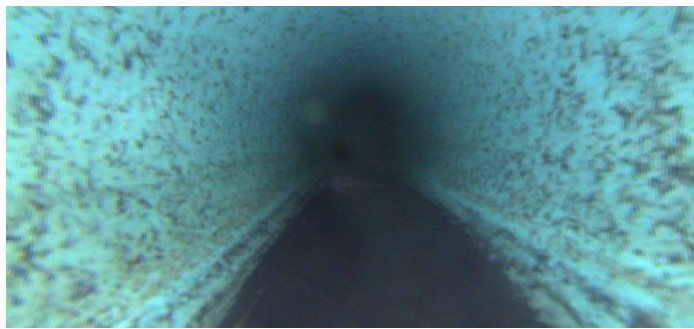
Code: **AMH**
Description: **Manhole**

Distance (ft): **.0**
Structural Grade: **0**
O&M Grade: **0**
Clock Start/From:
Clock To:
1st Value:
2nd Value:
Value Percent:
Continuous Index:
Within 8" of Joint: **NO**
Remarks: **M-803-070**

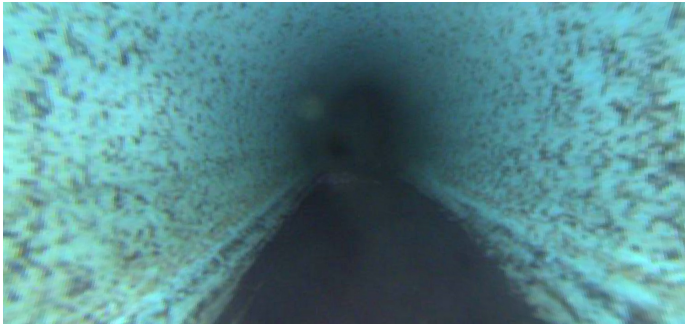
Code:	MWL
Description:	Water Level

Distance (ft):	.0
Structural Grade:	0
O&M Grade:	0
Clock Start/From:	
Clock To:	
1st Value:	
2nd Value:	
Value Percent:	5.000
Continuous Index:	
Within 8" of Joint:	NO
Remarks:

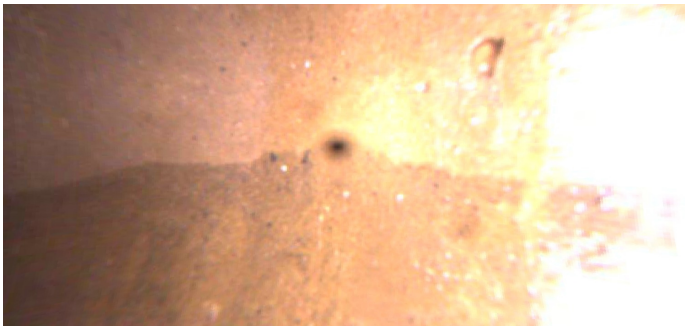
Code:	AMH
Description:	Manhole

Distance (ft):	50.5
Structural Grade:	0
O&M Grade:	0
Clock Start/From:	
Clock To:	
1st Value:	
2nd Value:	
Value Percent:	
Continuous Index:	
Within 8" of Joint:	NO
Remarks:	M-803-071
