## Profile/Photo Observation Report

Street:	<b>E CLEVELAND AVE &amp; S LIBERTY PL</b>	Flow Control:	<b>Not Controlled</b>
City:	<b>Hobart, IN</b>	Year Renewed:	
Location:	<b>Other</b>	Tape/Media #:	
Purpose:	<b>Not Known</b>	Dia/Height:	<b>8"</b>
Use:	<b>Sanitary</b>	Material:	<b>PVC</b>
Drain Area:	<b>NA</b>	Lining:	
Category:	<b>NA</b>		
Comment:

Location Details:		Direction of Survey:	<b>Upstream</b>
US MH:	<b>M-804-001</b>	DS MH:	<b>M-804-002</b>
		Total Length Surveyed (ft):	<b>10.9</b>

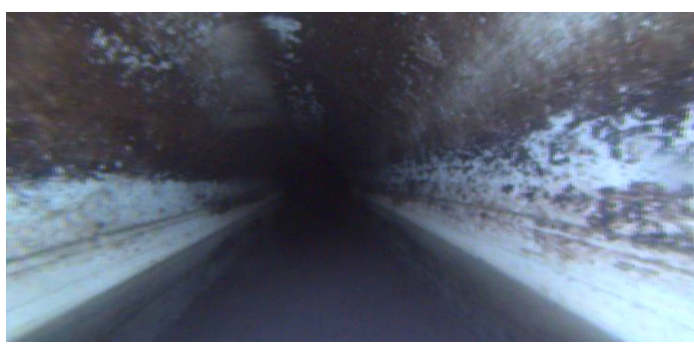
Code: **AMH**  
Description: **Manhole**

Distance (ft): **.0**  
Structural Grade: **0**  
O&M Grade: **0**  
Clock Start/From:  
Clock To:  
1st Value:  
2nd Value:  
Value Percent:  
Continuous Index:  
Within 8" of Joint: **NO**  
Remarks: **M-804-002**

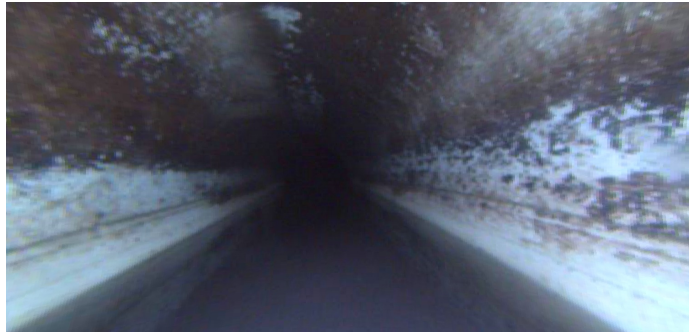
Code: **MWL**  
Description: **Water Level**

Distance (ft): **.0**  
Structural Grade: **0**  
O&M Grade: **0**  
Clock Start/From:  
Clock To:  
1st Value:  
2nd Value:  
Value Percent: **20.000**  
Continuous Index:  
Within 8" of Joint: **NO**  
Remarks:

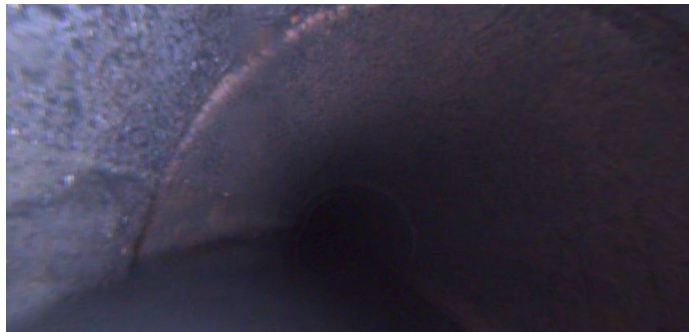
Code: **MSA**  
Description: **Abandoned Survey**

Distance (ft): **10.9**  
Structural Grade: **0**  
O&M Grade: **0**  
Clock Start/From:  
Clock To:  
1st Value:  
2nd Value:  
Value Percent:  
Continuous Index:  
Within 8" of Joint: **NO**  
Remarks: **camera stopped**
