# Profile/Photo Observation Report

Date: **09/15/2024**      Weather:      Coding: **PACP 7.0**  
 Pipe Length (ft): **491.0**      Owner: **City of Hobart**      Pre Clean: **Heavy Cleaning**  
 P.O.#: **YES502259**      Surveyor: **S. Bucklin**      PSR: **P-804-001-002**  
 Customer: **City of Hobart**      Clean Date: **09/04/2024**      Shape: **C**

Street: **East Cleveland Avenue**      Flow Control: **Not Controlled**  
 City: **Hobart, IN**      Year Renewed:  
 Location: **Local rural streets with light traffic, t**      Tape/Media #:  
 Purpose: **Sewer System Evaluation Survey (SS**      Dia/Height: **12"**  
 Use: **Sanitary Sewage Pipe**      Material: **VCP**  
 Drain Area:      Lining: **None**  
 Category: **NA**  
 Comment:  
 Location Details:      Direction of Survey: **Downstream**  
 US MH: **M-804-001**      DS MH: **M-804-002**      Total Length Surveyed (ft): **188.7**

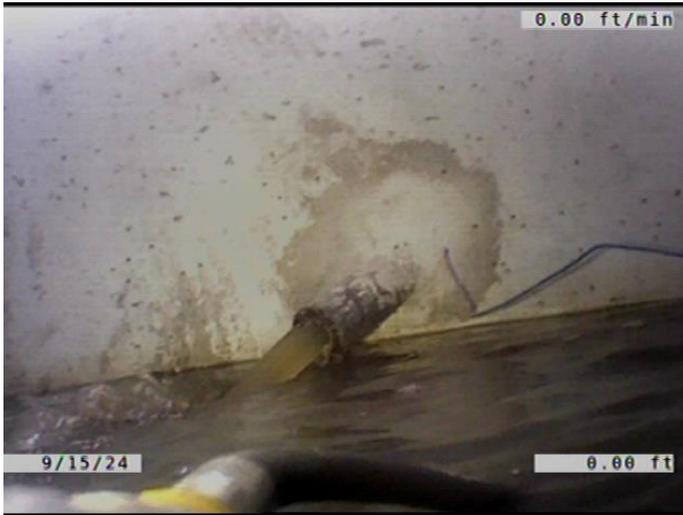
Code: **AMH**  
Description: **Manhole**

Distance (ft): **.0**  
Structural Grade: **0**  
O&M Grade: **0**  
Clock Start/From:  
Clock To:  
1st Value:  
2nd Value:  
Value Percent:  
Continuous Index:  
Within 8" of Joint: **NO**  
Remarks: **M-804-001**

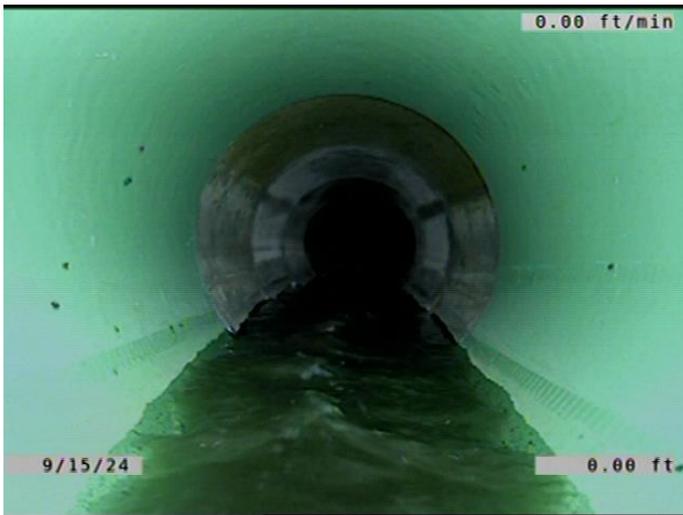
Code: **MWL**  
Description: **Miscellaneous Water Level**

Distance (ft): **.0**  
Structural Grade: **0**  
O&M Grade: **0**  
Clock Start/From:  
Clock To:  
1st Value:  
2nd Value:  
Value Percent: **5.000**  
Continuous Index:  
Within 8" of Joint: **NO**  
Remarks:

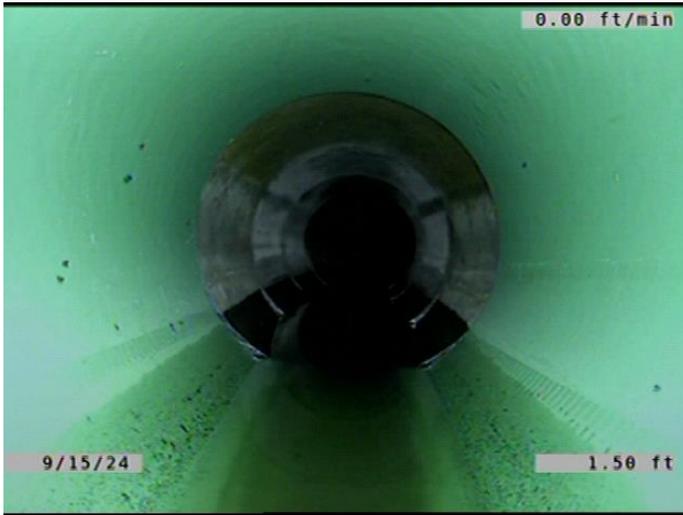
Code: **MGO**  
Description: **Miscellaneous General Observation**

Distance (ft): **1.5**  
Structural Grade: **0**  
O&M Grade: **0**  
Clock Start/From:  
Clock To:  
1st Value:  
2nd Value:  
Value Percent:  
Continuous Index:  
Within 8" of Joint: **NO**  
Remarks: **NO CHANNEL IN THE MANHOLE.  
HAD TO START IN THE PIPE.**

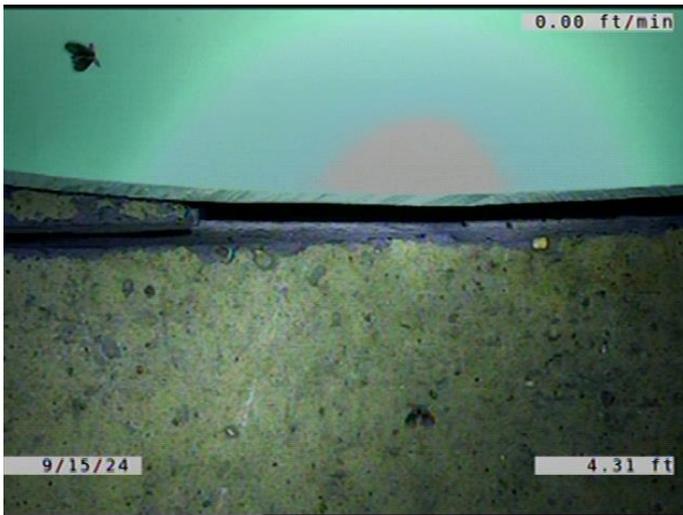
Code: **MMC**  
Description: **Miscellaneous Material Change**

Distance (ft): **4.3**  
Structural Grade: **0**  
O&M Grade: **0**  
Clock Start/From:  
Clock To:  
1st Value:  
2nd Value:  
Value Percent:  
Continuous Index:  
Within 8" of Joint: **NO**  
Remarks: **PVC TO VCP**

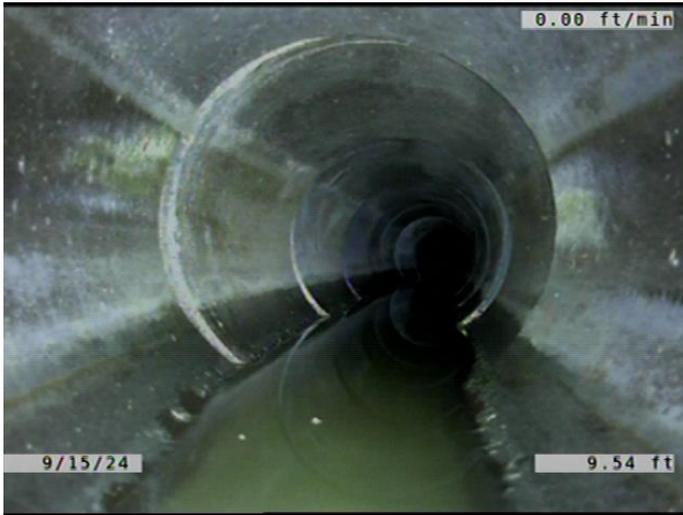
Code: **LR**  
Description: **Line Right**

Distance (ft): **9.5**  
Structural Grade: **0**  
O&M Grade: **1**  
Clock Start/From:  
Clock To:  
1st Value:  
2nd Value:  
Value Percent: **5.000**  
Continuous Index:  
Within 8" of Joint: **NO**  
Remarks:

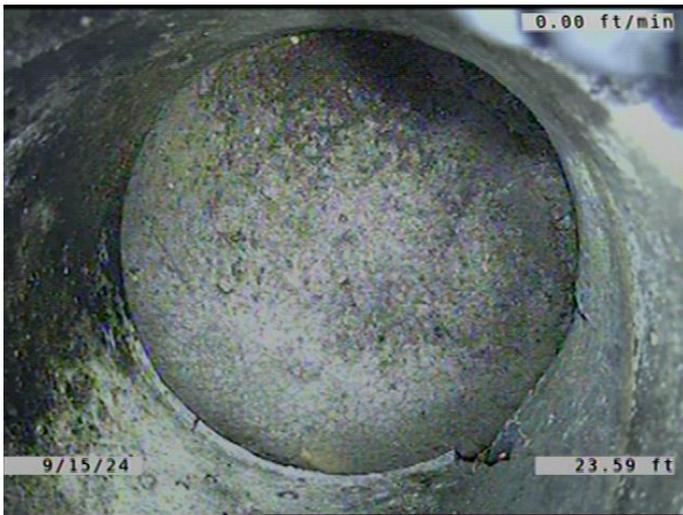
Code: **TFD**  
Description: **Tap Factory Defective**

Distance (ft): **23.6**  
Structural Grade: **0**  
O&M Grade: **3**  
Clock Start/From: **3**  
Clock To:  
1st Value: **6.000**  
2nd Value:  
Value Percent:  
Continuous Index:  
Within 8" of Joint: **YES**  
Remarks: **CAPPED. TAP BROKEN.**

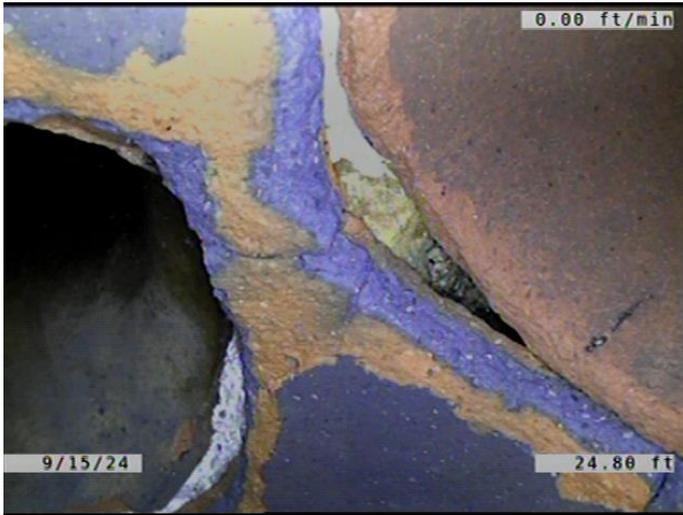
Code: **B**  
 Description: **Broken**

Distance (ft): **24.8**  
 Structural Grade: **4**  
 O&M Grade: **0**  
 Clock Start/From: **11**  
 Clock To: **4**  
 1st Value:  
 2nd Value:  
 Value Percent:  
 Continuous Index:  
 Within 8" of Joint: **YES**  
 Remarks:

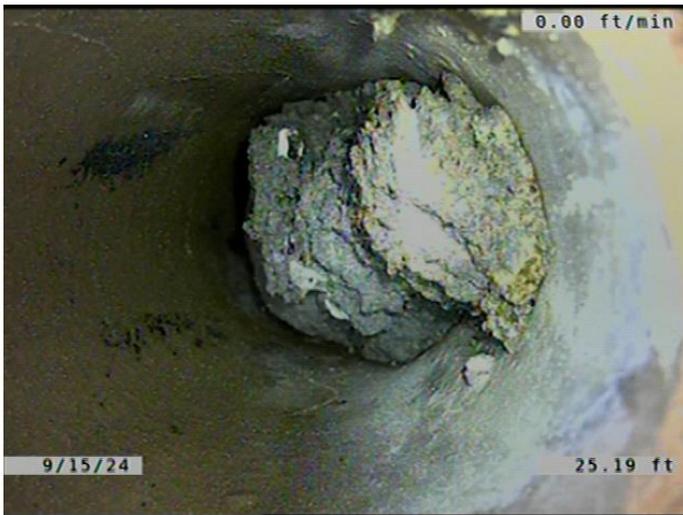
Code: **TBD**  
 Description: **Tap Break-in/Hammer Defective**

Distance (ft): **25.2**  
 Structural Grade: **0**  
 O&M Grade: **3**  
 Clock Start/From: **3**  
 Clock To:  
 1st Value: **6.000**  
 2nd Value:  
 Value Percent:  
 Continuous Index:  
 Within 8" of Joint: **YES**  
 Remarks: **LOOKS TO BE 100% PLUGGED WITH DIRT.**

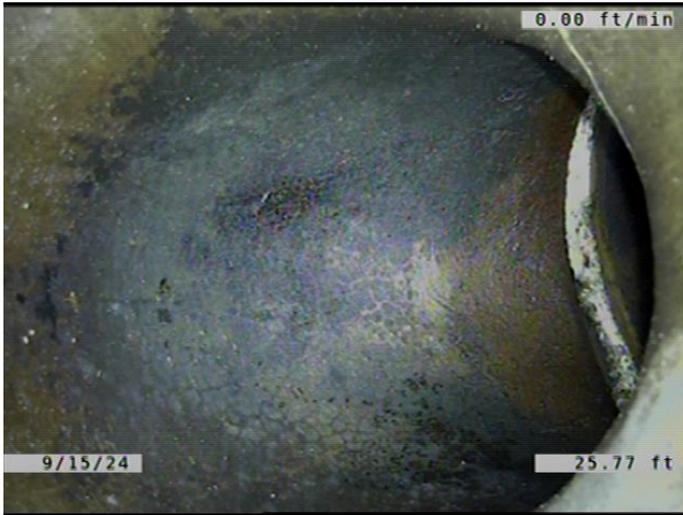
Code: **TB**  
 Description: **Tap Break-in/Hammer**

Distance (ft): **25.8**  
 Structural Grade: **0**  
 O&M Grade: **0**  
 Clock Start/From: **1**  
 Clock To:  
 1st Value: **6.000**  
 2nd Value:  
 Value Percent:  
 Continuous Index:  
 Within 8" of Joint: **YES**  
 Remarks:

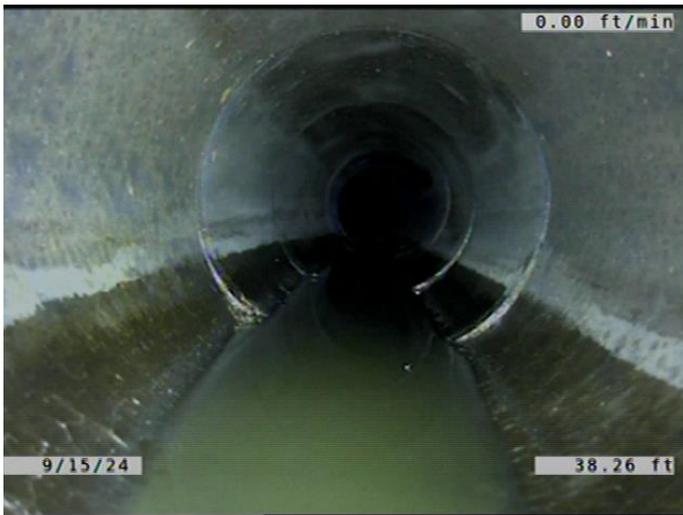
Code: **MWLS**  
 Description: **Miscellaneous Water Level Sag**

Distance (ft): **38.3**  
 Structural Grade: **2**  
 O&M Grade: **0**  
 Clock Start/From:  
 Clock To:  
 1st Value:  
 2nd Value:  
 Value Percent: **10.000**  
 Continuous Index: **S01**  
 Within 8" of Joint: **NO**  
 Remarks:

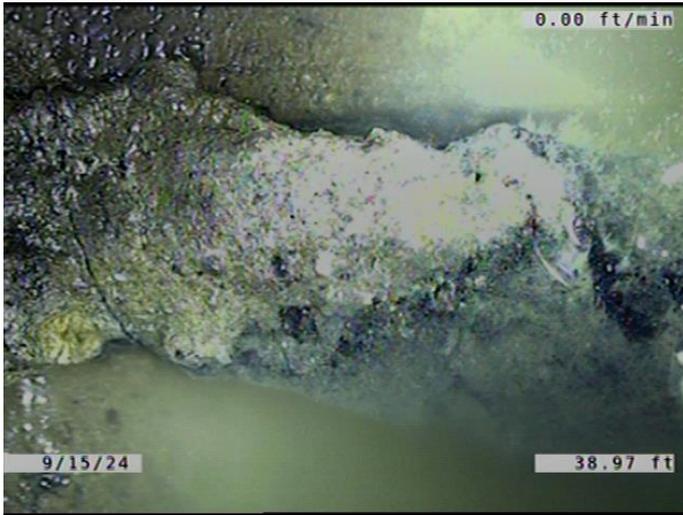
Code: **ISGT**  
 Description: **Intruding Sealing Material Grout**

Distance (ft): **39.0**  
 Structural Grade: **0**  
 O&M Grade: **2**  
 Clock Start/From: **4**  
 Clock To: **8**  
 1st Value:  
 2nd Value:  
 Value Percent: **5.000**  
 Continuous Index:  
 Within 8" of Joint: **NO**  
 Remarks:

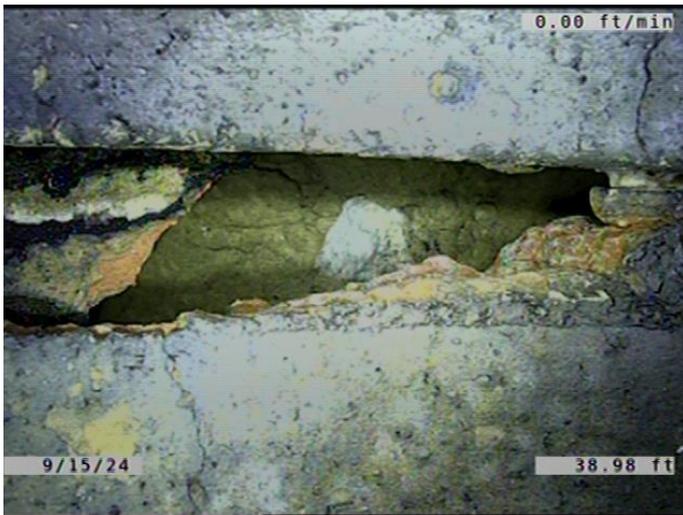
Code: **SMW**  
 Description: **Surface Damage Missing Wall**

Distance (ft): **39.0**  
 Structural Grade: **5**  
 O&M Grade: **0**  
 Clock Start/From: **1**  
 Clock To: **2**  
 1st Value:  
 2nd Value:  
 Value Percent:  
 Continuous Index:  
 Within 8" of Joint: **YES**  
 Remarks:

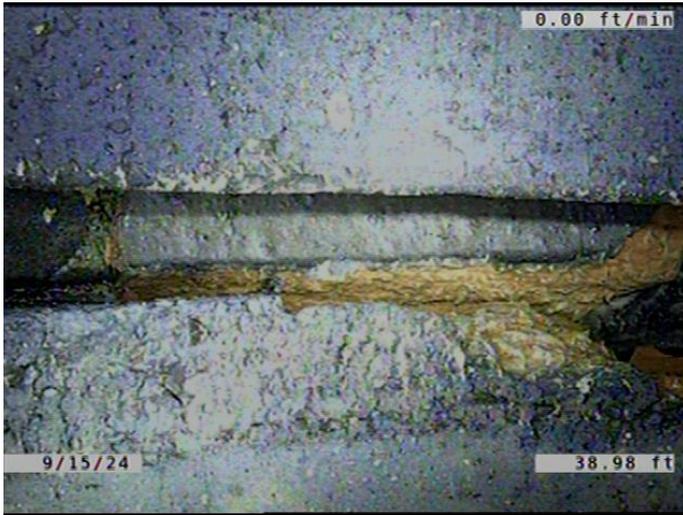
Code: **BVV**  
Description: **Broken Void Visible**

Distance (ft): **39.0**  
Structural Grade: **5**  
O&M Grade: **0**  
Clock Start/From: **9**  
Clock To: **2**  
1st Value:  
2nd Value:  
Value Percent:  
Continuous Index:  
Within 8" of Joint: **YES**  
Remarks: **SOIL VISIBLE ALSO.**

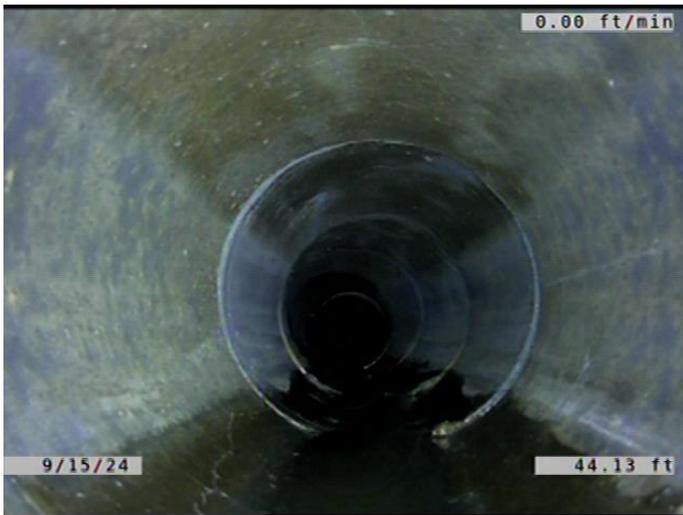
Code: **MWLS**  
Description: **Miscellaneous Water Level Sag**

Distance (ft): **44.1**  
Structural Grade: **2**  
O&M Grade: **0**  
Clock Start/From:  
Clock To:  
1st Value:  
2nd Value:  
Value Percent: **10.000**  
Continuous Index: **F01**  
Within 8" of Joint: **NO**  
Remarks:

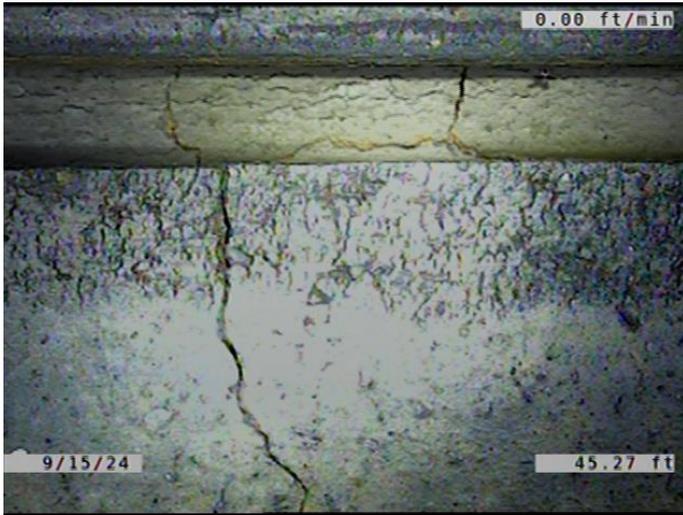
Code: **FM**  
 Description: **Fracture Multiple**

Distance (ft): **45.3**  
 Structural Grade: **4**  
 O&M Grade: **0**  
 Clock Start/From: **7**  
 Clock To: **5**  
 1st Value:  
 2nd Value:  
 Value Percent:  
 Continuous Index: **S02**  
 Within 8" of Joint: **YES**  
 Remarks:

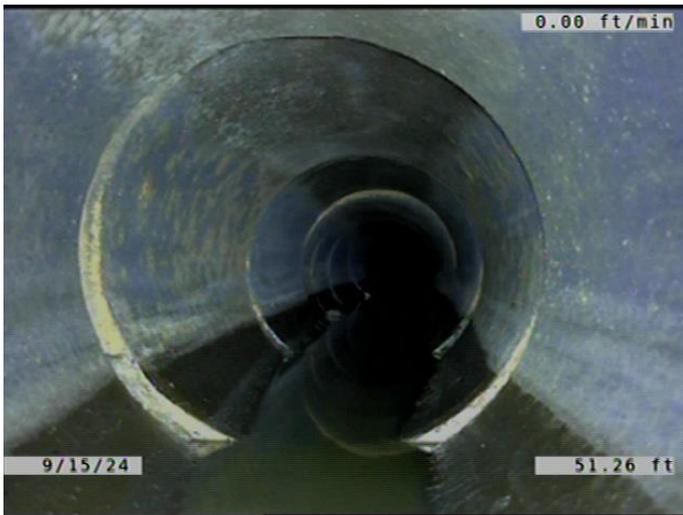
Code: **MWLS**  
 Description: **Miscellaneous Water Level Sag**

Distance (ft): **51.3**  
 Structural Grade: **2**  
 O&M Grade: **0**  
 Clock Start/From:  
 Clock To:  
 1st Value:  
 2nd Value:  
 Value Percent: **10.000**  
 Continuous Index: **S03**  
 Within 8" of Joint: **NO**  
 Remarks:

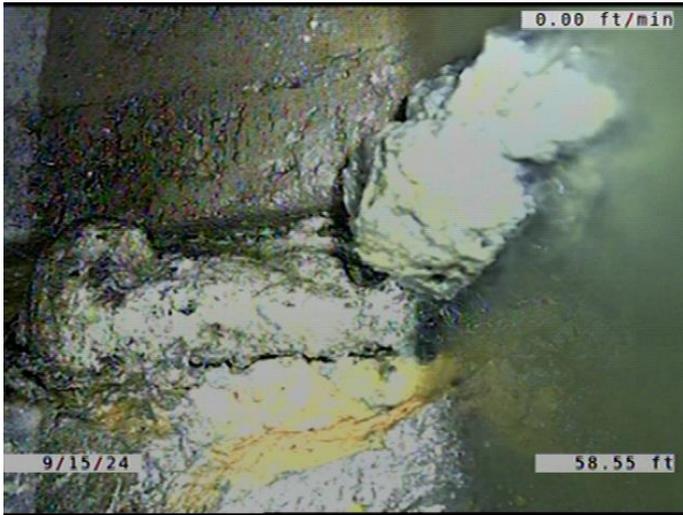
Code: **ISGT**  
Description: **Intruding Sealing Material Grout**

Distance (ft): **58.6**  
Structural Grade: **0**  
O&M Grade: **2**  
Clock Start/From: **4**  
Clock To: **8**  
1st Value:  
2nd Value:  
Value Percent: **5.000**  
Continuous Index: **S04**  
Within 8" of Joint: **NO**  
Remarks:

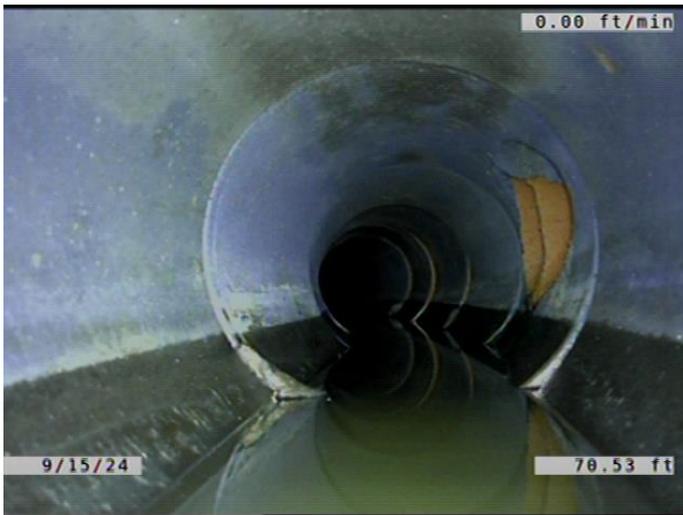
Code: **LR**  
Description: **Line Right**

Distance (ft): **70.5**  
Structural Grade: **0**  
O&M Grade: **1**  
Clock Start/From:  
Clock To:  
1st Value:  
2nd Value:  
Value Percent: **5.000**  
Continuous Index:  
Within 8" of Joint: **NO**  
Remarks:

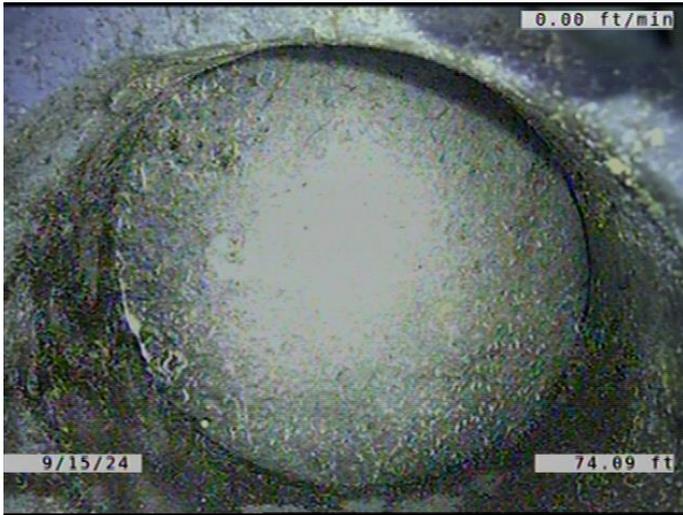
Code: **TFD**  
 Description: **Tap Factory Defective**

Distance (ft): **74.1**  
 Structural Grade: **0**  
 O&M Grade: **3**  
 Clock Start/From: **2**  
 Clock To:  
 1st Value: **6.000**  
 2nd Value:  
 Value Percent:  
 Continuous Index:  
 Within 8" of Joint: **YES**  
 Remarks: **CAPPED. TAP BROKEN.**

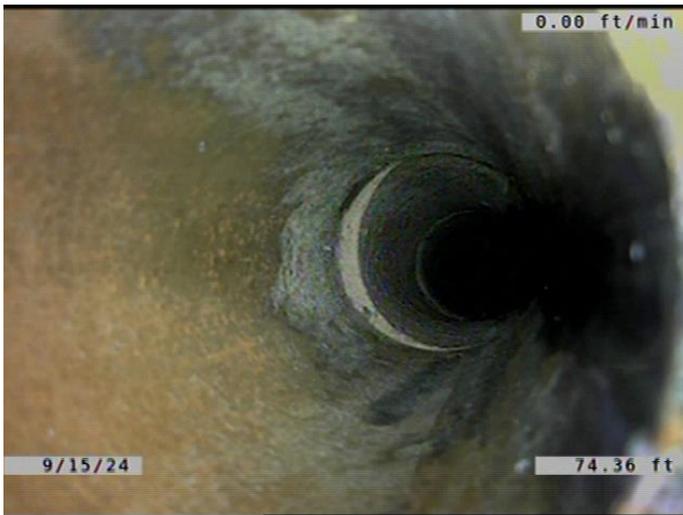
Code: **TBD**  
 Description: **Tap Break-in/Hammer Defective**

Distance (ft): **74.4**  
 Structural Grade: **0**  
 O&M Grade: **3**  
 Clock Start/From: **3**  
 Clock To:  
 1st Value: **6.000**  
 2nd Value:  
 Value Percent:  
 Continuous Index:  
 Within 8" of Joint: **YES**  
 Remarks: **CONSTANTLY RUNNING WATER.**

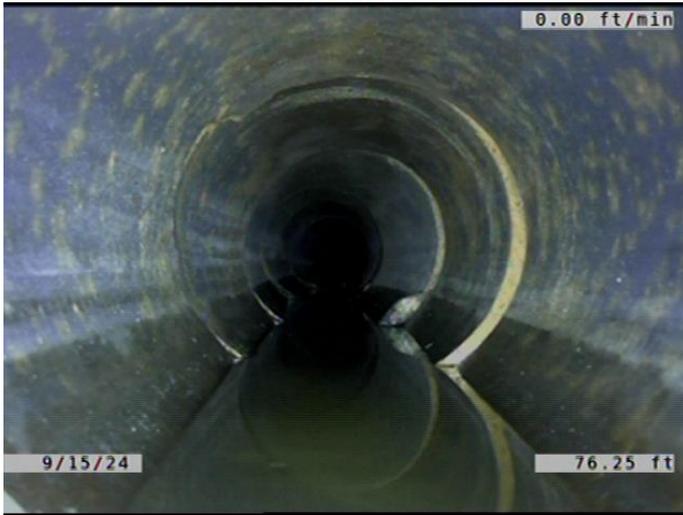
Code: **LL**  
Description: **Line Left**

Distance (ft): **76.2**  
Structural Grade: **0**  
O&M Grade: **1**  
Clock Start/From:  
Clock To:  
1st Value:  
2nd Value:  
Value Percent: **5.000**  
Continuous Index:  
Within 8" of Joint: **NO**  
Remarks:

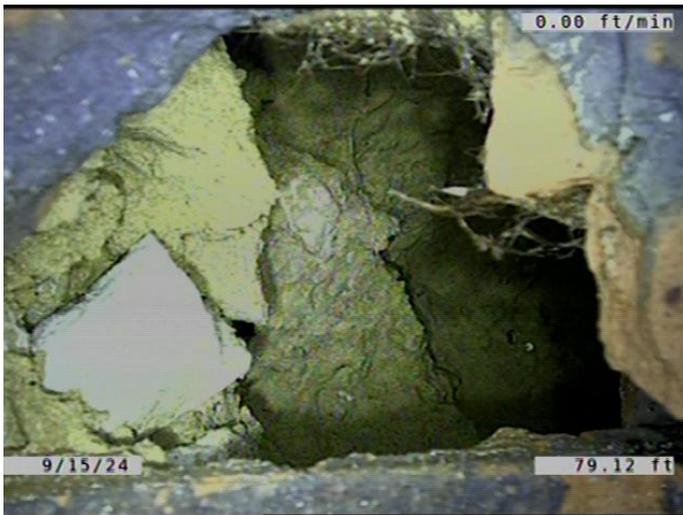
Code: **HVV**  
Description: **Hole Void Visible**

Distance (ft): **79.1**  
Structural Grade: **5**  
O&M Grade: **0**  
Clock Start/From: **8**  
Clock To: **11**  
1st Value:  
2nd Value:  
Value Percent:  
Continuous Index:  
Within 8" of Joint: **YES**  
Remarks:

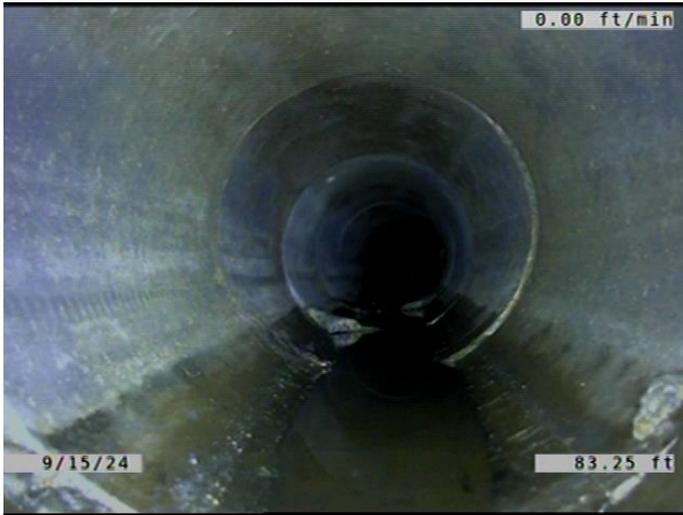
Code: **MWLS**  
Description: **Miscellaneous Water Level Sag**

Distance (ft): **83.2**  
Structural Grade: **2**  
O&M Grade: **0**  
Clock Start/From:  
Clock To:  
1st Value:  
2nd Value:  
Value Percent: **10.000**  
Continuous Index: **F03**  
Within 8" of Joint: **NO**  
Remarks:

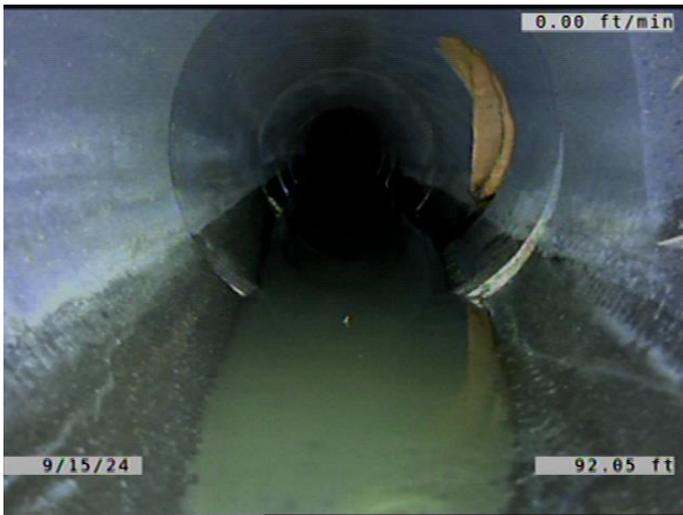
Code: **MWLS**  
Description: **Miscellaneous Water Level Sag**

Distance (ft): **92.0**  
Structural Grade: **2**  
O&M Grade: **0**  
Clock Start/From:  
Clock To:  
1st Value:  
2nd Value:  
Value Percent: **15.000**  
Continuous Index: **S05**  
Within 8" of Joint: **NO**  
Remarks:

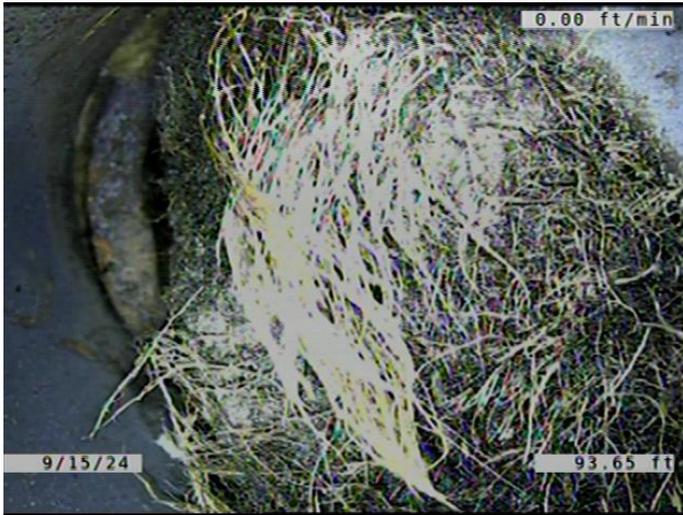
Code: **TFD**  
 Description: **Tap Factory Defective**

Distance (ft): **93.6**  
 Structural Grade: **0**  
 O&M Grade: **3**  
 Clock Start/From: **2**  
 Clock To:  
 1st Value: **6.000**  
 2nd Value:  
 Value Percent:  
 Continuous Index:  
 Within 8" of Joint: **YES**  
 Remarks: **SERVICE OFFSET. SOIL VISIBLE. LOOKS TO BE 95% PLUGGED WITH R**

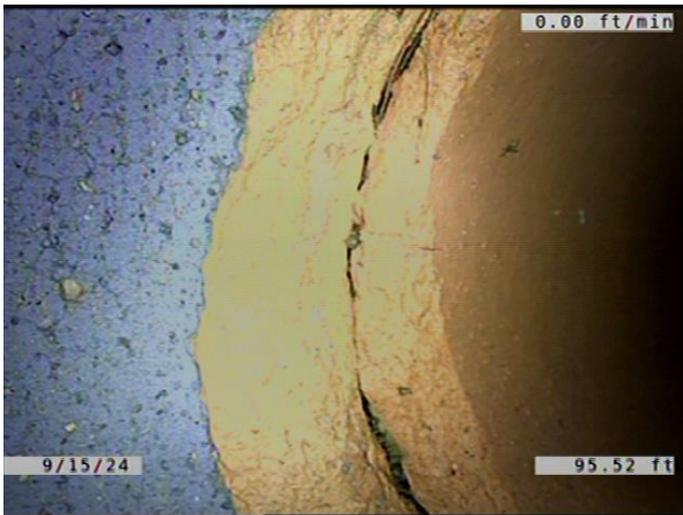
Code: **SSS**  
 Description: **Surface Damage Surface Spalling**

Distance (ft): **95.5**  
 Structural Grade: **2**  
 O&M Grade: **0**  
 Clock Start/From: **1**  
 Clock To: **4**  
 1st Value:  
 2nd Value:  
 Value Percent:  
 Continuous Index:  
 Within 8" of Joint: **YES**  
 Remarks:

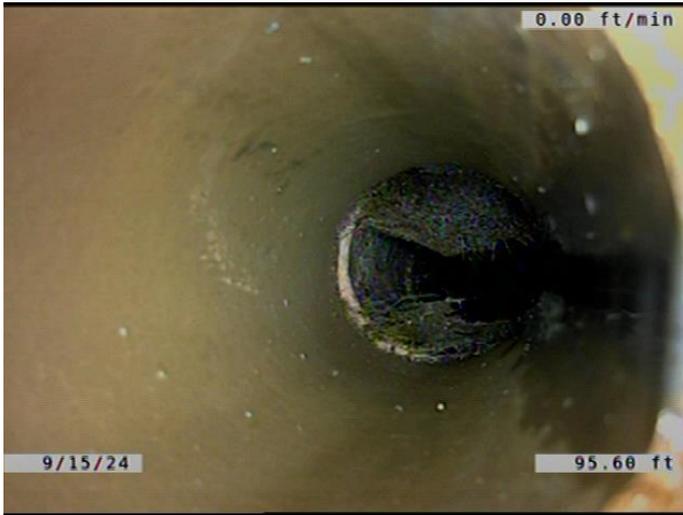
Code: **TBD**  
Description: **Tap Break-in/Hammer Defective**

Distance (ft): **95.6**  
Structural Grade: **0**  
O&M Grade: **3**  
Clock Start/From: **3**  
Clock To:  
1st Value: **6.000**  
2nd Value:  
Value Percent:  
Continuous Index:  
Within 8" of Joint: **YES**  
Remarks: **SERVICE CRACKED. LOOKS TO BE 95 % PLUGGED WITH ROOTS. CONSTAN**

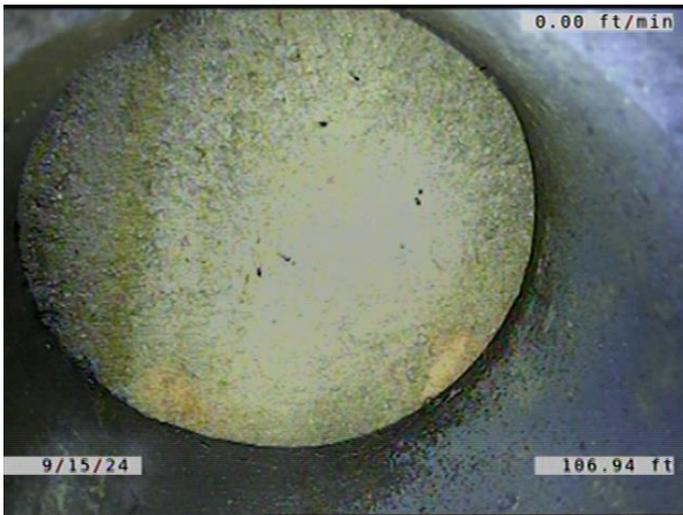
Code: **TFD**  
Description: **Tap Factory Defective**

Distance (ft): **106.9**  
Structural Grade: **0**  
O&M Grade: **3**  
Clock Start/From: **9**  
Clock To:  
1st Value: **6.000**  
2nd Value:  
Value Percent:  
Continuous Index:  
Within 8" of Joint: **YES**  
Remarks: **CAPPED. TAP CRACKED.**

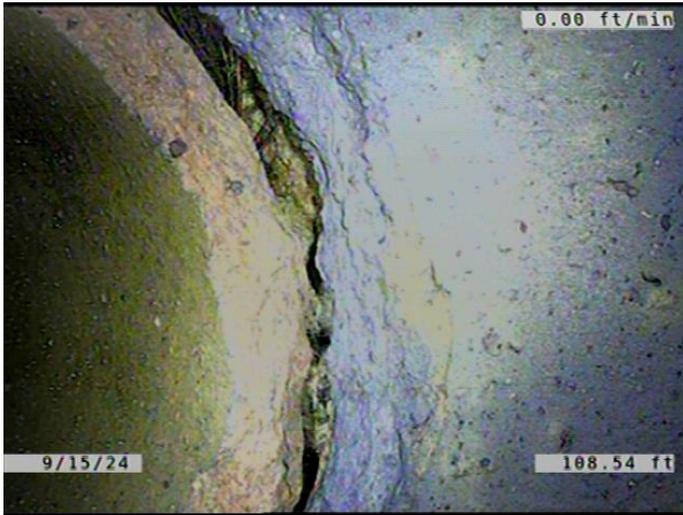
Code: **SSS**  
Description: **Surface Damage Surface Spalling**

Distance (ft): **108.5**  
Structural Grade: **2**  
O&M Grade: **0**  
Clock Start/From: **8**  
Clock To: **11**  
1st Value:  
2nd Value:  
Value Percent:  
Continuous Index:  
Within 8" of Joint: **YES**  
Remarks:

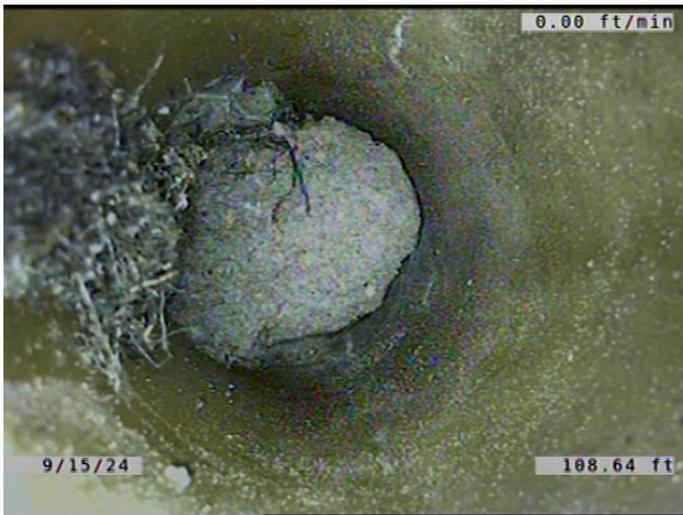
Code: **TBD**  
Description: **Tap Break-in/Hammer Defective**

Distance (ft): **108.6**  
Structural Grade: **0**  
O&M Grade: **3**  
Clock Start/From: **9**  
Clock To:  
1st Value: **6.000**  
2nd Value:  
Value Percent:  
Continuous Index:  
Within 8" of Joint: **YES**  
Remarks: **LOOKS TO BE 100% PLUGGED WITH DIRT.**

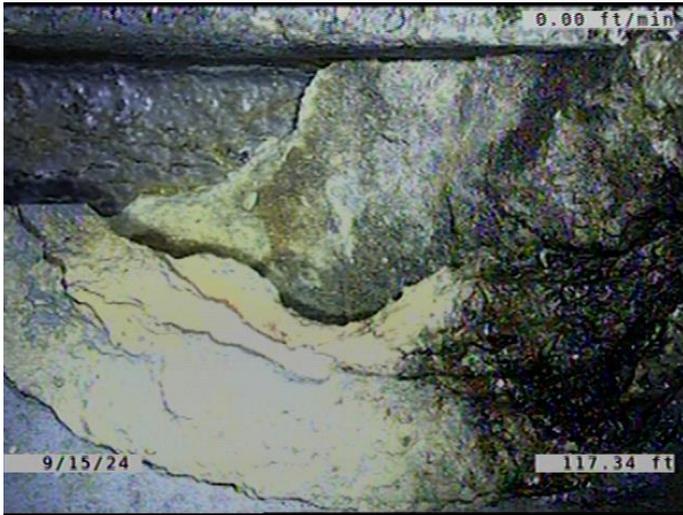
Code: **SMW**  
Description: **Surface Damage Missing Wall**

Distance (ft): **117.3**  
Structural Grade: **5**  
O&M Grade: **0**  
Clock Start/From: **7**  
Clock To: **9**  
1st Value:  
2nd Value:  
Value Percent:  
Continuous Index:  
Within 8" of Joint: **YES**  
Remarks: **THE INSIDE OF THE JOINT.**

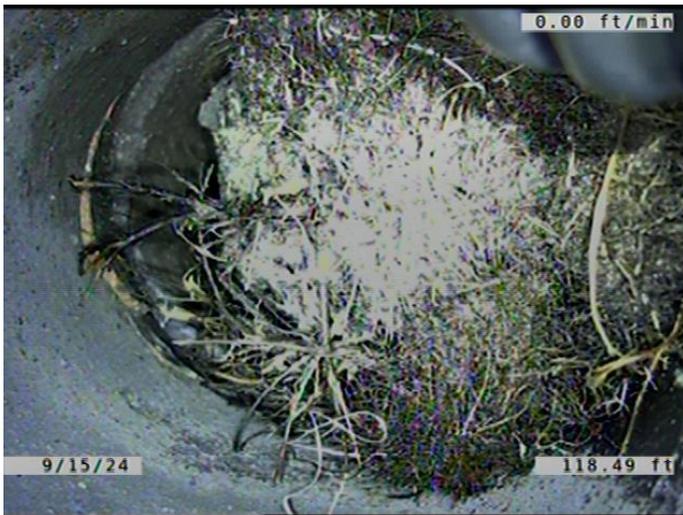
Code: **TFD**  
Description: **Tap Factory Defective**

Distance (ft): **118.5**  
Structural Grade: **0**  
O&M Grade: **3**  
Clock Start/From: **2**  
Clock To:  
1st Value: **6.000**  
2nd Value:  
Value Percent:  
Continuous Index:  
Within 8" of Joint: **YES**  
Remarks: **TAP BROKEN. SERVICE LOOKS TO BE 95% PLUGGED WITH ROOTS.**

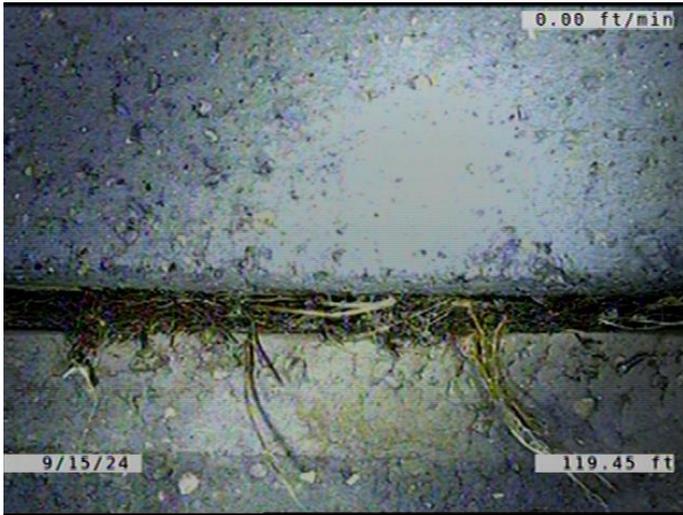
Code: **RFJ**  
Description: **Roots Fine Joint**

Distance (ft): **119.4**  
Structural Grade: **0**  
O&M Grade: **1**  
Clock Start/From: **8**  
Clock To: **4**  
1st Value:  
2nd Value:  
Value Percent:  
Continuous Index:  
Within 8" of Joint: **YES**  
Remarks:

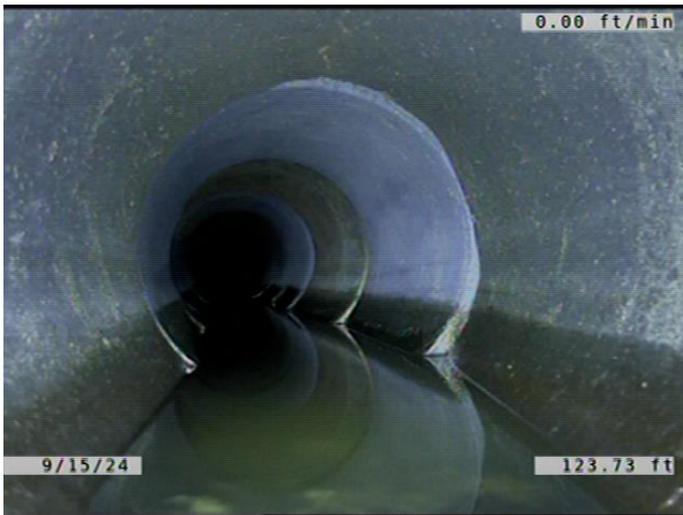
Code: **LL**  
Description: **Line Left**

Distance (ft): **123.7**  
Structural Grade: **0**  
O&M Grade: **2**  
Clock Start/From:  
Clock To:  
1st Value:  
2nd Value:  
Value Percent: **15.000**  
Continuous Index:  
Within 8" of Joint: **NO**  
Remarks:

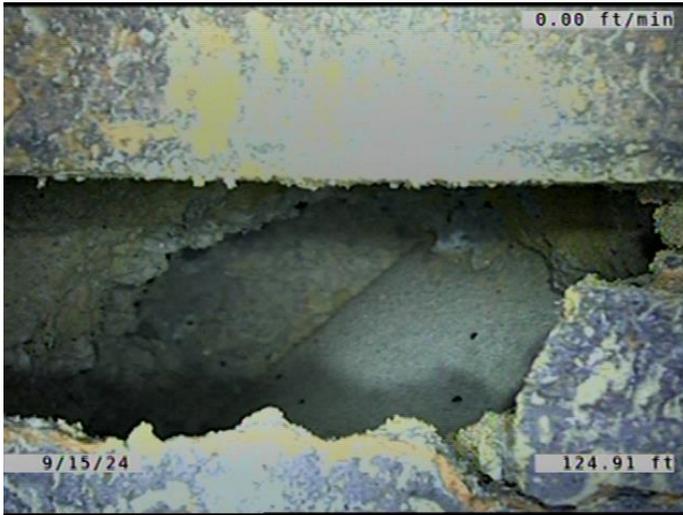
Code: **SMW**  
 Description: **Surface Damage Missing Wall**

Distance (ft): **124.9**  
 Structural Grade: **5**  
 O&M Grade: **0**  
 Clock Start/From: **11**  
 Clock To: **1**  
 1st Value:  
 2nd Value:  
 Value Percent:  
 Continuous Index:  
 Within 8" of Joint: **YES**  
 Remarks: **LARGE VOID AND SOIL VISIBLE. CAN SEE THE NEW STORM PIPE LAID BY G**

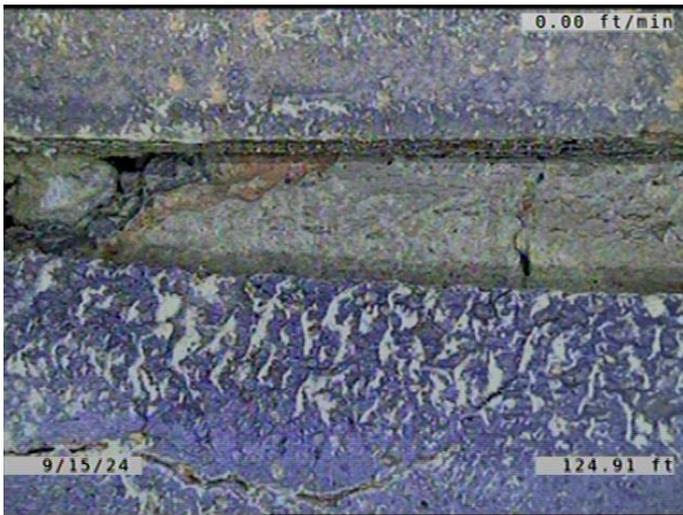
Code: **BVV**  
 Description: **Broken Void Visible**

Distance (ft): **124.9**  
 Structural Grade: **5**  
 O&M Grade: **0**  
 Clock Start/From: **8**  
 Clock To: **4**  
 1st Value:  
 2nd Value:  
 Value Percent:  
 Continuous Index:  
 Within 8" of Joint: **YES**  
 Remarks: **SOIL VISIBLE ALSO.**

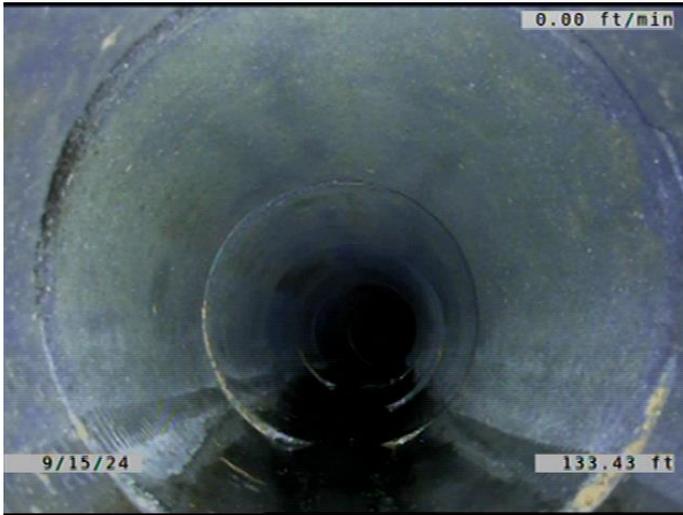
Code: **MWLS**  
Description: **Miscellaneous Water Level Sag**

Distance (ft): **133.4**  
Structural Grade: **2**  
O&M Grade: **0**  
Clock Start/From:  
Clock To:  
1st Value:  
2nd Value:  
Value Percent: **15.000**  
Continuous Index: **F05**  
Within 8" of Joint: **NO**  
Remarks:

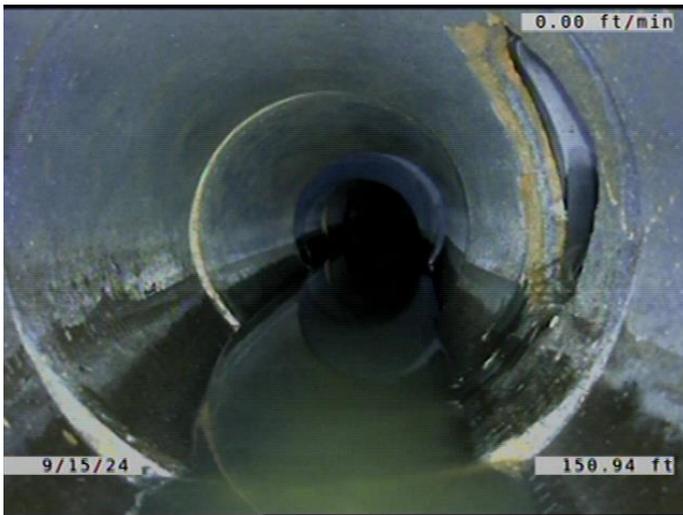
Code: **MWLS**  
Description: **Miscellaneous Water Level Sag**

Distance (ft): **150.9**  
Structural Grade: **4**  
O&M Grade: **0**  
Clock Start/From:  
Clock To:  
1st Value:  
2nd Value:  
Value Percent: **55.000**  
Continuous Index: **S06**  
Within 8" of Joint: **NO**  
Remarks:

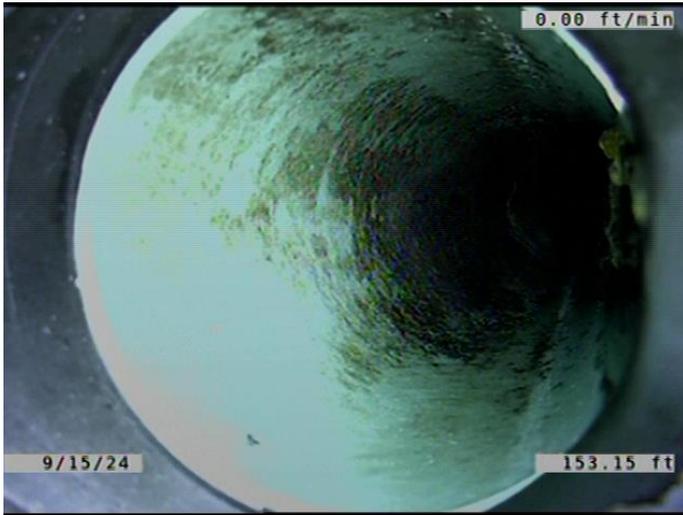
Code: **TS**  
Description: **Tap Saddle**

Distance (ft): **153.2**  
Structural Grade: **0**  
O&M Grade: **0**  
Clock Start/From: **3**  
Clock To:  
1st Value: **6.000**  
2nd Value:  
Value Percent:  
Continuous Index:  
Within 8" of Joint: **YES**  
Remarks: **PVC SERVICE.**

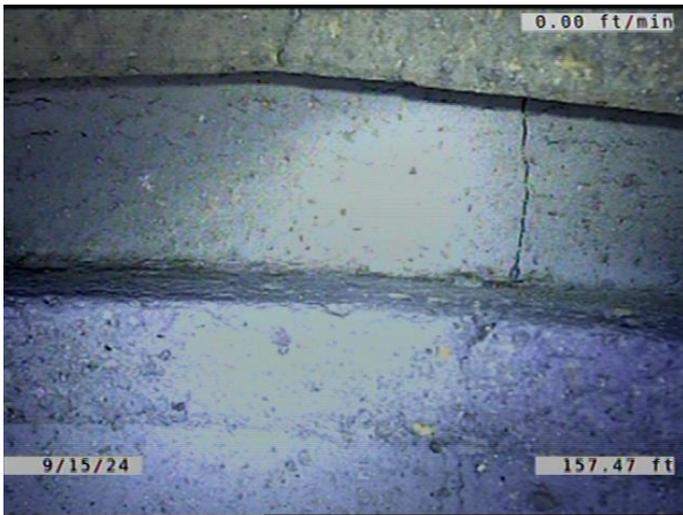
Code: **JAL**  
Description: **Joint Angular Large**

Distance (ft): **157.5**  
Structural Grade: **4**  
O&M Grade: **0**  
Clock Start/From:  
Clock To:  
1st Value:  
2nd Value:  
Value Percent:  
Continuous Index:  
Within 8" of Joint: **NO**  
Remarks:

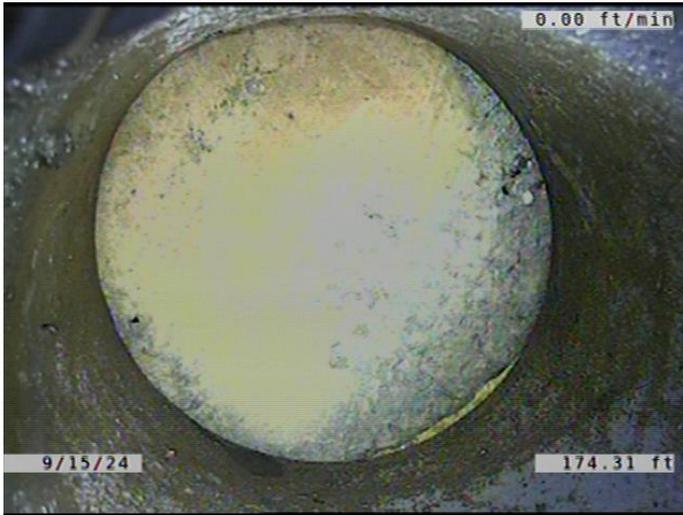
Code: **TFD**  
 Description: **Tap Factory Defective**

Distance (ft): **174.3**  
 Structural Grade: **0**  
 O&M Grade: **3**  
 Clock Start/From: **10**  
 Clock To:  
 1st Value: **6.000**  
 2nd Value:  
 Value Percent:  
 Continuous Index:  
 Within 8" of Joint: **YES**  
 Remarks: **CAPPED. SOIL VISIBLE. AROUND THE CAP.**
