## Profile/Photo Observation Report

Street:	<b>E Cleveland Ave.</b>	Flow Control:	<b>Not Controlled</b>
City:	<b>Hobart, IN</b>	Year Renewed:	
Location:	<b>Other</b>	Tape/Media #:	
Purpose:	<b>Not Known</b>	Dia/Height:	<b>8"</b>
Use:	<b>Sanitary</b>	Material:	<b>VCP</b>
Drain Area:	<b>NA</b>	Lining:	
Category:	<b>NA</b>		
Comment:

Location Details:		Direction of Survey:	<b>Upstream</b>
US MH:	<b>M-804-001</b>	DS MH:	<b>M-804-007</b>
		Total Length Surveyed (ft):	<b>1.3</b>

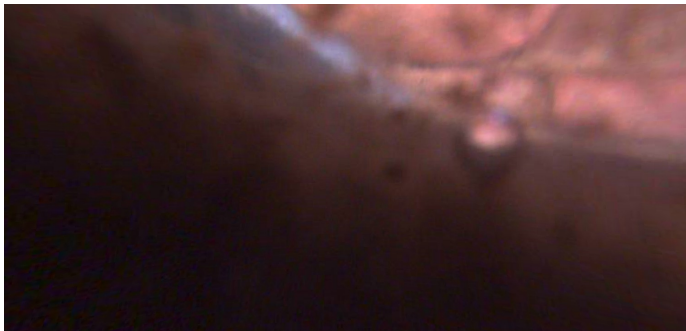
Code: **AMH**  
Description: **Manhole**

Distance (ft): **.0**  
Structural Grade: **0**  
O&M Grade: **0**  
Clock Start/From:  
Clock To:  
1st Value:  
2nd Value:  
Value Percent:  
Continuous Index:  
Within 8" of Joint: **NO**  
Remarks: **M-804-007**

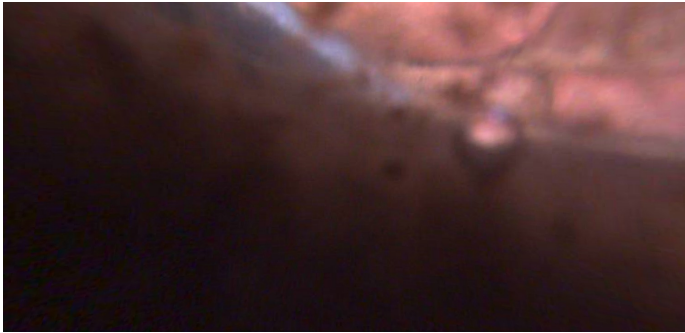
Code:	<b>MWL</b>
Description:	<b>Water Level</b>

Distance (ft):	<b>.0</b>
Structural Grade:	<b>0</b>
O&M Grade:	<b>0</b>
Clock Start/From:	
Clock To:	
1st Value:	
2nd Value:	
Value Percent:	<b>100.000</b>
Continuous Index:	
Within 8" of Joint:	<b>NO</b>
Remarks:
