Profile/Photo Observation Report

O&M Index:	1.75	O&M Quick:	4131	O&M Rating:	28.00
Structural Index:	3.42	Structural Quick:	534H	Structural Rating:	263.00
Overall Index:	3.13	Overall Quick:	534H	Overall Rating:	291.00

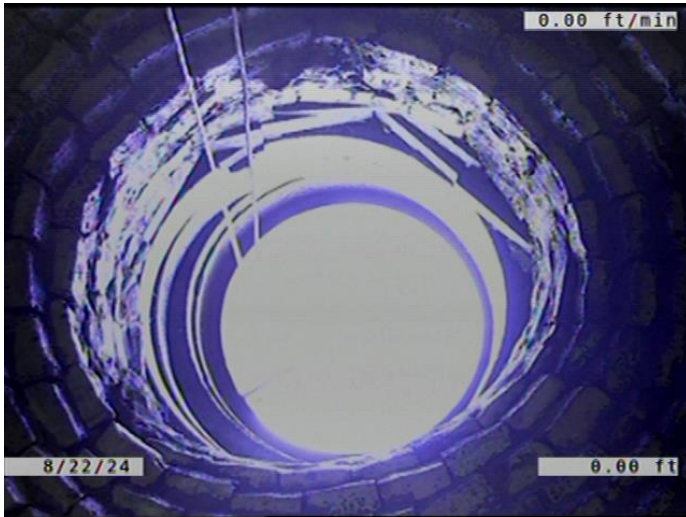
Code: **AMH**
Description: **Manhole**

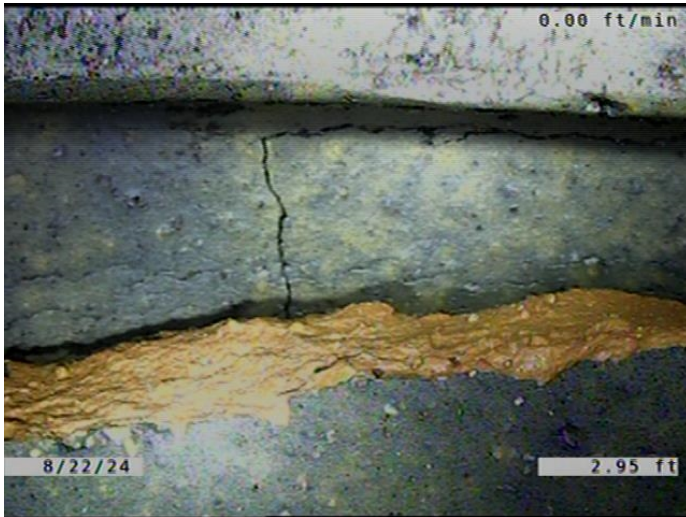
Code: **CM**
 Description: **Crack Multiple**

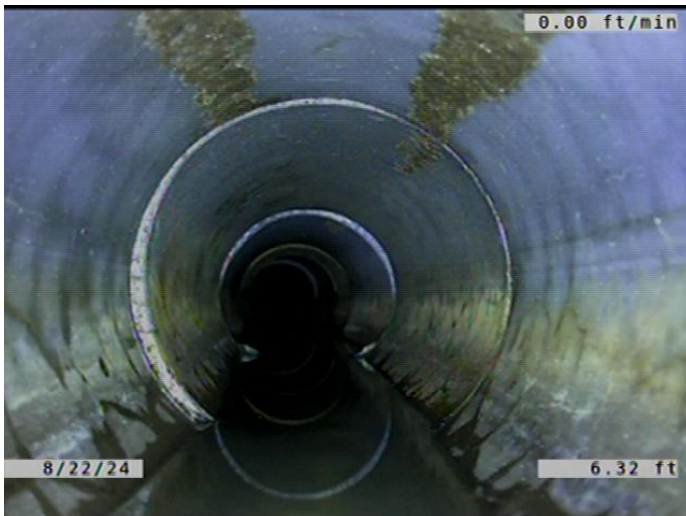
Code: **DAGS**
 Description: **Deposits Attached Grease**

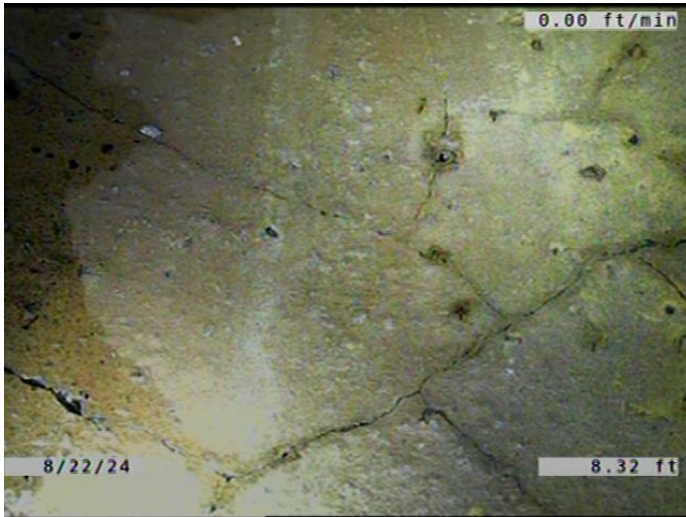
Code: **FM**
Description: **Fracture Multiple**

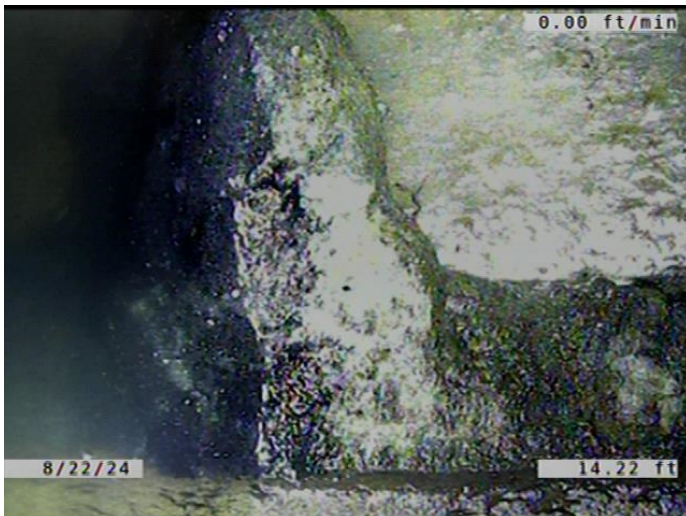
Code: **ISGT**
Description: **Intruding Sealing Material Grout**

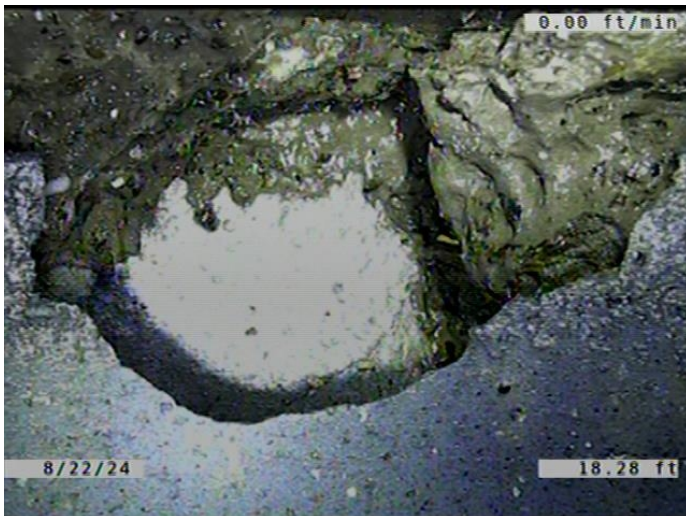
Code: **BSV**
Description: **Broken Soil Visible**

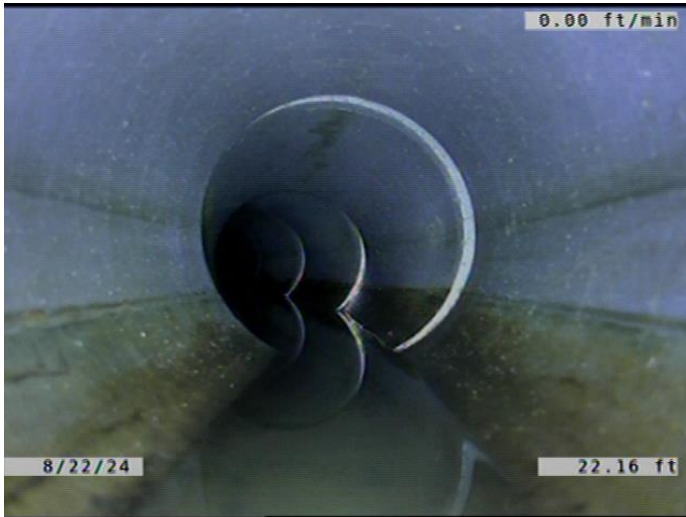
Code: **MWLS**
Description: **Miscellaneous Water Level Sag**

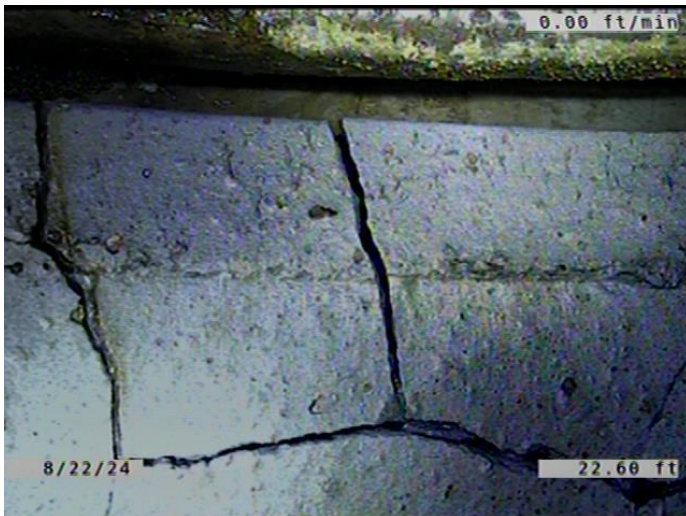
Code: **B**
Description: **Broken**

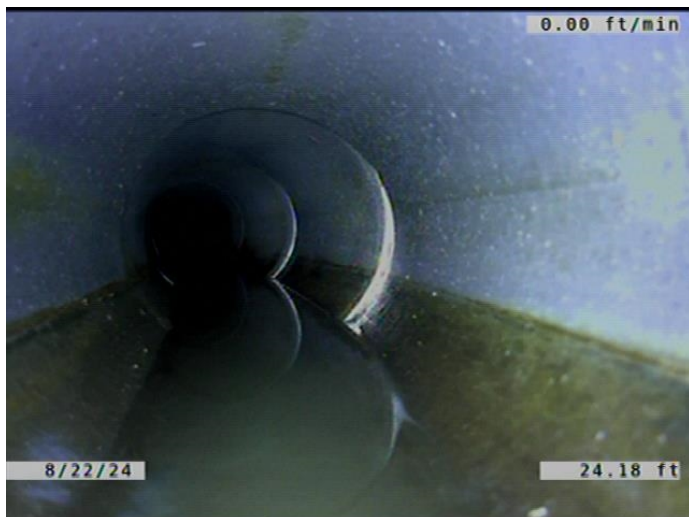
Code: **LL**
 Description: **Line Left**

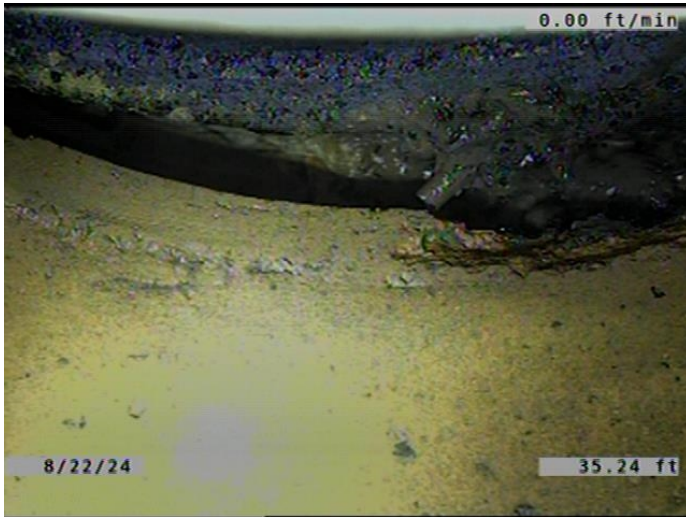
Code: **JOMD**
Description: **Joint Offset Medium Defective**

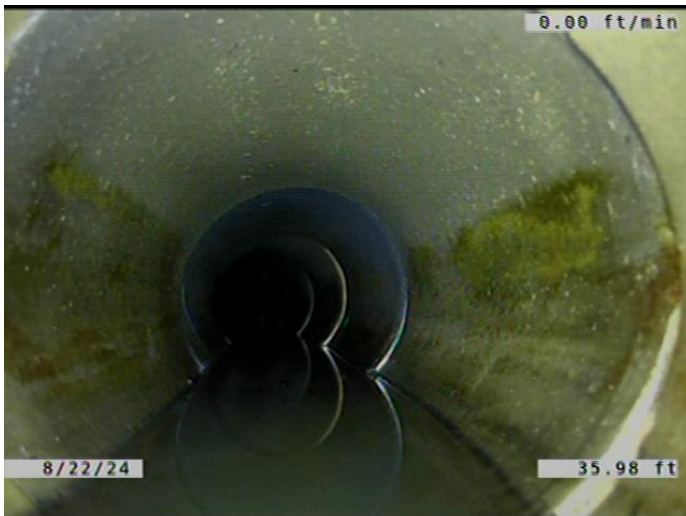
Code: **MWLS**
Description: **Miscellaneous Water Level Sag**

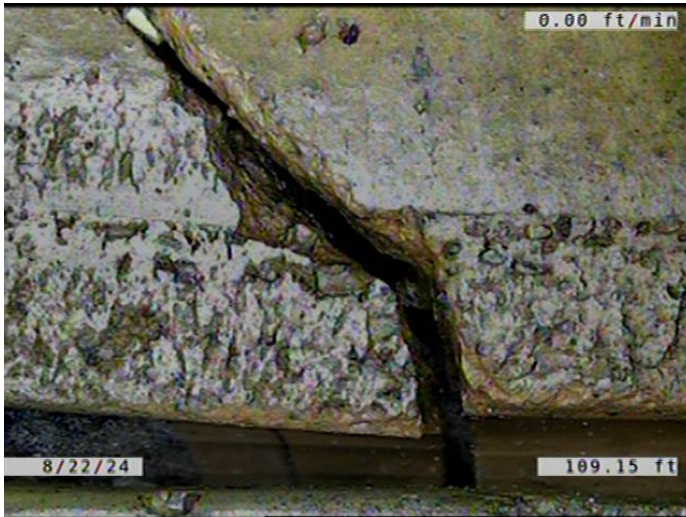
Code: **BSV**
Description: **Broken Soil Visible**

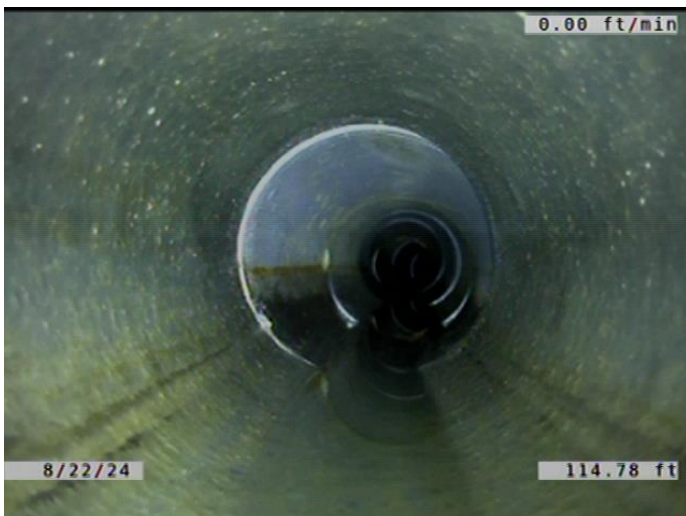
Code: **MWLS**
Description: **Miscellaneous Water Level Sag**

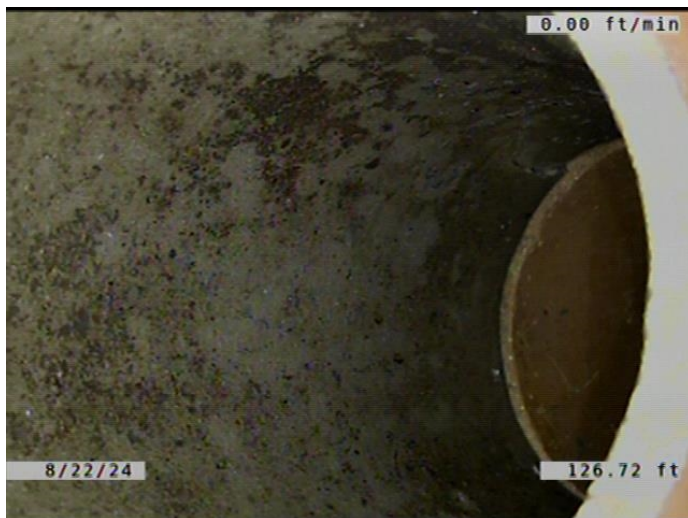
Code: **TBI**
Description: **Tap Break-in Intruding**

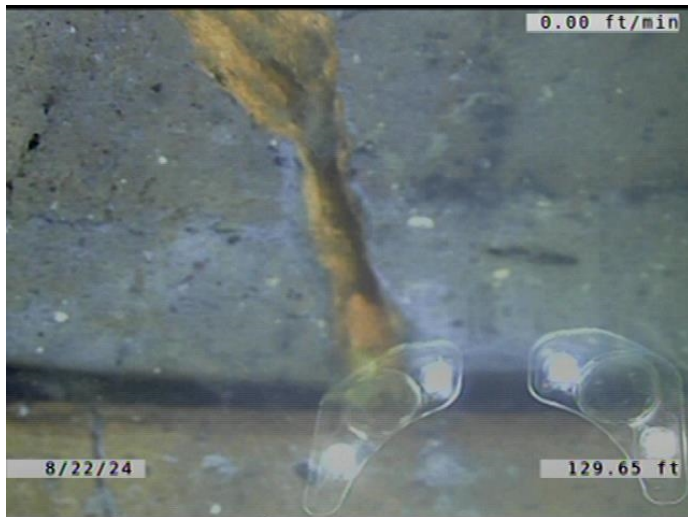
Code: **B**
 Description: **Broken**

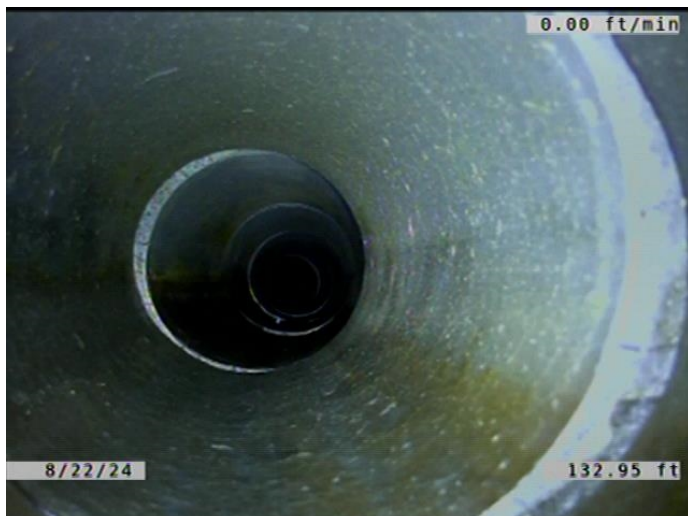
Code: **MWLS**
 Description: **Miscellaneous Water Level Sag**

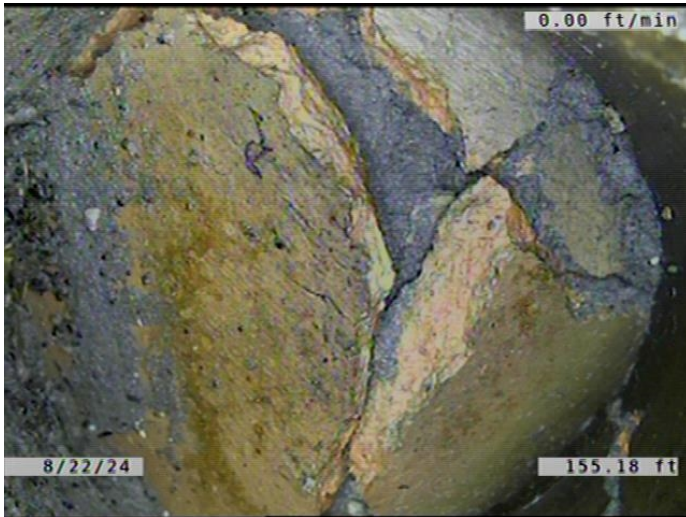
Code:	TFD
Description:	Tap Factory Defective
Distance (ft):	155.2
Structural Grade:	0
O&M Grade:	3
Clock Start/From:	3
Clock To:	
1st Value:	6.000
2nd Value:	
Value Percent:	
Continuous Index:	
Within 8" of Joint:	YES
Remarks:	CAPPED. CAP BROKEN STARTING TO FALL INTO THE MAIN. SOIL VISIBLE.

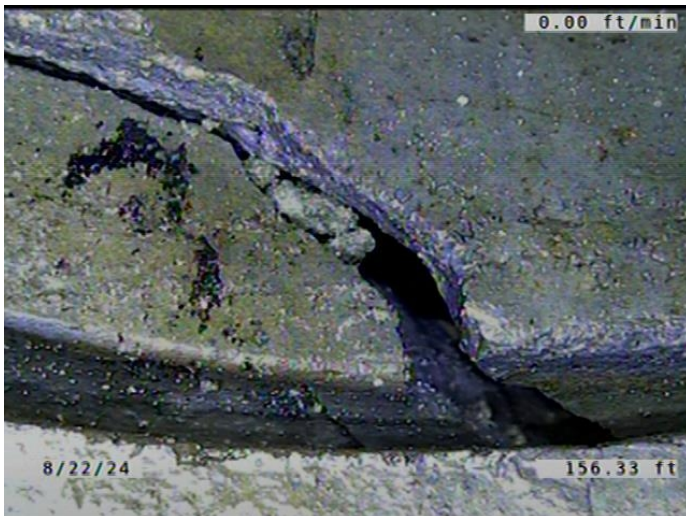
Code:	BVV
Description:	Broken Void Visible
Distance (ft):	156.3
Structural Grade:	5
O&M Grade:	0
Clock Start/From:	3
Clock To:	8
1st Value:	
2nd Value:	
Value Percent:	
Continuous Index:	
Within 8" of Joint:	YES
Remarks:

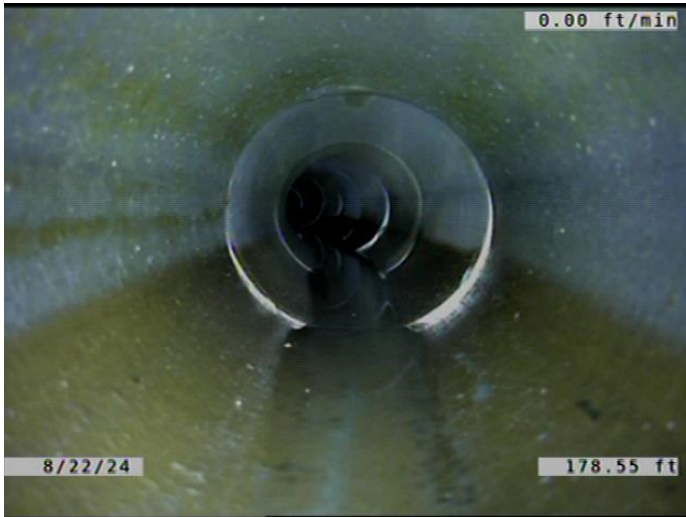
Code: **MWLS**
Description: **Miscellaneous Water Level Sag**

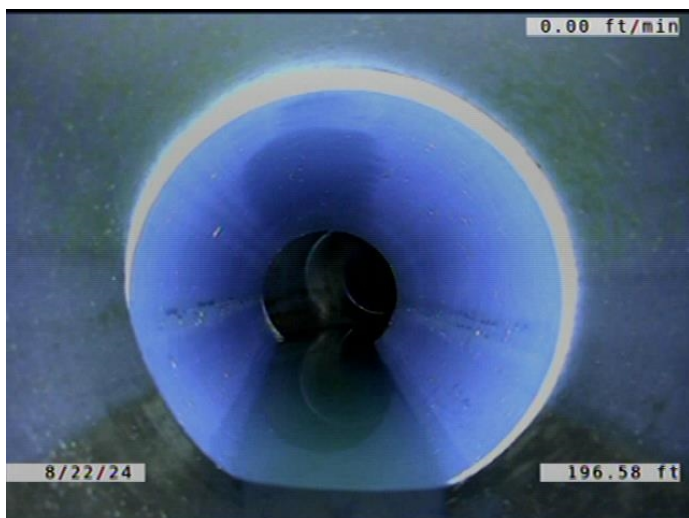
Code: **RPR**
Description: **Point Repair Replacement**

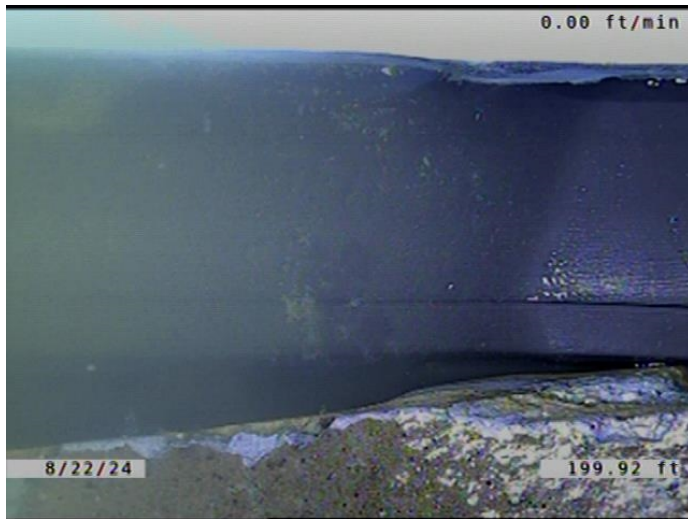
Code: **JAL**
Description: **Joint Angular Large**

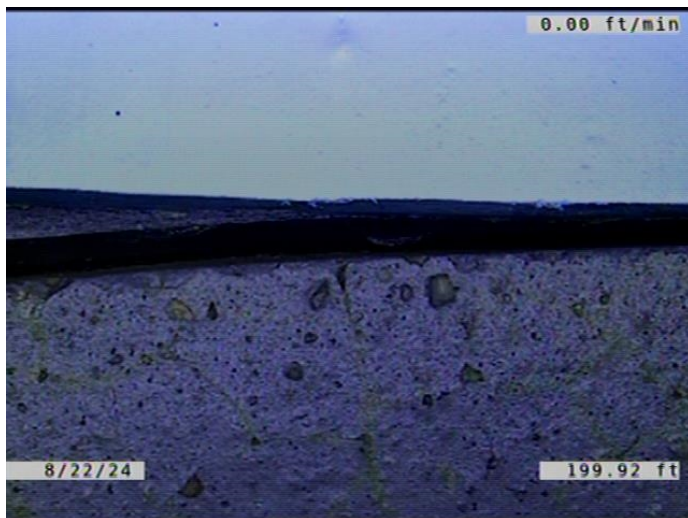
Code: **RPR**
Description: **Point Repair Replacement**

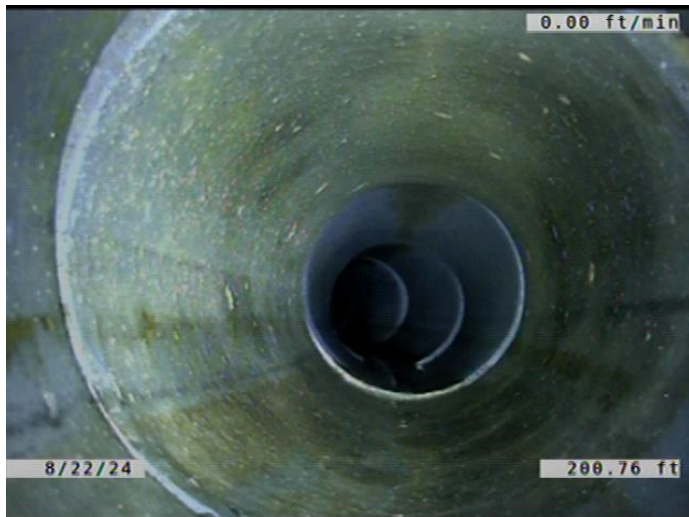
Code: **MWLS**
Description: **Miscellaneous Water Level Sag**

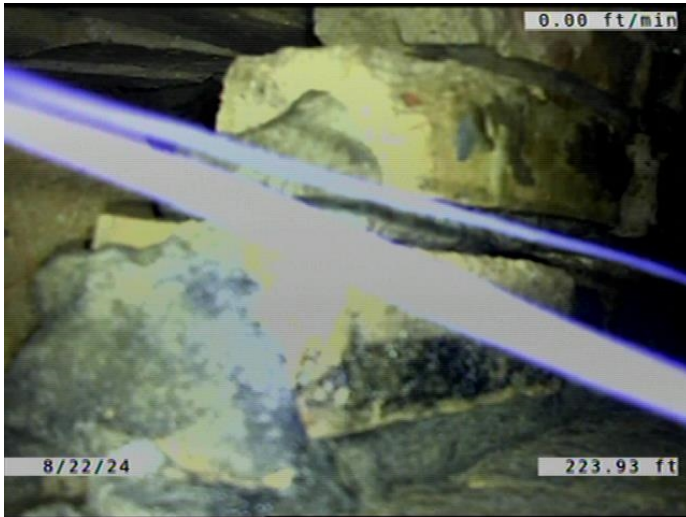
Code: **FM**
Description: **Fracture Multiple**

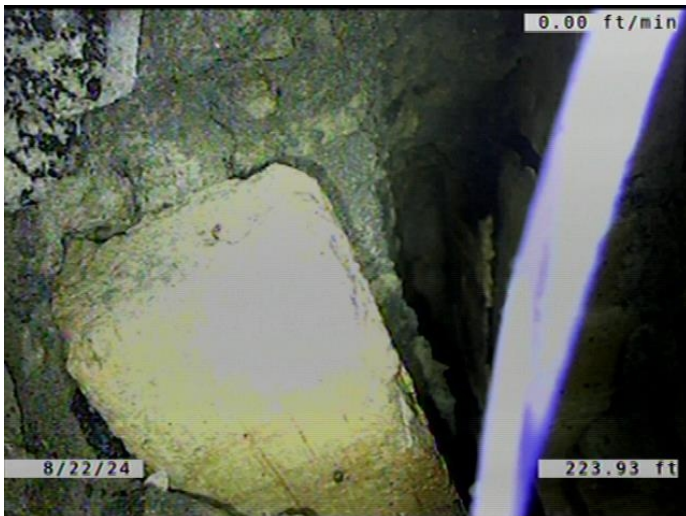
Code: **MGO**
Description: **Miscellaneous General Observation**

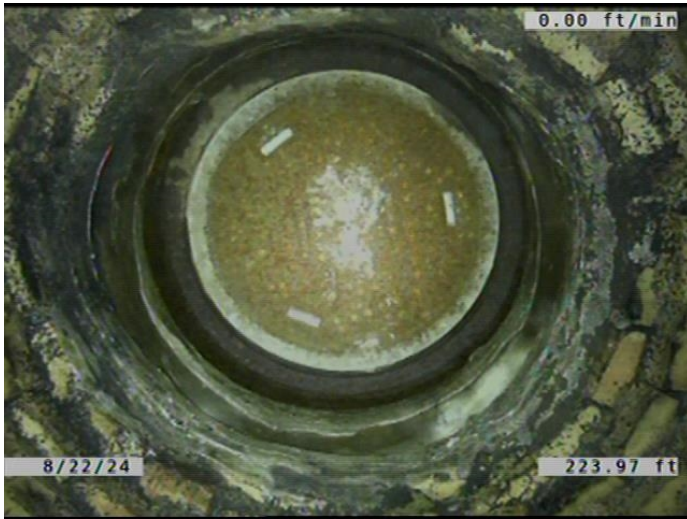
Code:	AMH
Description:	Manhole
Distance (ft):	224.0
Structural Grade:	0
O&M Grade:	0
Clock Start/From:	
Clock To:	
1st Value:	
2nd Value:	
Value Percent:	
Continuous Index:	
Within 8" of Joint:	NO
Remarks:	M-804-007
