Profile/Photo Observation Report

Street:	E CLEVELAND AVE	Flow Control:	Not Controlled
City:	Hobart, IN	Year Renewed:	
Location:	Other	Tape/Media #:	
Purpose:	Not Known	Dia/Height:	8"
Use:	Sanitary	Material:	VCP
Drain Area:	NA	Lining:	
Category:	NA		
Comment:

Location Details:		Direction of Survey:	Upstream
US MH:	M-804-002	DS MH:	M-804-003
		Total Length Surveyed (ft):	3.6

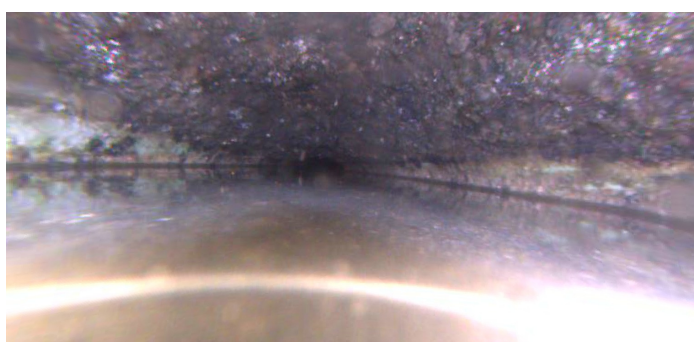
Code: **AMH**
Description: **Manhole**

Distance (ft): **.0**
Structural Grade: **0**
O&M Grade: **0**
Clock Start/From:
Clock To:
1st Value:
2nd Value:
Value Percent:
Continuous Index:
Within 8" of Joint: **NO**
Remarks: **M-804-003**

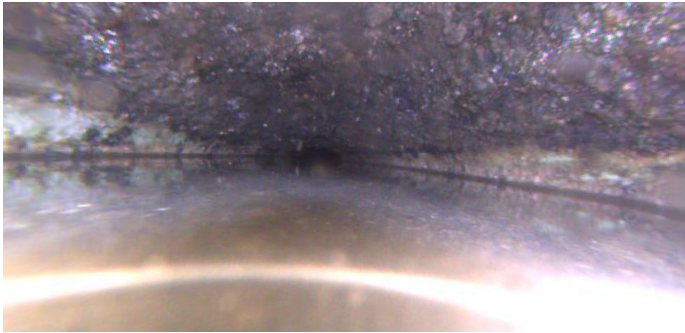
Code:	MWL
Description:	Water Level

Distance (ft):	.0
Structural Grade:	0
O&M Grade:	0
Clock Start/From:	
Clock To:	
1st Value:	
2nd Value:	
Value Percent:	40.000
Continuous Index:	
Within 8" of Joint:	NO
Remarks:

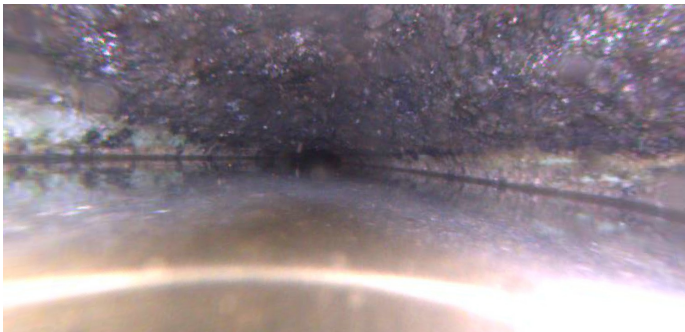
Code:	DAGS
Description:	Deposits Attached Grease

Distance (ft):	.0
Structural Grade:	0
O&M Grade:	2
Clock Start/From:	8
Clock To:	4
1st Value:	
2nd Value:	
Value Percent:	10.000
Continuous Index:	
Within 8" of Joint:	NO
Remarks:
