Profile/Photo Observation Report

Date:	04/22/2018	Weather:		Coding:	PACP 6.0
Pipe Length (ft):	115.6	Owner:	NA	Pre Clean:	Not Known
P.O.#:		Surveyor:	Jen Costello	PSR:	P-804-003-002
Customer:		Clean Date:	01/01/1900	Shape:	C

Street:	E Cleveland Ave.	Flow Control:	Not Controlled
City:	Hobart, IN	Year Renewed:	
Location:	Other	Tape/Media #:	
Purpose:	Not Known	Dia/Height:	8"
Use:	Sanitary	Material:	VCP
Drain Area:	NA	Lining:	
Category:	NA		
Comment:

Location Details:		Direction of Survey:	Upstream
US MH:	M-804-002	DS MH:	M-804-003
		Total Length Surveyed (ft):	3.6

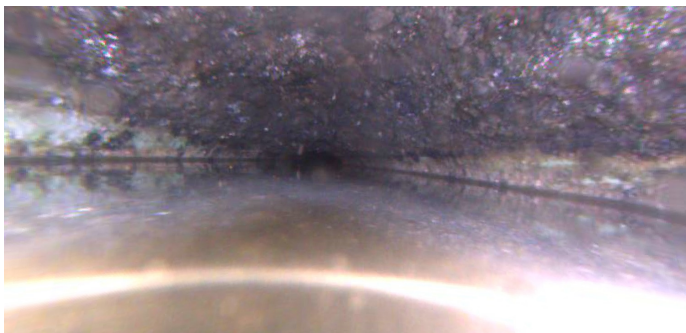
Code: **AMH**
Description: **Manhole**

Distance (ft): **.0**
Structural Grade: **0**
O&M Grade: **0**
Clock Start/From:
Clock To:
1st Value:
2nd Value:
Value Percent:
Continuous Index:
Within 8" of Joint: **NO**
Remarks: **M-804-003**

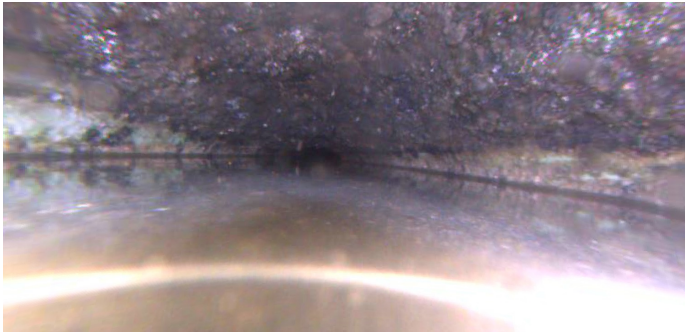
Code:	MWL
Description:	Water Level

Distance (ft):	.0
Structural Grade:	0
O&M Grade:	0
Clock Start/From:	
Clock To:	
1st Value:	
2nd Value:	
Value Percent:	40.000
Continuous Index:	
Within 8" of Joint:	NO
Remarks:

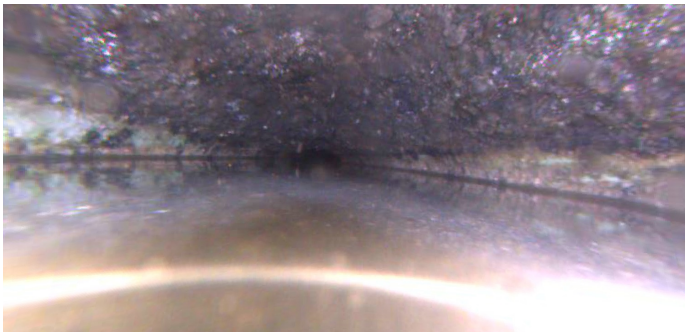
Code:	DAGS
Description:	Deposits Attached Grease

Distance (ft):	.0
Structural Grade:	0
O&M Grade:	2
Clock Start/From:	8
Clock To:	4
1st Value:	
2nd Value:	
Value Percent:	10.000
Continuous Index:	
Within 8" of Joint:	NO
Remarks:
