Profile/Photo Observation Report

Date:	09/11/2024	Weather:		Coding:	PACP 7.0
Pipe Length (ft):	116.0	Owner:	City of Hobart	Pre Clean:	Heavy Cleaning
P.O.#:	YES502259	Surveyor:	S. Bucklin	PSR:	P-804-003-002
Customer:	City of Hobart	Clean Date:	09/11/2024	Shape:	C

Location Details:		Direction of Survey:	Downstream
US MH:	M-804-002	DS MH:	M-804-003
		Total Length Surveyed (ft):	35.1

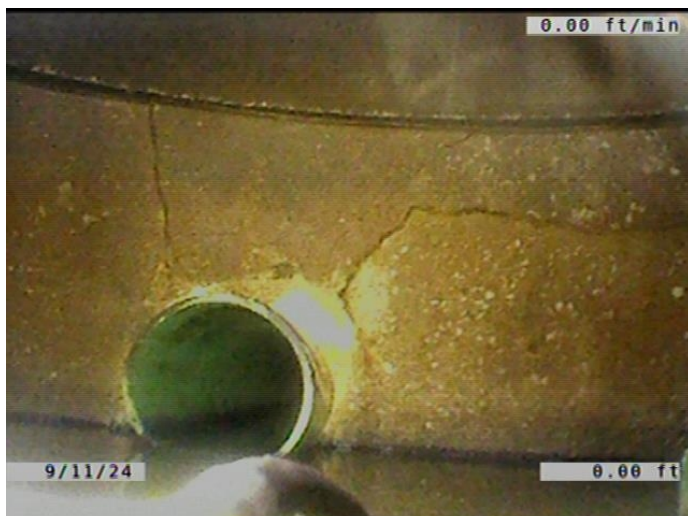
Code: **AMH**
 Description: **Manhole**

Distance (ft): **.0**
 Structural Grade: **0**
 O&M Grade: **0**
 Clock Start/From:
 Clock To:
 1st Value:
 2nd Value:
 Value Percent:
 Continuous Index:
 Within 8" of Joint: **NO**
 Remarks: **M-804-002**

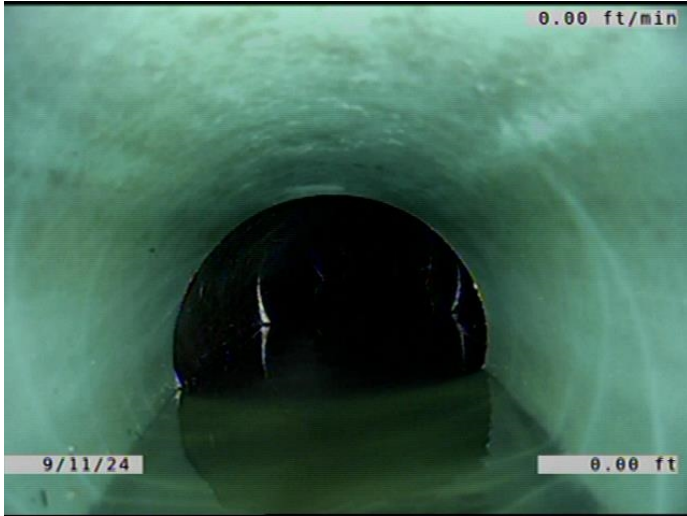
Code: **MWL**
Description: **Miscellaneous Water Level**

Distance (ft): **.0**
Structural Grade: **0**
O&M Grade: **0**
Clock Start/From:
Clock To:
1st Value:
2nd Value:
Value Percent: **5.000**
Continuous Index:
Within 8" of Joint: **NO**
Remarks:

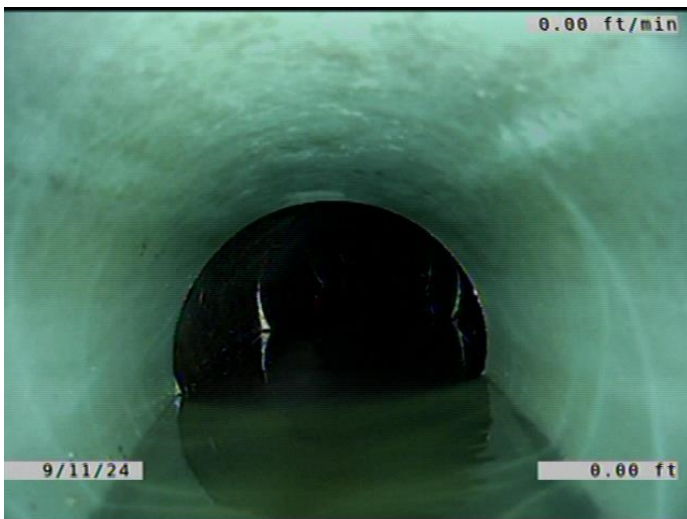
Code: **MWLS**
Description: **Miscellaneous Water Level Sag**

Distance (ft): **.0**
Structural Grade: **2**
O&M Grade: **0**
Clock Start/From:
Clock To:
1st Value:
2nd Value:
Value Percent: **25.000**
Continuous Index: **S01**
Within 8" of Joint: **NO**
Remarks:

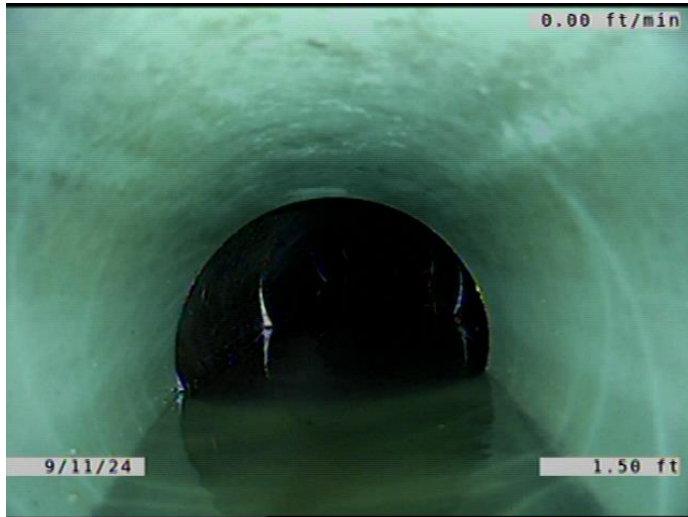
Code:	MGO
Description:	Miscellaneous General Observation
Distance (ft):	1.5
Structural Grade:	0
O&M Grade:	0
Clock Start/From:	
Clock To:	
1st Value:	
2nd Value:	
Value Percent:	
Continuous Index:	
Within 8" of Joint:	NO
Remarks:	HAD TO START IN THE PIPE DUE TO THERE NOT BEING A CHANNEL IN TH

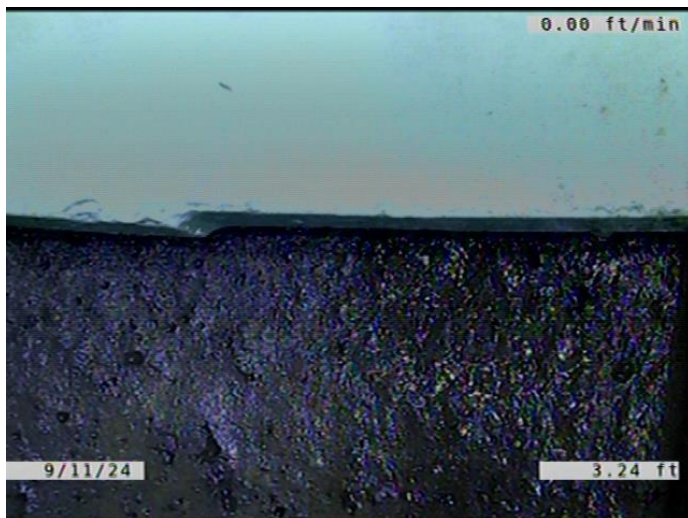
Code:	MMC
Description:	Miscellaneous Material Change
Distance (ft):	3.2
Structural Grade:	0
O&M Grade:	0
Clock Start/From:	
Clock To:	
1st Value:	
2nd Value:	
Value Percent:	
Continuous Index:	
Within 8" of Joint:	NO
Remarks:	PVC TO VCP

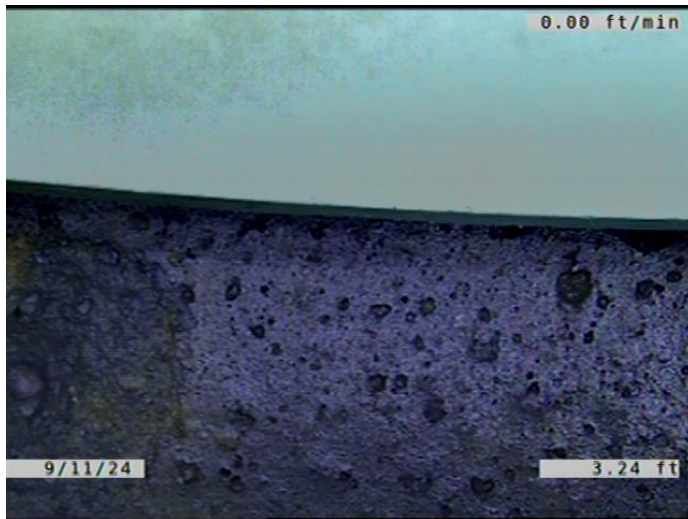
Code: **JOMD**
Description: **Joint Offset Medium Defective**

Distance (ft): **3.2**
Structural Grade: **3**
O&M Grade: **0**
Clock Start/From:
Clock To:
1st Value:
2nd Value:
Value Percent:
Continuous Index:
Within 8" of Joint: **NO**
Remarks:

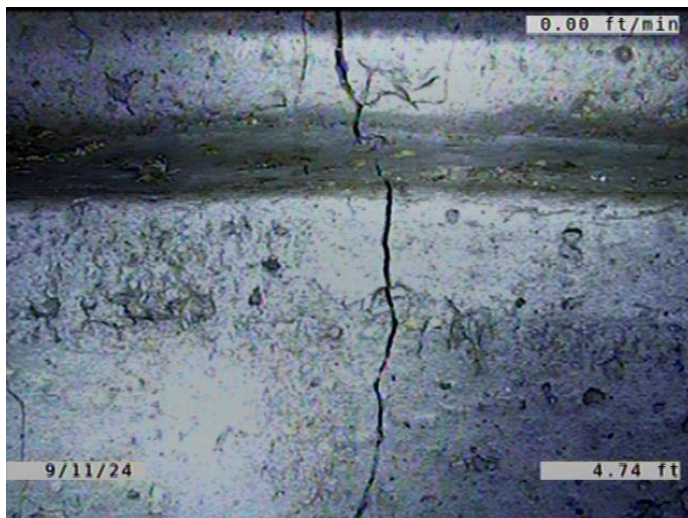
Code: **FM**
Description: **Fracture Multiple**

Distance (ft): **4.7**
Structural Grade: **4**
O&M Grade: **0**
Clock Start/From: **8**
Clock To: **4**
1st Value:
2nd Value:
Value Percent:
Continuous Index: **S02**
Within 8" of Joint: **YES**
Remarks:

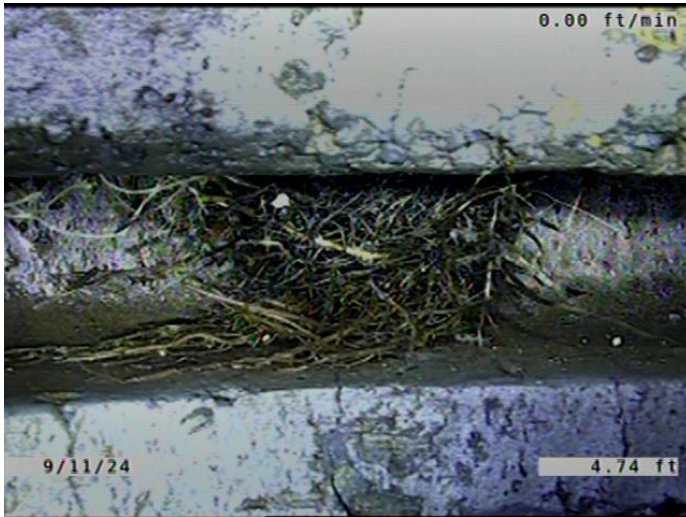
Code: **RFJ**
Description: **Roots Fine Joint**

Distance (ft): **4.7**
Structural Grade: **0**
O&M Grade: **1**
Clock Start/From: **8**
Clock To: **4**
1st Value:
2nd Value:
Value Percent:
Continuous Index: **S03**
Within 8" of Joint: **YES**
Remarks:

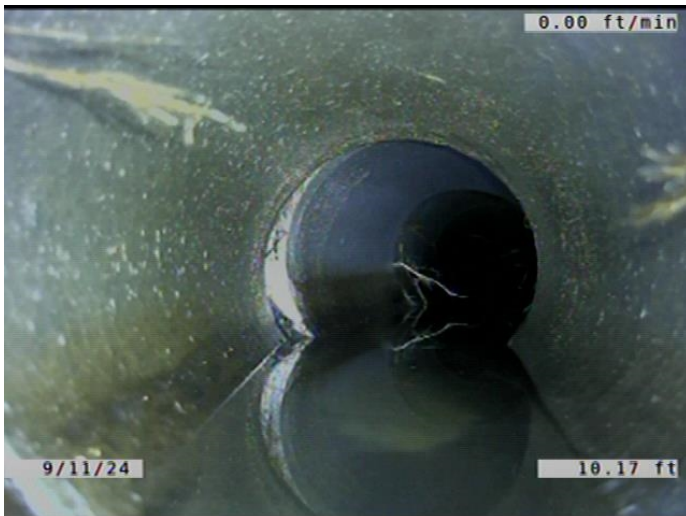
Code: **LR**
Description: **Line Right**

Distance (ft): **10.2**
Structural Grade: **0**
O&M Grade: **1**
Clock Start/From:
Clock To:
1st Value:
2nd Value:
Value Percent: **5.000**
Continuous Index:
Within 8" of Joint: **NO**
Remarks:

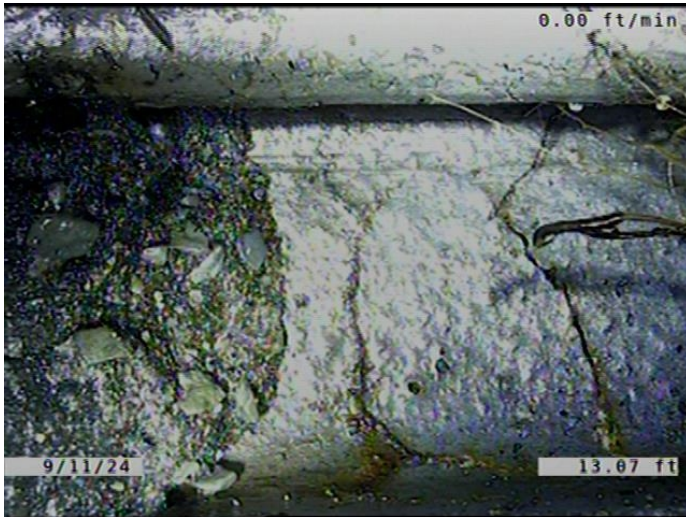
Code: **JAL**
Description: **Joint Angular Large**

Distance (ft): **13.1**
Structural Grade: **4**
O&M Grade: **0**
Clock Start/From:
Clock To:
1st Value:
2nd Value:
Value Percent:
Continuous Index:
Within 8" of Joint: **NO**
Remarks:

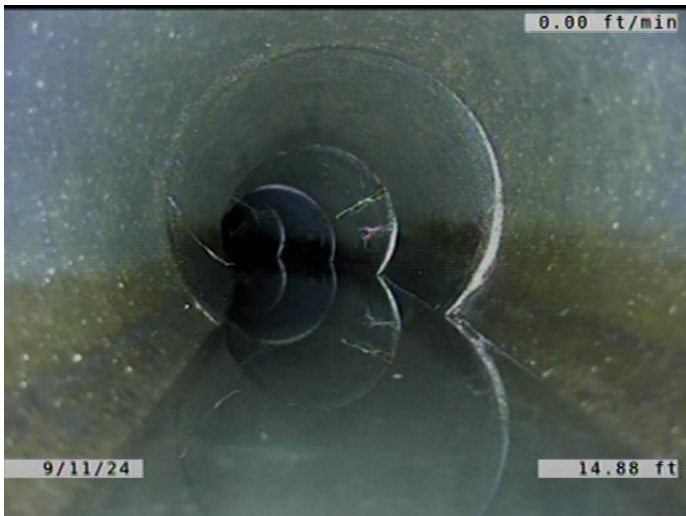
Code: **LL**
Description: **Line Left**

Distance (ft): **14.9**
Structural Grade: **0**
O&M Grade: **1**
Clock Start/From:
Clock To:
1st Value:
2nd Value:
Value Percent: **5.000**
Continuous Index: **S04**
Within 8" of Joint: **NO**
Remarks:

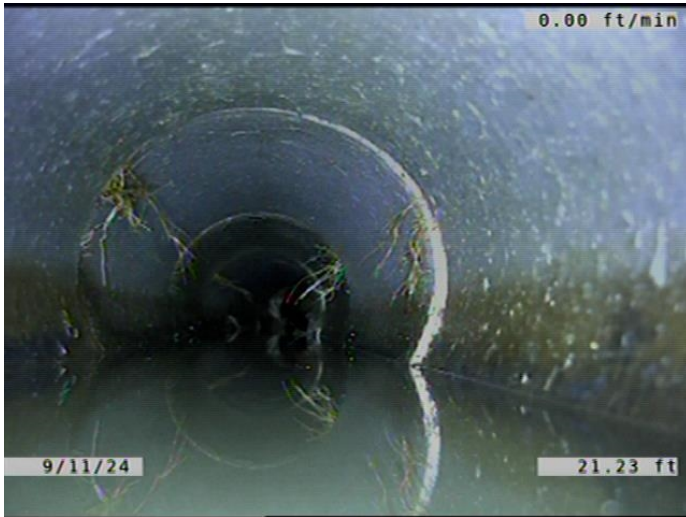
Code: **LL**
Description: **Line Left**

Distance (ft): **21.2**
Structural Grade: **0**
O&M Grade: **1**
Clock Start/From:
Clock To:
1st Value:
2nd Value:
Value Percent: **5.000**
Continuous Index: **F04**
Within 8" of Joint: **NO**
Remarks:

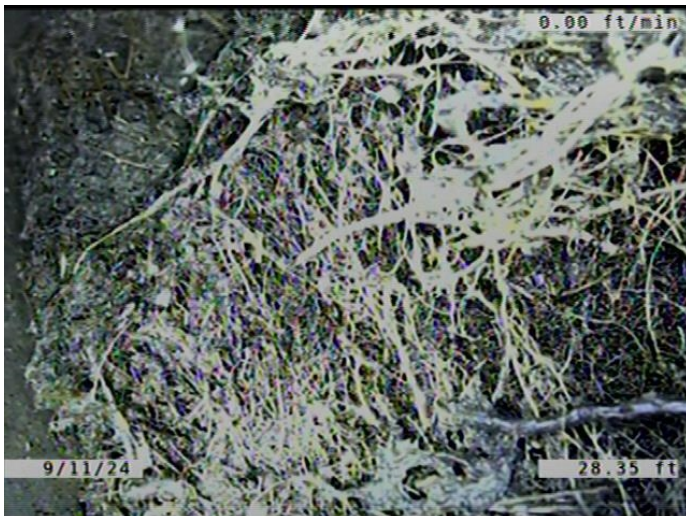
Code: **TFD**
Description: **Tap Factory Defective**

Distance (ft): **28.4**
Structural Grade: **0**
O&M Grade: **3**
Clock Start/From: **2**
Clock To:
1st Value: **6.000**
2nd Value:
Value Percent:
Continuous Index:
Within 8" of Joint: **YES**
Remarks: **100% PLUGGED WITH ROOTS.**

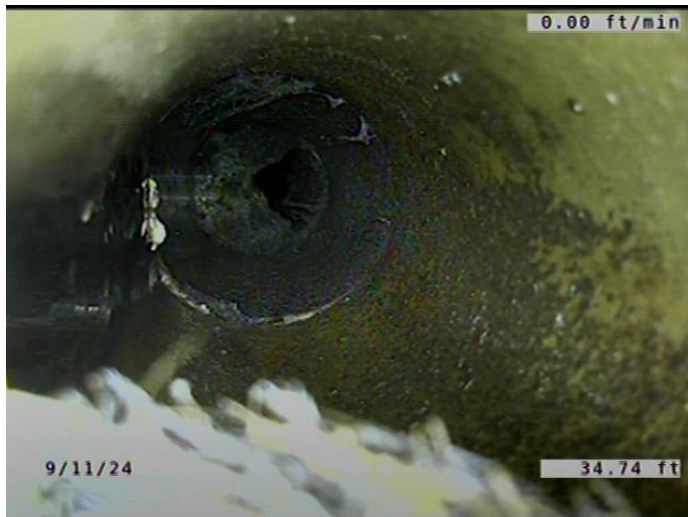
Code:	TBI
Description:	Tap Break-in Intruding
Distance (ft):	34.7
Structural Grade:	0
O&M Grade:	2
Clock Start/From:	9
Clock To:	
1st Value:	6.000
2nd Value:	3.000
Value Percent:	
Continuous Index:	
Within 8" of Joint:	YES
Remarks:	SERVICE IS 85% PLUGGED WITH ROOTS. ROOTS GROWING FROM TH

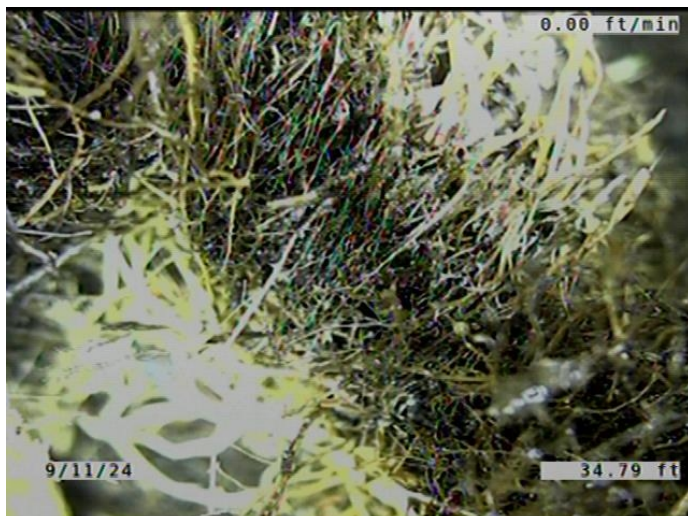
Code:	RMC
Description:	Roots Medium Connection
Distance (ft):	34.8
Structural Grade:	0
O&M Grade:	3
Clock Start/From:	8
Clock To:	11
1st Value:	
2nd Value:	
Value Percent:	5.000
Continuous Index:	
Within 8" of Joint:	NO
Remarks:

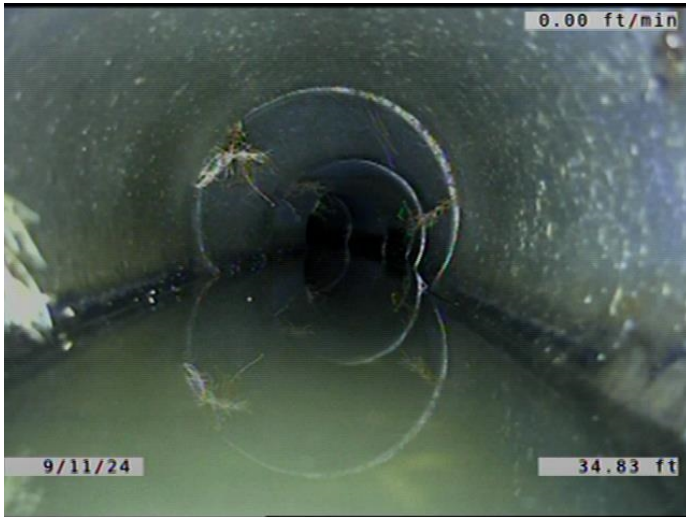
Code: **MWLS**
Description: **Miscellaneous Water Level Sag**

Distance (ft): **34.8**
Structural Grade: **2**
O&M Grade: **0**
Clock Start/From:
Clock To:
1st Value:
2nd Value:
Value Percent: **25.000**
Continuous Index: **F01**
Within 8" of Joint: **NO**
Remarks:

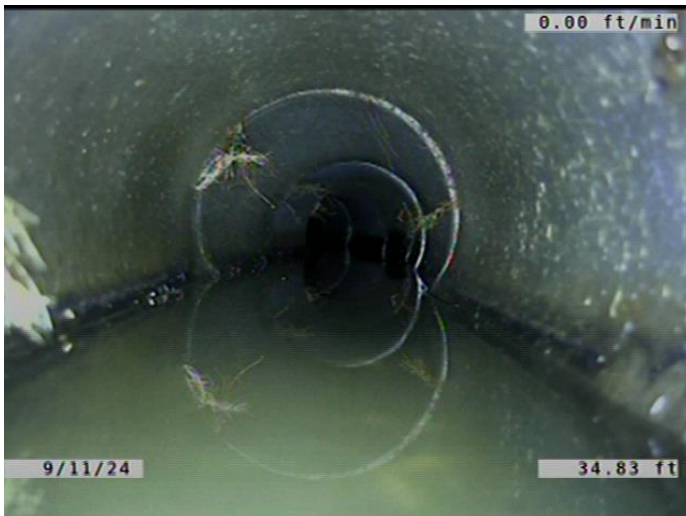
Code: **FM**
Description: **Fracture Multiple**

Distance (ft): **34.8**
Structural Grade: **4**
O&M Grade: **0**
Clock Start/From: **8**
Clock To: **4**
1st Value:
2nd Value:
Value Percent:
Continuous Index: **F02**
Within 8" of Joint: **YES**
Remarks:

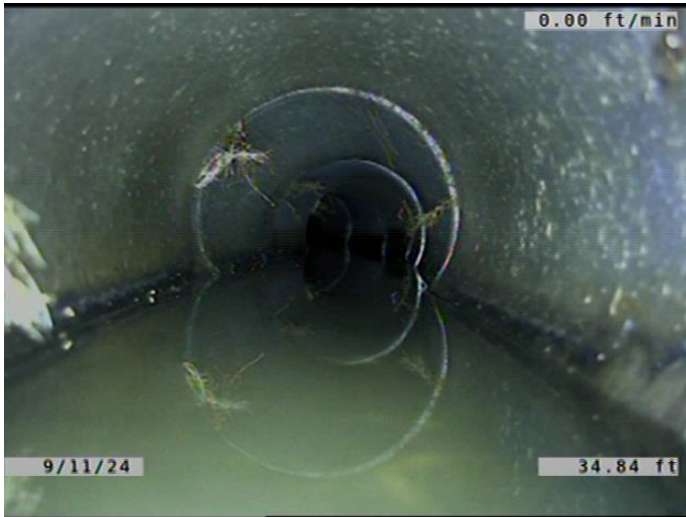
Code: **RFJ**
Description: **Roots Fine Joint**

Distance (ft): **34.8**
Structural Grade: **0**
O&M Grade: **1**
Clock Start/From: **8**
Clock To: **4**
1st Value:
2nd Value:
Value Percent:
Continuous Index: **F03**
Within 8" of Joint: **YES**
Remarks:

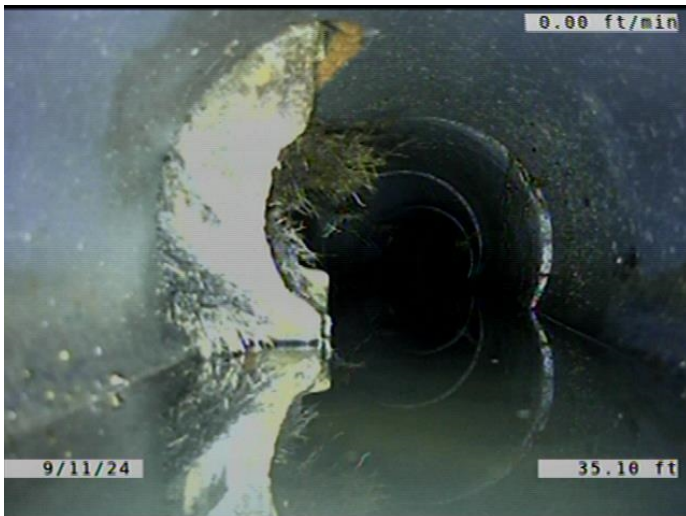
Code: **MSA**
Description: **Miscellaneous Survey Abandoned**

Distance (ft): **35.1**
Structural Grade: **0**
O&M Grade: **0**
Clock Start/From:
Clock To:
1st Value:
2nd Value:
Value Percent:
Continuous Index:
Within 8" of Joint: **NO**
Remarks: **CAMERA CANT MAKE IT PAST PROTRUDING TAP.**
