## Profile/Photo Observation Report

Street:	<b>E CLEVELAND AVE</b>	Flow Control:	<b>Not Controlled</b>
City:	<b>Hobart, IN</b>	Year Renewed:	
Location:	<b>Other</b>	Tape/Media #:	
Purpose:	<b>Not Known</b>	Dia/Height:	<b>8"</b>
Use:	<b>Sanitary</b>	Material:	<b>PVC</b>
Drain Area:	<b>NA</b>	Lining:	
Category:	<b>NA</b>		
Comment:

Location Details:		Direction of Survey:	<b>Upstream</b>
US MH:	<b>M-804-003</b>	DS MH:	<b>M-804-004</b>
		Total Length Surveyed (ft):	<b>84.0</b>

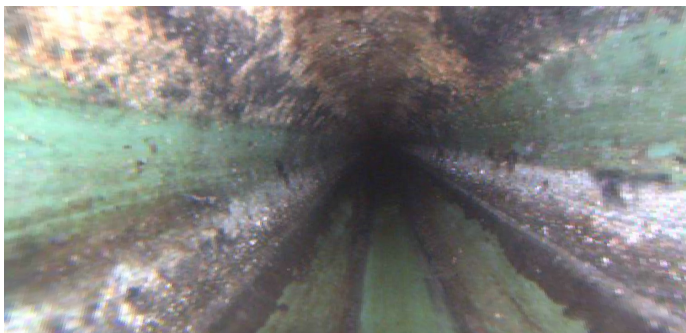
Code: **AMH**  
Description: **Manhole**

Distance (ft): **.0**  
Structural Grade: **0**  
O&M Grade: **0**  
Clock Start/From:  
Clock To:  
1st Value:  
2nd Value:  
Value Percent:  
Continuous Index:  
Within 8" of Joint: **NO**  
Remarks: **M-804-004**

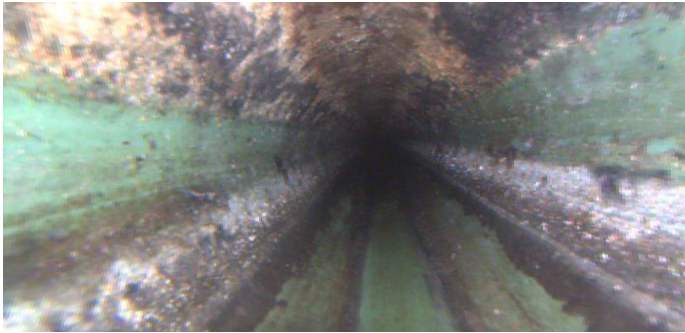
Code:	<b>MWL</b>
Description:	<b>Water Level</b>

Distance (ft):	<b>.0</b>
Structural Grade:	<b>0</b>
O&M Grade:	<b>0</b>
Clock Start/From:	
Clock To:	
1st Value:	
2nd Value:	
Value Percent:	<b>5.000</b>
Continuous Index:	
Within 8" of Joint:	<b>NO</b>
Remarks:

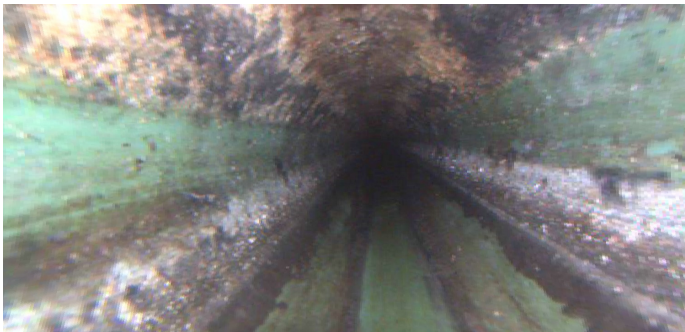
Code:	<b>DAGS</b>
Description:	<b>Deposits Attached Grease</b>

Distance (ft):	<b>.0</b>
Structural Grade:	<b>0</b>
O&M Grade:	<b>2</b>
Clock Start/From:	<b>7</b>
Clock To:	<b>5</b>
1st Value:	
2nd Value:	
Value Percent:	<b>5.000</b>
Continuous Index:	<b>S01</b>
Within 8" of Joint:	<b>NO</b>
Remarks:

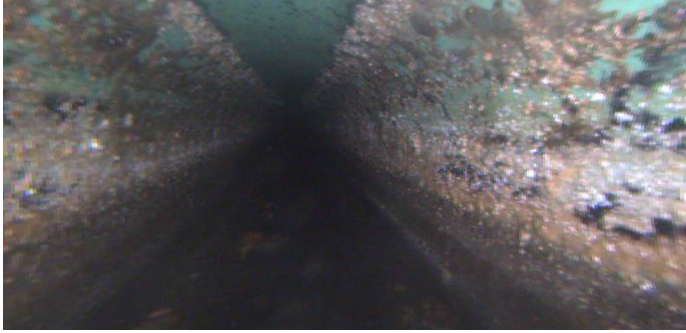
Code: **DSZ**  
Description: **Deposits Settled Other**

Distance (ft): **23.9**  
Structural Grade: **0**  
O&M Grade: **2**  
Clock Start/From: **6**  
Clock To:  
1st Value:  
2nd Value:  
Value Percent: **5.000**  
Continuous Index: **S02**  
Within 8" of Joint: **NO**  
Remarks: **debris**

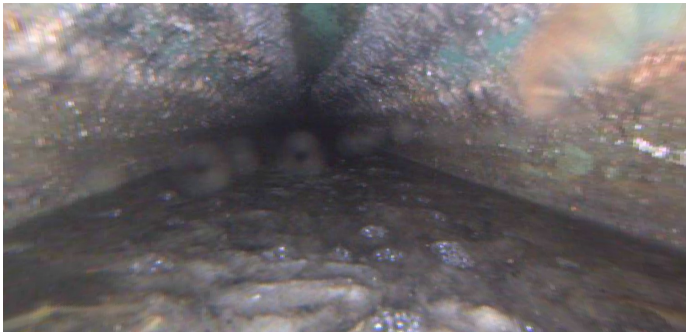
Code: **MWL**  
Description: **Water Level**

Distance (ft): **84.0**  
Structural Grade: **0**  
O&M Grade: **0**  
Clock Start/From:  
Clock To:  
1st Value:  
2nd Value:  
Value Percent: **50.000**  
Continuous Index:  
Within 8" of Joint: **NO**  
Remarks:

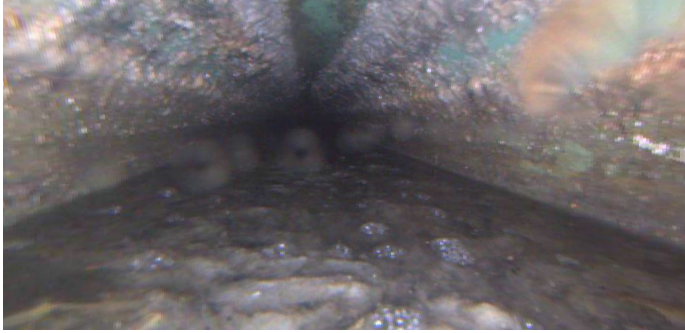
Code: **MSA**  
Description: **Abandoned Survey**

Distance (ft): **84.0**  
Structural Grade: **0**  
O&M Grade: **0**  
Clock Start/From:  
Clock To:  
1st Value:  
2nd Value:  
Value Percent:  
Continuous Index:  
Within 8" of Joint: **NO**  
Remarks: **no blockage**

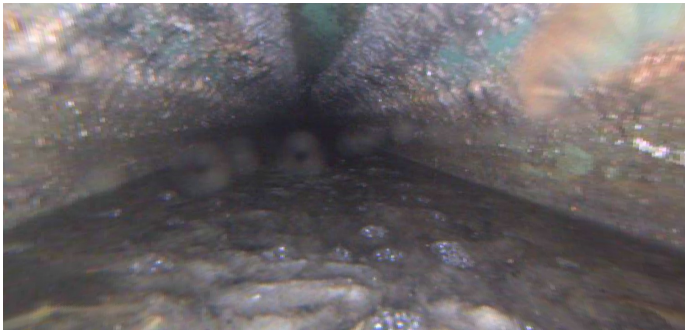
Code: **DSZ**  
Description: **Deposits Settled Other**

Distance (ft): **84.0**  
Structural Grade: **0**  
O&M Grade: **2**  
Clock Start/From: **6**  
Clock To:  
1st Value:  
2nd Value:  
Value Percent: **5.000**  
Continuous Index: **F02**  
Within 8" of Joint: **NO**  
Remarks: **debris**

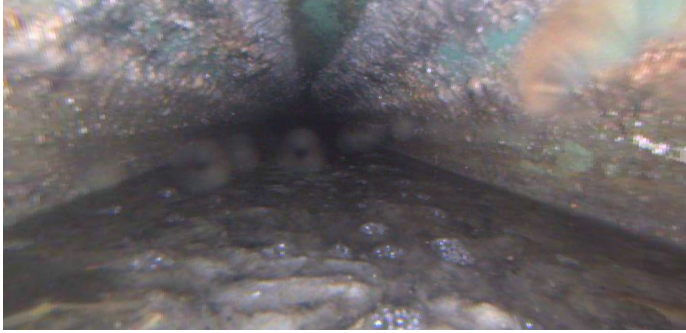
Code:	<b>DAGS</b>
Description:	<b>Deposits Attached Grease</b>
Distance (ft):	<b>84.0</b>
Structural Grade:	<b>0</b>
O&M Grade:	<b>2</b>
Clock Start/From:	<b>7</b>
Clock To:	<b>5</b>
1st Value:	
2nd Value:	
Value Percent:	<b>5.000</b>
Continuous Index:	<b>F01</b>
Within 8" of Joint:	<b>NO</b>
Remarks:
